# Failure Analysis of Billet Caster Tundish Tilter Bolts

**Abstract** - A detailed failure analysis was carried out on prematurely failed 60mm diameter bolts of billet caster tundish tilter. The analysis involves visual examination, chemical composition, microstructure, inclusion, bulk hardness, charpy impact toughness, fractography of the failed and new bolt. The result show that the bolts were of 34CrNiMo6 grade with tempered martensitic microstructure, having MnS and alumina inclusions. All the bolts has failed at thread grooves with the river mark on the failed surface indicating fast fracture of the bolts. The bolts were found to be heat treated at a wrong tempering temperature leading to poor impact toughness and hence while tilting; the bots were failed prematurely due to impact load from the jerk. A mix mode of failure with numerus cracks are seen on the fracture surface indicating poor toughness of the bolts conformed by charpy test. It is recommended to correct the heat treatment as per the specification to prevent such premature failures.

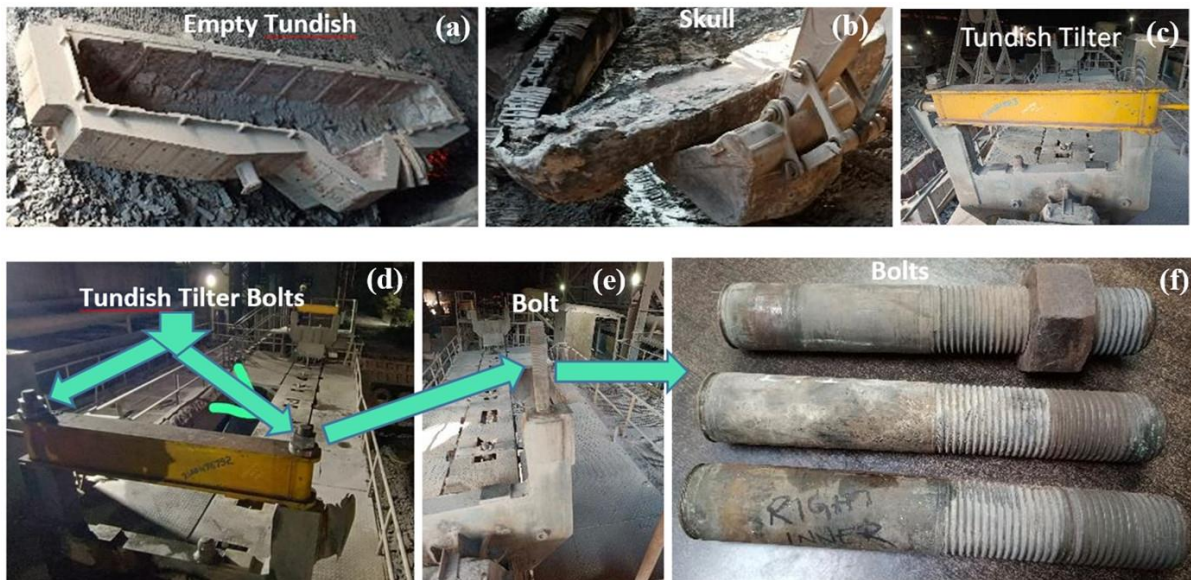
Fig. 1 shows digital image of (a) empty tundish, (b) skull from the tundish (c) tundish tilter (d) – (f) bolts on tundish tilter which were being failed. Fig. 2 (a) - (d) shows close view of the bolts with their fracture surface. It can be seen that the bolts are failed at the thread regions where the stress concentration is supposed to be high. The river marks on the fracture surface indicates fast fracture of the bolts [13].

**Fig-1:** (a) Empty Tundish (b) Skull (c) Tundish Tilter (d)-(f) Tundish Tilter Bolts.

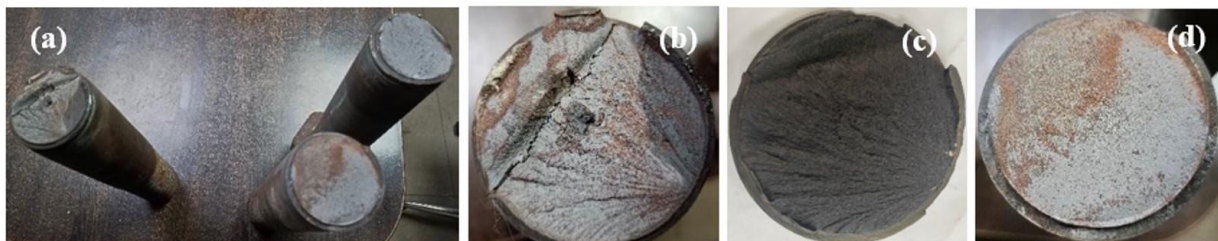
**Fig-2:** (a) Failed tundish tilter bolts, (b) – (d) fracture surface of the three tundish tilter bolts.

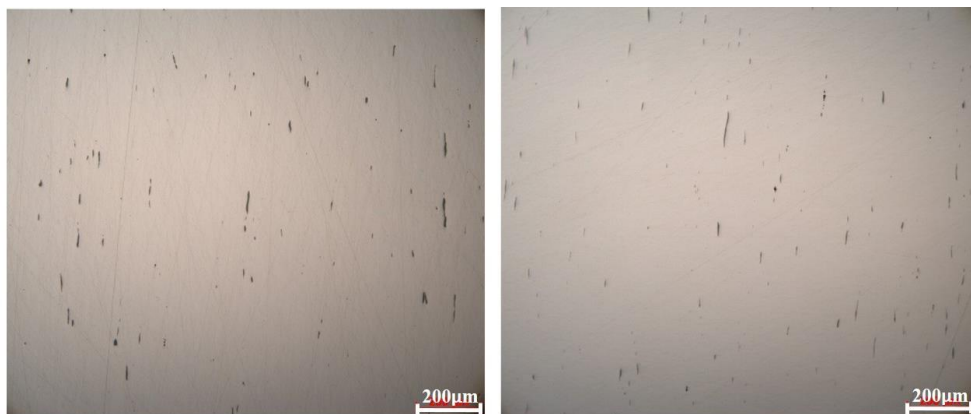
The optical microstructure of the steel show inclusion as shown in Fig.3 (a) and (b) obtained from new bolt and failed bolt respectively to evaluate the worst field inclusion ratings as per ASTM E-45 as in Table 2. The inclusion rating in the failed and the newly made bolt is given. The bolt has high level of inclusion, but in service the high level of inclusion has potential to initiate fatigue cracks.

**Fig-3:** Optical image of the inclusion in new bolt(a) and failed bolt (b).

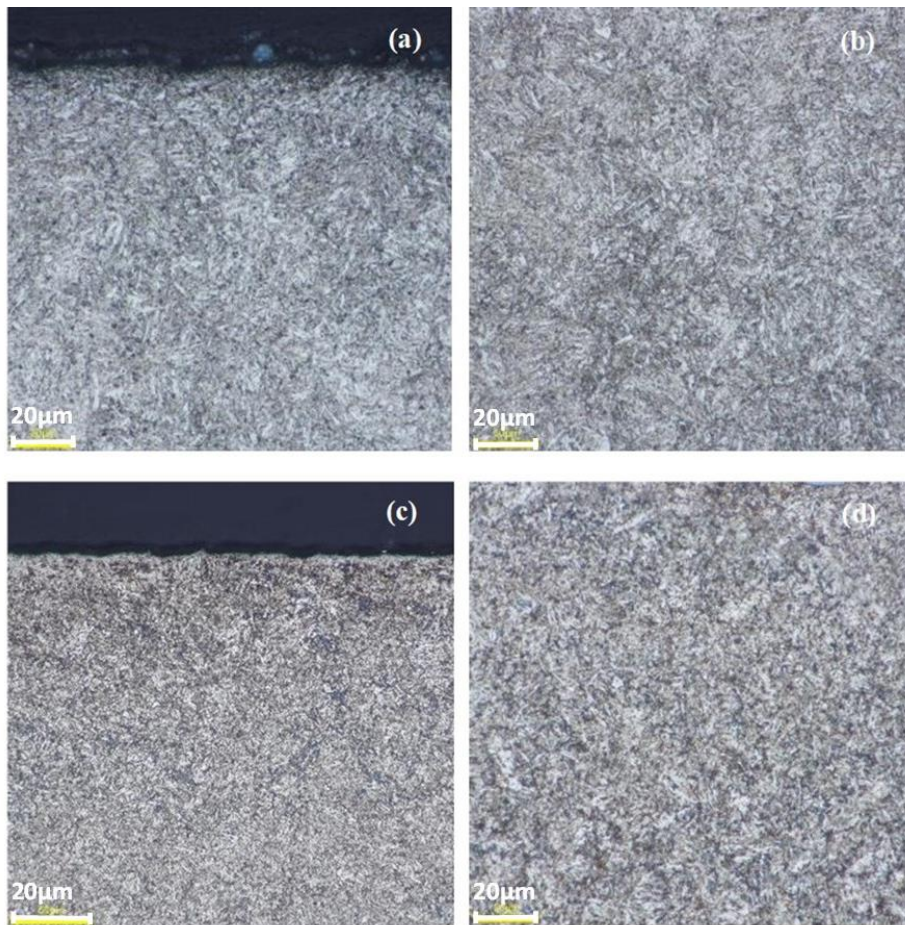
The optical microstructure in Fig. 4 (a) and (b) shows the new bolts at the edge and center region whereas (c) & (d) corresponds to the microstructure of the failed bolts. The microstructure of the new and failed bolts were found to be tempered martensitic in nature. No significant variation in microstructure was seen from the surface to the center of the bolts indicating no surface hardening treatment is made on the bolts.

**Fig-4:** Optical microstructure (a) edge and (b) center of the new bolt with (c) and (d) are their corresponding microstructure of the failed bolt.

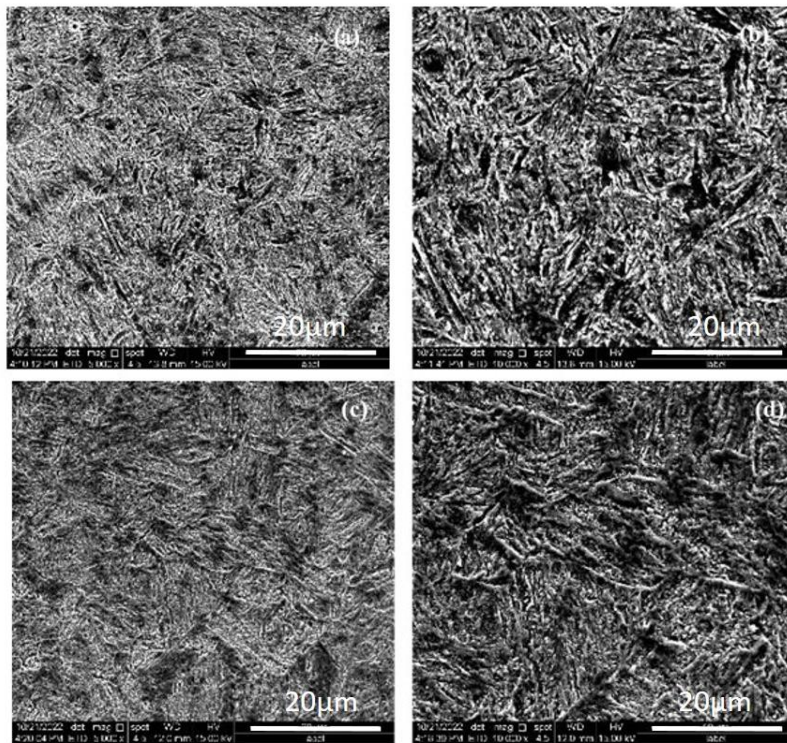
The SEM microstructure of the new bolt at the edge region at low and high magnification is shown in Fig.5 (a) & (b) and that of the failed bolt in Fig. 5 (c) & (d) respectively. The core microstructure of the new bolts is shown in Fig. 6(a) & (b) and that of the failed bolts is shown in Fig. 6(c) & (d) respectively. The tempered martensitic structure is seen in the micrographs of both the new and old bolts. However, the martensitic laths found in the microstructure of the new bolts indicating its low temperature tempering.

**Fig-5:** SEM micrograph (a) & (b) low and high magnification of the new bolt at the edge region with (c) & (d) corresponding micrograph of the failed bolt.

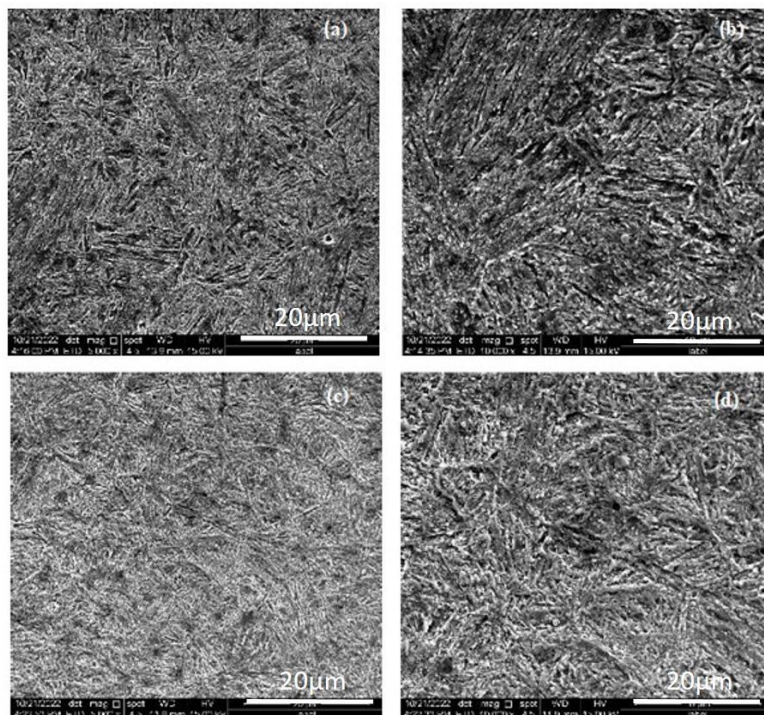
**Fig-6:** SEM micrograph (a) & (b) low and high magnification of the new bolt at the center region with (c) & (d) corresponding micrographs of the failed bolt.

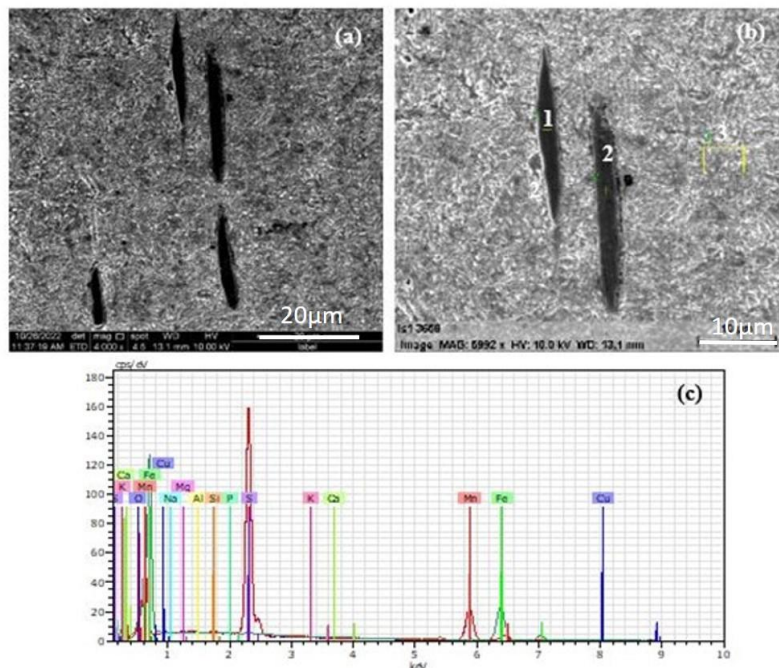
Numerous inclusions are seen in the SEM micrograph as shown in Fig. 7(a). The EDS analysis was done on the inclusion 1 and 2 and on the matrix 3 shown in (b) with the spectrum of the EDS in (c). The chemical composition of the inclusions along with the matrix is shown in Table-3, shows that the inclusions as MnS. Such large inclusions and their populations are not desirable for dynamic application of any engineering components. Inclusions are the points of stress concentration regions for fatigue crack initiation, which propagates for final fracture of the engineering components.

Fig-7: (a) SEM micrograph of inclusions (b) SEM-EDS of the inclusions 1 & 2 with 3 at matrix (c) SEM-EDS spectrum conforming MnS inclusion.

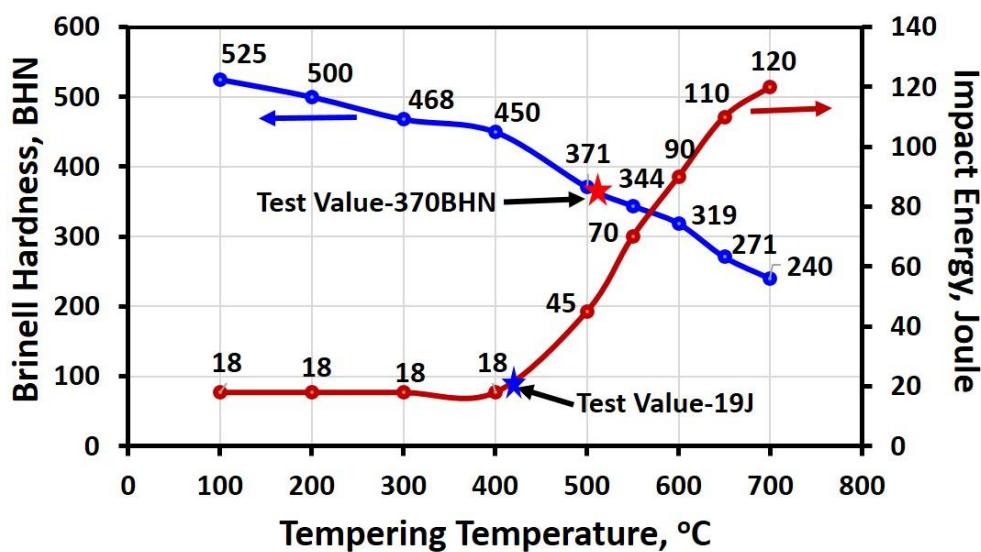
The average bulk hardness (Brinell hardness) was found to be 370 BHN for the failed bolt and 380 BHN for the new bolt. The hardness and impact toughness data with tempering temperature were found from the literature for the 34CrNiMo6 grade and plotted in Fig. 8. It can be seen that the hardness for both the new and failed bolts are corresponding to the tempering temperature around 500°C which corresponds to an impact energy of 45Joule. Hence, to conform the exact value of impact toughness standard samples of Charpy impact specimen were made and tested in a Zwick/Roell make impact tester. The results were found to be 19 Joule, corresponding to 425°C tempering temperature. Hence, it is inferred that the low impact energy obtained in the bolts, due to low temperature tempering.

Fig- 8: Bulk hardness and impact energy of the 34NiCrMo6 grade with tested value of failed bolts.

Poor toughness of the bolts (19Joule) due to low temperature tempering is the major cause of failure of the bolts and hence it is suggested to temper the steel as per specification of 540 to 660°C to get very good impact toughness in the range of 70-110Joule or minimum of 45Joule. The material surface hardening can further improve the fatigue life of the bolts. Use of clean steel can give better life of the steel in dynamic loading condition by minimizing the stress concentration from inclusions. As the bolts are experiencing high temperature (100-200°C) there is a chance of loosening of the bolts and hence need to be tightening periodically to avoid fatigue failure of the bolts.

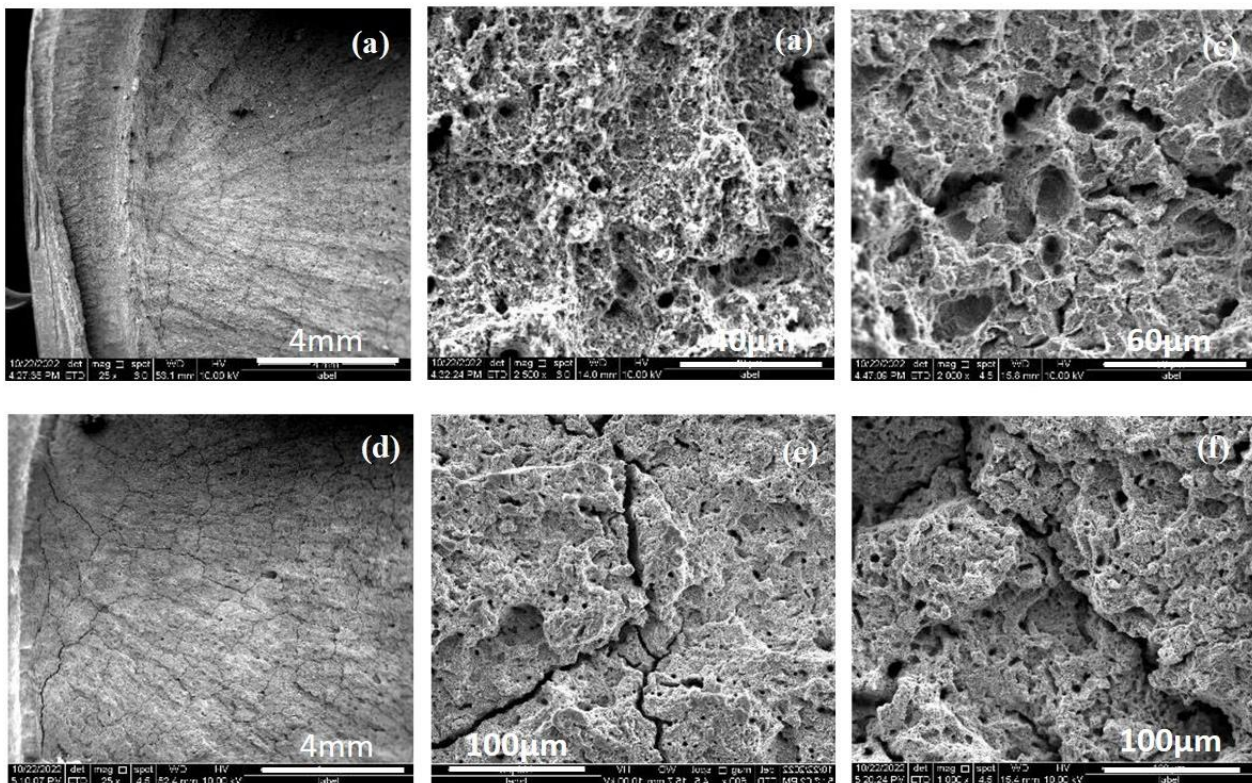
SEM Fractograph of the bolt-1 and bolt-2 at various magnifications are shown in Fig. 9 (a)-(c) and (d)-(f) respectively. The radiating cracks are indicative of fatigue failure of the bolts. The river marks are indicative of low cycle fatigue of the bolts also failure in impact load. The cracks in the samples indicates poor toughness of the steel. The fractography of the failed bolt after impact test is shown in Fig. 10. Mixed mode of failure with both cleavages and dimples are seen in the fracture surface of the bolt.

Fig-9: (a)- (c) low to high magnification fractographic image of the bolt-1 with (d)-(f) corresponding micrographs of the bolt-2.

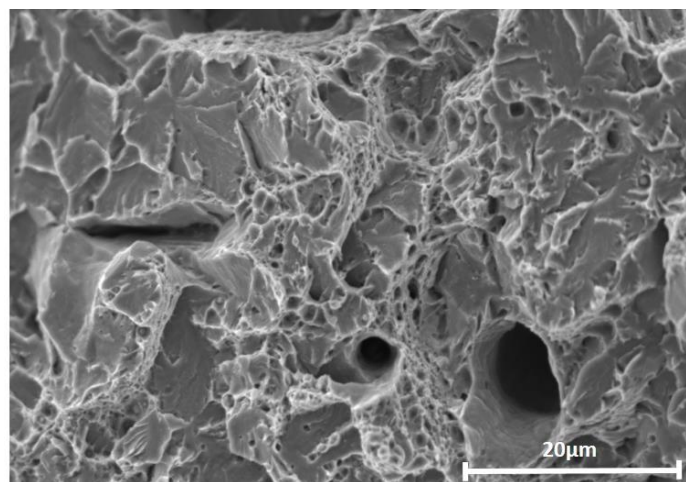
Fig-10: Fractography of the bolt after impact test.
