Material Characterization of Buried GFRP Pipeline Failed during Hydrostatic Testing

^aDepartment of Scientific Services, Metallography Laboratories, Tata Steel Limited, Jamshedpur 831007, India

Abstract - Glass Fiber Reinforced Plastic (GFRP) pipe is made up of diverse materials, the qualities of the different materials combine to provide superior properties. GRP pipes consist of glass fibers, vinyl ester resins, or unsaturated polyester and different reinforcing agents. There was premature failure of GFRP composite pipes during hydrostatic (hydro) testing while laying out in the construction site. The hydro test is a process where components are tested for strength and leaks before putting them in service. Two pipe samples, one referred to as good pipe and another referred to as leaked or used pipe, were investigated to find out the root cause of failure. The investigation consisted of field-visit, studying the layout procedure, visual observation, microstructural characterization, Raman spectroscopy analysis, Thermogravimetric analysis (TGA) and Fourier transform infrared spectroscopy (FTIR) analysis analyses. Visual observations of the leaked or used pipe sample reveals some a

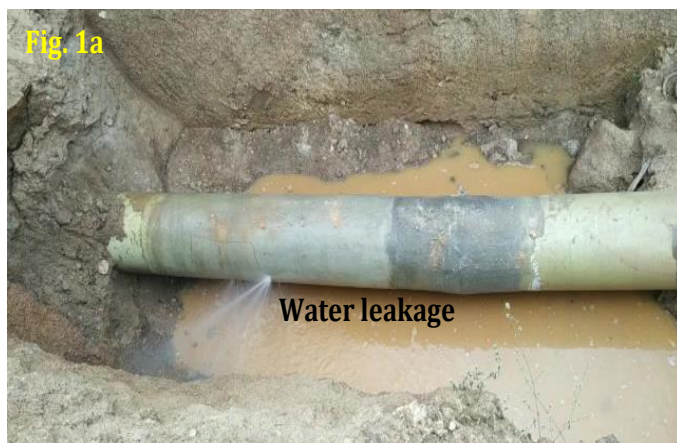
During laying of GRP pipe of around 4500 m long pipeline network, leakage was observed during hydrostatic test. The diameter of pipe was 500 mm and thickness were around 7.4 mm. After laying down the pipeline underground, a hydrotest procedure (as per ASME B31) [5] was carried out to check any leakage through pipeline as per standard. In hydrotest, the pipeline is subjected to a pressure of 1.5 times the design pressure for approximately 1 hour and any drop in pressure during that time indicates a leakage. Pipelines of different length were laid down at 9-10 locations, and the hydrotest was conducted at all locations. At all locations, first a leakage through the joints was observed (Fig.1a-b). The manufacturer of the pipes provided lamination at all the joints where leakage was found. After providing lamination at joints, leakage from joints stopped. But hydrotest failed due to seepage from the main pipe body at some locations. To conduct the hydro test, lamination was provided on the seepage locations, but the test failed as the location of leakage could not be detected since most part of pipeline is underground and not visible, except joints.

Fig.1a: Leakage through main pipe body; **Fig.1b:** Seepage through main pipe body

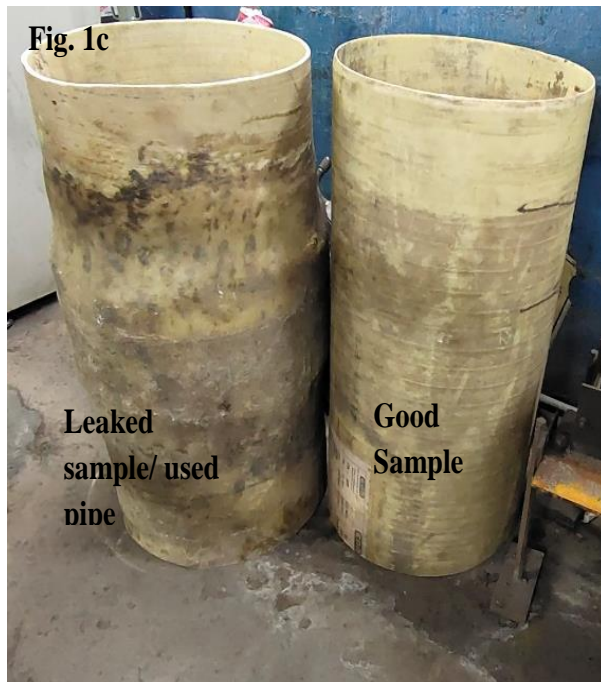
Two pipe samples were received for investigation to find out the root cause of failure. Leaked or used sample refers to the part of the pipe which was in service, and leakage was found through it during hydro test (Fig.1c). However, the leaked sample has a coupler joint within it and a thick layer of lamination was observed on it. Therefore, the location of leakage is not clear. Good pipe refers to the part of pipe which was pass though hydro test.

Fig.1c: Pipe samples received for investigation; **Fig.1d:** Air pockets and adherent materials; **Fig. 1e:** Heterogeneity of colors

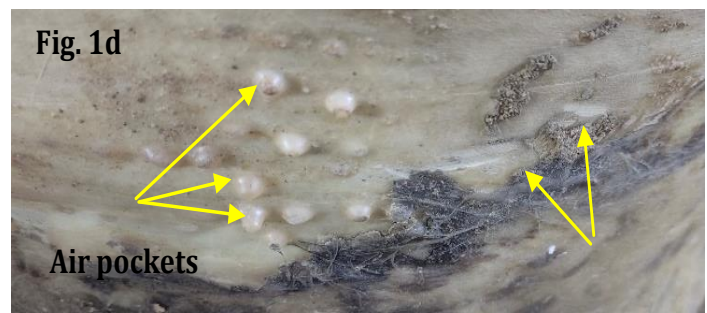
Visual observations of leaked pipe sample revealed some abnormal features like air pockets, adherent foreign materials, visible fibers and heterogeneity of colors (Fig 1d-e). When the Curing speed is too high (styrene is entrapped in surface) air pockets were observed in the surface. Visual observations of good pipe sample didn't reveal any such abnormal features.

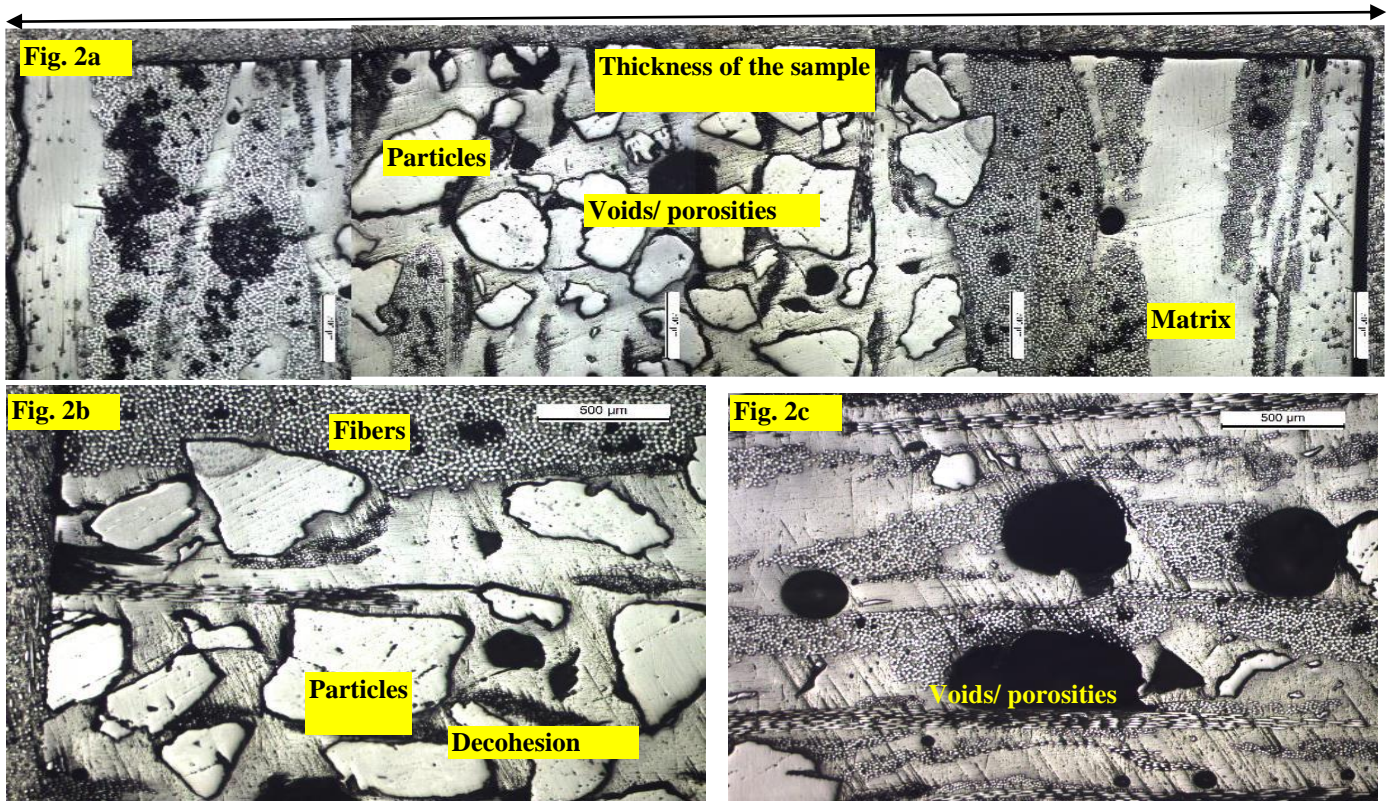
The samples were prepared in EXTEC Labcut 1010 Low Speed Diamond Saw for precision cutting of a GRP pipe micro sample. Samples were cut with minimal damage and deformation. Variable wheel rotation speeds were used with range from 100 to 200 rpm for cutting the GRP pipes. The microstructures of the composites were analysed by optical microscopy and scanning electron microscopy to observe the different component and presence of voids along with the distribution of the fibers. In case of Leaked sample, volume fraction of fibers was observed to be very less compared to resin matrix; distribution of fibers was observed to be non-uniform (Fig.2a). Numerous voids or porosities were observed in the sample; voids were found to be bigger in size and more in numbers (volume fraction of voids: $V_v < 25\%$ volume fraction of fibers: V_f ranging from 35-40%) compared to those of good GRP Pipe sample (volume fraction of voids: $V_v < 10\%$ volume fraction of fibers: V_f ranging from 50-65%) as shown in Table 1. Plenty of particle like features were observed in the matrix. Decohesion or separation between the matrix and particles were distinctly observed (Fig.2b-c). Both the samples were having non-uniform sand content which may result in false weight gain and reduced the strength of composite as they hinder the bonding between fibers and polymer.

Fig.2a-c: Microstructural examination of leaked/used pipe at different magnifications.

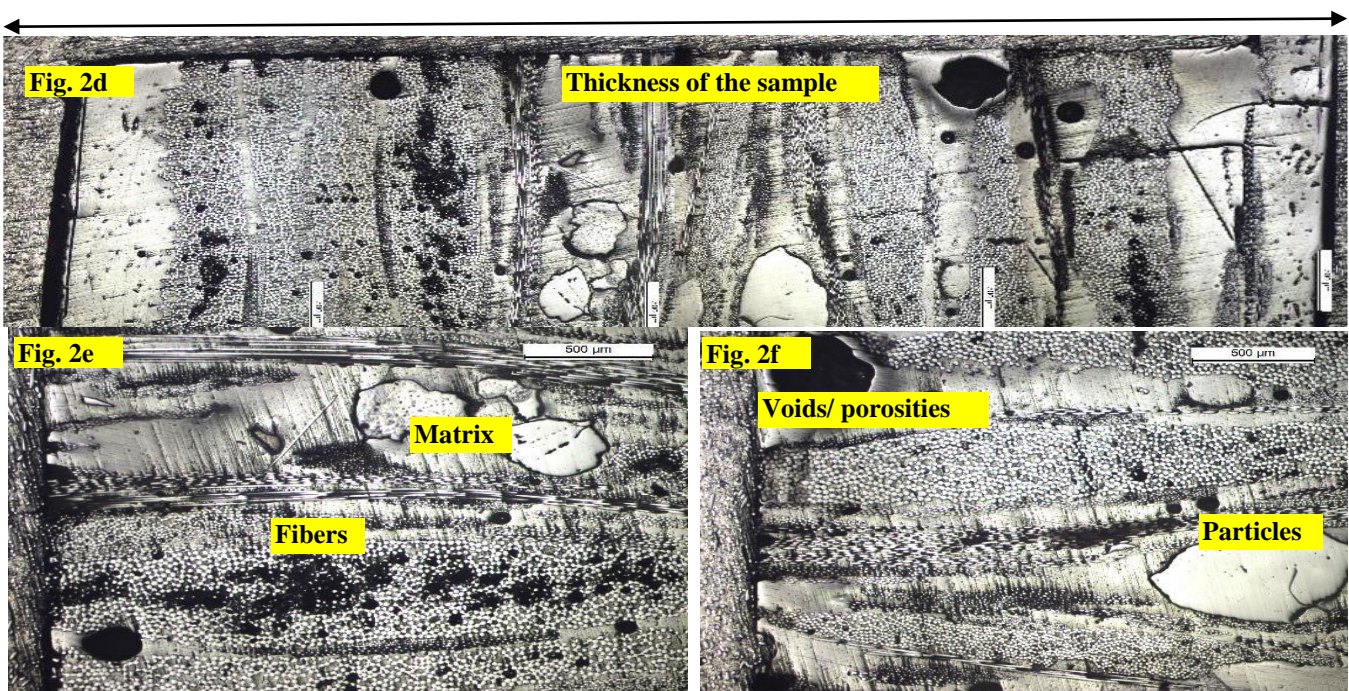
To make the process cost-effective, sand was inserted between the filament wound layers, as a part of shell wall. The structural wall of the pipe was formed by an inner layer of quartz sand-filled polyester resin, followed by a layer continuous fibrous glass strand roving saturated with polyester resin, then another ply of sand-filled resin and, finally four layers of wound continuous glass fiber composite [6]

Fig.2d-f: Microstructural examination of leaked/used pipe at different magnifications.

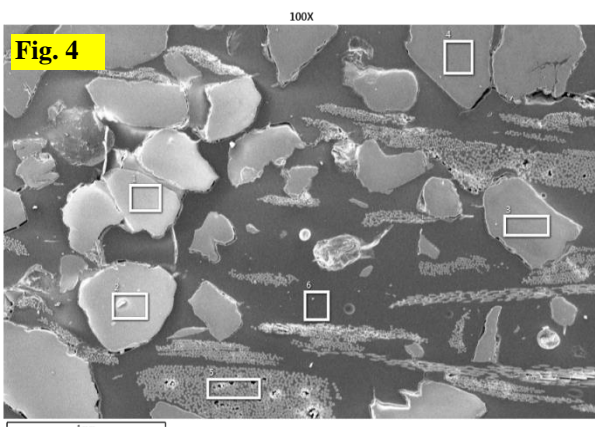
Two GRP pipes (Leaked and Good sample) were observed by Field Emission Gun Scanning Electron Microscope (FEG-SEM). The GRP pipes were observed directly without any coating. The accelerating voltage was 5 kV. EDX analysis of the GRP pipes was conducted using a JEOL JSM 6460LV SEM instrument (JEOL Ltd., Tokyo, Japan) with a silicon drift detector. The testing was performed at 5^{10-8} A probe current and 15 keV accelerating voltage. The GRP pipes were coated with gold using a vacuum coater. The gold input was manually withdrawn from the final EDX data. EDX analysis of particles revealed significant content of Si and O suggesting presence of sand (~95%) as shown in Table 2. Fibers were non-uniform and varying in size. Large voids with entangled fibers inside were observed (Fig.4). Voids present were very big (~1386 micron max.) in size.

Fig.4: EDX analysis of the leaked pipe sample

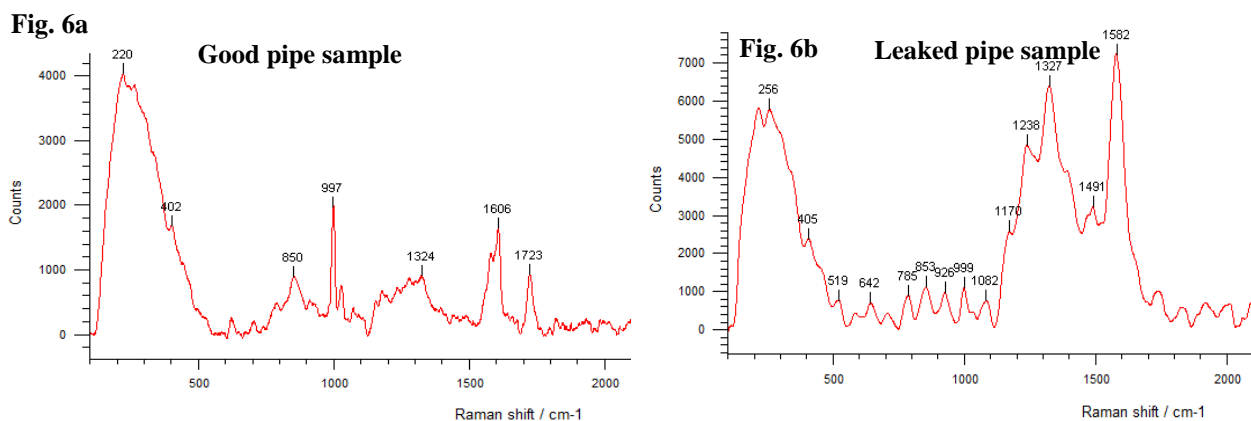
Fig.6a-b: Raman Spectroscopy Analysis of leaked and good pipe analysis

Table 3 presents the peak assignments and it can be observed that peak for PET is not seen in case of the leaked pipe sample indicating a weaker polymerization. Furthermore, peak assignments of leaked pipe sample suggest the presence of OPA, IPA and TPA indicating a mixture of all the 3 isomers, whereas presence of only TPA is observed in case of the good pipe sample. Thus, in case of leaked pipe, it can be said that resin is contaminated, and polymerization is also weaker, which could cause failure of the sample during the end application.

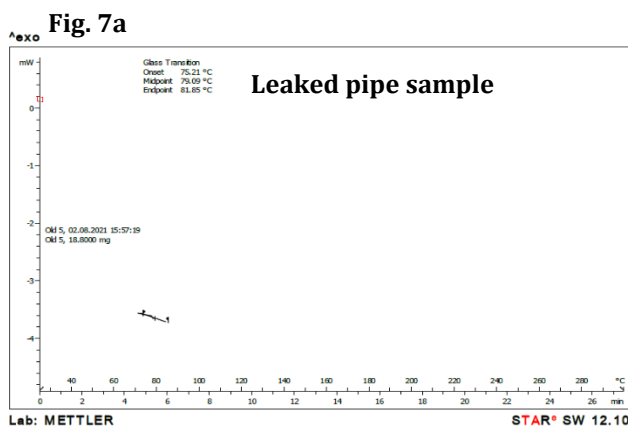
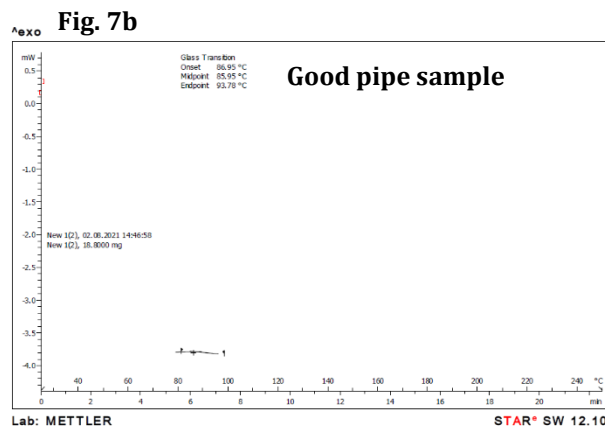
TMDSC is a thermal analysis technique that has been found to be an accurate tool for measuring the temperatures of various transitions occurring in materials. In the present investigation, the TMDSC was employed to determine the Glass Transition Temperature (T_g) value of the composite pipe materials. T_g is the temperature range during which the polymer shifts from a tough glassy state to a soft rubbery state. The test was conducted from 30°C to 250 °C at the heating rate of 10 °C/min. T_g value of leaked pipe material showed a relatively lower value than that of new pipe material Fig 7a-b and Table.4. At temperatures above T_g, a polymer experiences a sudden drop in its mechanical stiffness. Typically, when mechanical stiffness is desired, a polymer's service temperature should be below its T_g.

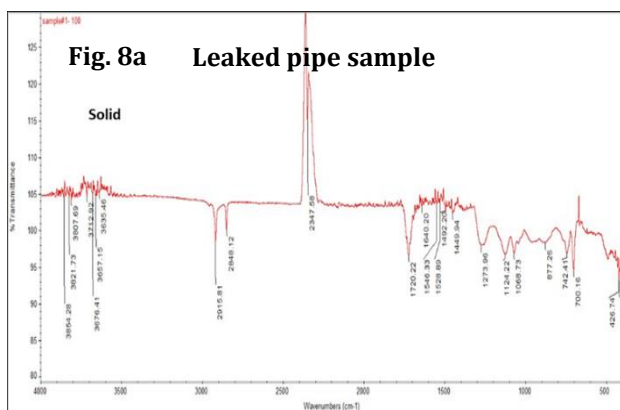
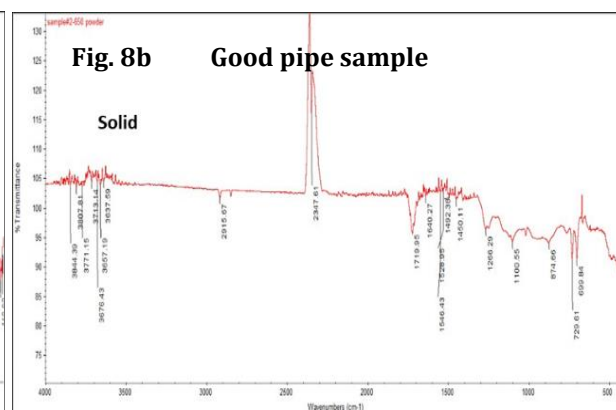
The FTIR analysis was done using a Nicolet Magna 550 Fourier transform infrared spectroscopy (FT-IR) analyzer with a resolution of 4 cm⁻¹ in the range of 400-4,000 cm⁻¹ wave number. FTIR analysis shows that the intensity of FTIR peaks for leaked or used pipe was lower than that of new or unused pipe. Peak assignments for both the samples are presented in Table 5. From these observations, it is seen that peak position 1643 cm⁻¹ is present in case of the leaked pipe sample which is a characteristic assignment for TPA [10-12]. Thus, the leaked pipe sample is not pure in form which can also be correlated to observations of Raman analysis and is prone to failure.
