Failure analysis of the multistage de-scaling pump impeller of the hot strip mill plant

R&D and Scientific Services, JSW Steel Ltd, Bellary-583275, Karnataka-India

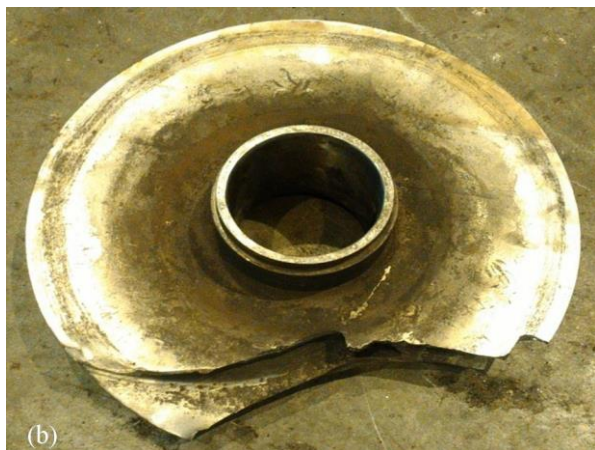
Fig-1 (b) Damaged impeller

Visual examination of the damaged impeller revealed that the crack originated at sharp edge or other stress raisers, crack first initiates and then propagate to critical size, at which time sudden failure occurs. The fatigue life consists of crack initiation and propagation. On the other hand, when fatigue failures are caused by inclusion or pre-existing crack-life defects, the entire life consists of crack

propagation. Such situations are commonly encountered during service failure [08]. The stainless-steel impeller as shown in Figure 1(b) was a curve-shaped vane with a diameter of 305 mm. Figure 2 (a) and 2 (b) show that the material loss due to erosion and the cavities was observed.

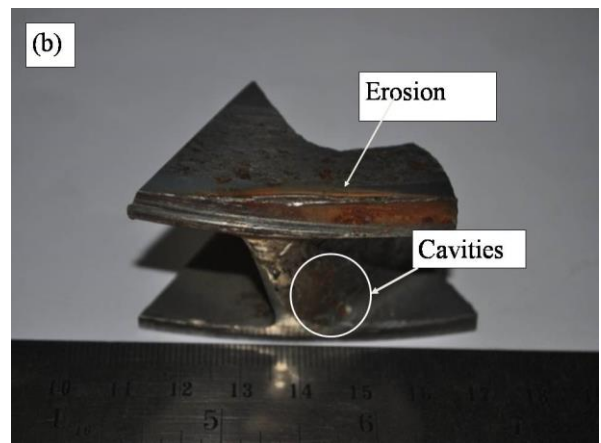
Fig- 2 (b) Erosion and cavities

reveals at sharp edge or other stress raisers, crack first initiates and then propagate to critical size where erosion and the cavities observed, the formation of cavities & erosion because of variation of a pressure and turbulent flow inside the casing. The chemical analysis confirms that the impeller material is a martensitic stainless steel; the actual chemical composition shows carbon, silicon and manganese somewhat on the lower side as can be seen in table-1. The universal hardness in Brinell scale at room temperature taken, the results of obtaining hardness values are lower than the specified standard hardness as seen in table-2. The fractography by EPMA showed as a mixed fracture mode of brittle cleavage and fatigue rupture. From the EDS analysis of the failed sample it is observed that there is a deposition of Cr along the crack line. The microstructure shows light contrast area is ferrite and dark contrast area is martensite phase. Thus premature failure of impeller happened from a fatigue crack through continued operation and changes in operational conditions.

Check the material properties and composition matches with the specified standard, and avoid the pressure variation inside the casing for future failure

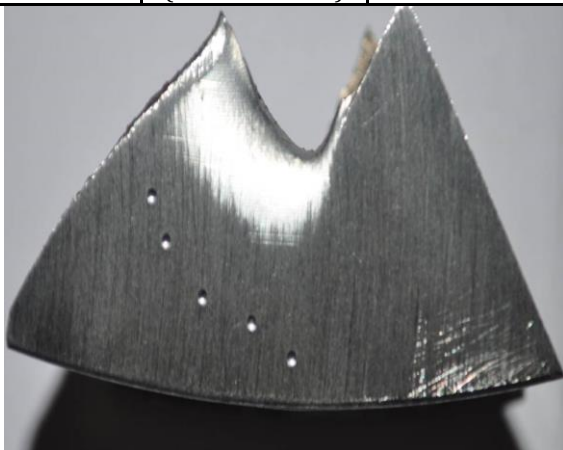
Fig-3: sample for hardness test

A hardness value of the machined impeller sample is presented in Table 2 and sample as shown in Figure 3. The brinell hardness was evaluated as per the standard ISO 6506-2:2005 [10] in Wolper Wilson instruments, model 930N having ball indentation ball size 2.5 mm with weight applied 187.5 kg. The measured hardness values are found to be much lower than that of the specified standard value for the equivalent AISI-414 grade.

The estimated value of tensile strength (772 MPa) of impeller is found much lower than that of the specified standard tensile strength of 1555 MPa [11].

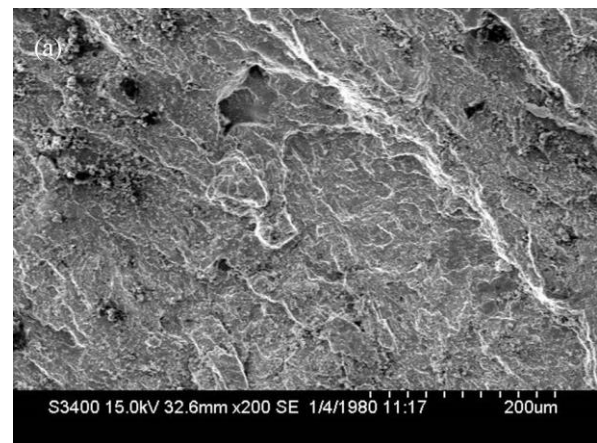
Fig-4: (a) Surface of brittle cleavage fracture

The EPMA examination of the fracture surfaces was identified as a mixed fracture mode of brittle cleavage and fatigue rupture.

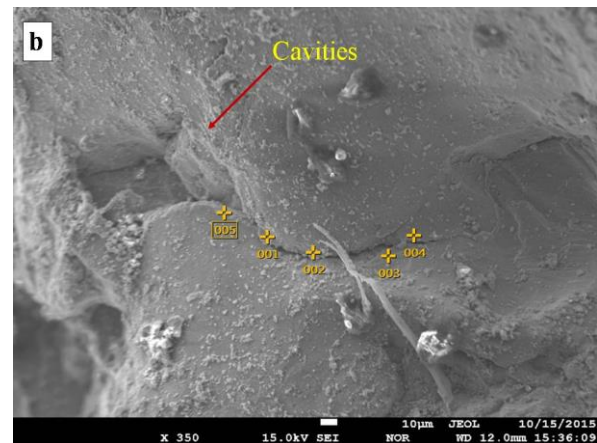
It is observed that the Precipitation of chromium was observed along the grain boundary as shown in Fig. 4

Fig-4: (b) EPMA image of fracture surface

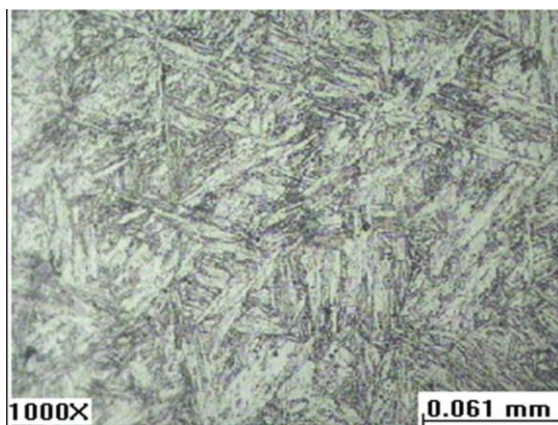
Fig-5: Optical images taken at 1000X of impeller sample

Metallographic samples were prepared as per ASTM E 1078-02 [12] standard and the etchant used was 4% nital solution for microstructure examination. Microstructure examination was carried out by using a Carl Zeiss Optical microscope at a magnification of 1000X. The microstructure consists martensite in uniform distribution of ferrite matrix as shown in figure 5.
