A case study: Failure analysis of crude oil pipeline rupture

Abstract: A cross-country crude oil pipeline section of 18" diameter API 5 LX 65, LSAW of 996 km was ruptured during its operation. This pipeline is used for carrying the crude oil from an offshore tank farm to a land-locked refinery. The failure occurred along the longitudinal seam. The affected pipeline section length was 206 km. The pipeline section was in operation since a 2002 and failure reported in 2017 i.e. more than 15 years of operation. This pipeline is laid as two parallel strings of 18" diameter pipelines. Prior to failure about two years back the pipeline was inspected using Axial MFL technology based intelligent pigging survey. However, no significant corrosion or other defect was identified in ILI findings in the section which would have eventually failed. Pipeline failed from its longitudinal seam, failure initiated from HAZ when the pipeline was in operation. The failure occurred much below the MAOP of the Pipeline. The MAOP is 91.4 kg/cm² where the pipeline was operational at 77 Kg/cm². Failure appeared to be fish mouth type of failure. Pipeline failure was examined from an operational as well as metal

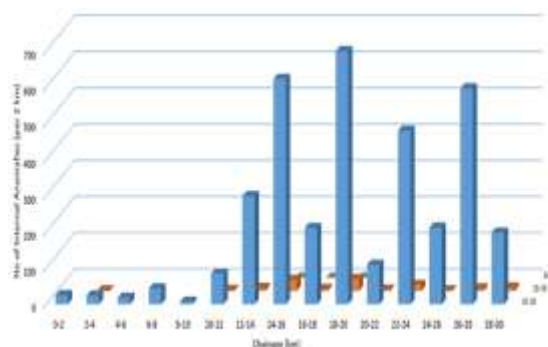
Figure 2: Corrosion anomalies distribution with chainage

As part of integrity assessment program, Inline inspection tool is considered to give the photograph of the pipeline. An axial Magnetic Flux Leakage based inline inspection survey was carried out recently before the failure. Small patches of corrosion were present in the pipeline but not near the vicinity of the pipeline. Moreover, the corrosion patches were evaluated as per ASME B31G. [3] The pipeline corrosion defects are marked as in figure no. 2.

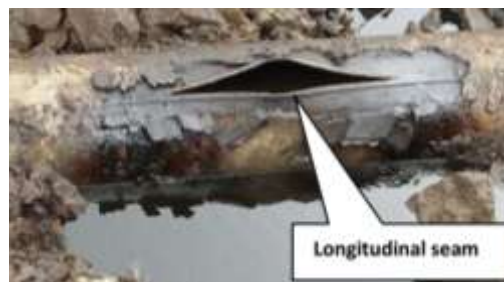
Figure 3b: Preliminary failure photographs at site

After isolation of the affected section, excavation & collection of crude oil from the leaked site, the pipeline was exposed. The seam opening was to the extent of 800 mm in length and the center opening was 110 mm wide, bearing a concave curvature of pipe wall at the center resembling a fish mouth. No scales, dents or laminations were observed in the internal or external surface of the failed section. No internal or external corrosion was noticed near the failure zone. Moreover, no corrosion on seam was observed in the pipeline. Pipeline section had not shown any sign of necking or thinning near the rupture area.

A small amount of swelling was noticed near the surface. Rupture spanned over 800 mm along the pipeline longitudinal seam. The failed pipeline section is represented as figure 3.

The 100 mm long portion of the ruptured surface in the middle of the entire 800mm long failed span from where failure originated can be clearly seen to bear layer or a band-like marks implying advancement of a crack which enlarged over time (Figure:3). The crack propagation might have stopped intermittently when the pipeline was operated at lower pressures.
