Analysis of Landslide near Ambo City, Ethiopia, East Africa

Anand Hulagabali¹, Dumesa Gudissa², Woyesa Ararsa³

^{1,2,3}Civil Engineering Department, Institute of Technology, Ambo University
Ambo, West Showa, Ethiopia, East Africa

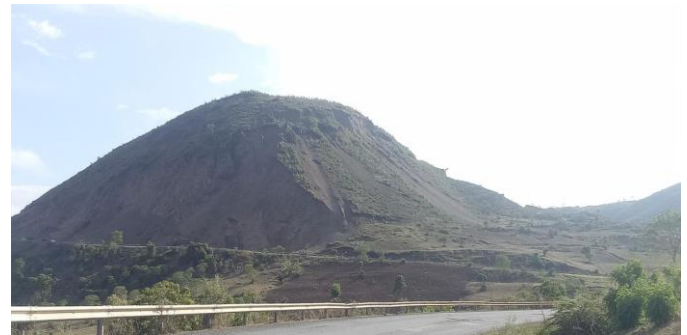
The site is located at Guder Gorfa Mountain, near Ambo on the way to Nekemte. The site is located with Longitude as 8°09'35.7"N and latitude as 37°04'64"E. The site is located at a distance of 16 km from Ambo and 4 km from Guder. Initially, slope was stabilized with gabion walls. But, because of less height of gabion walls and more lateral pressure from backside, gabion walls failed. The Location of Landslide showed in Google Earth is as follows,

Fig -2: Photographic view of landslide from front side

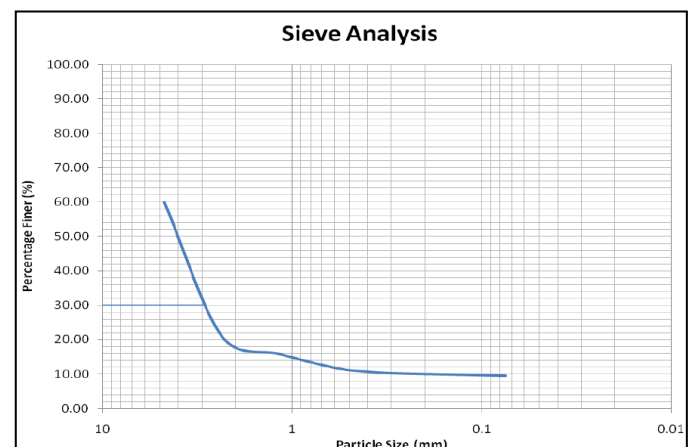
Fig -3: Grain Size Distribution Curve

The values of D₁₀, D₃₀ and D₆₀ are respectively 0.4, 3 and 4.75.

So, from the above results it is clear that, soil is poorly graded sand (SP), Because, C_c is not lying between 1 and 3; C_u is greater than 6.

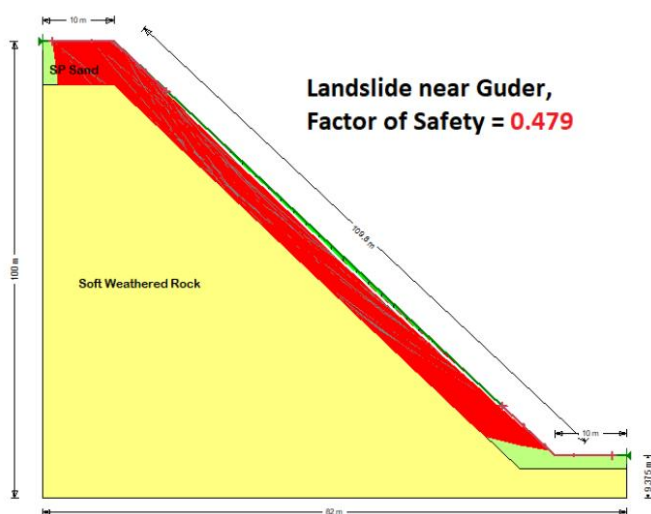
Model was carried by using ordinary limit equilibrium analysis. In this analysis, lot of slip surfaces were drawn, and out of all, critical slip surface with minimum factor of safety was considered. Factor of safety with less than 1.5, is considered to be more critical. From the present analysis, it was observe that factor of safety is 0.479, which is very critical for failure. The main reason for this failure is because of type of soil presents there, also human activities at the toe of slope.

Fig -4: The Numerical model from GeoSTUDIO 2012, of Guder slope

of the slope was disturbed for mining purpose, which leads to failure of slope in a huge quantity.

Even though slope contains rock strata inside, it started failing, as the outer part of slope contains loose deposit of poorly graded sand. In the software, slope was simulated, just similar to field conditions, which got factor of safety as 0.479. This shows that slope is very critical for failure. Immediate action has to be taken for stability of the failing slope, as it can cause severe damages to adjacent road and also serious fatalities.
