# A CASE STUDY: CAUSE OF OIL LEAKS & ELIMINATING BY OPTIMIZING BEARING SEALS

A case study of 5200 kW BFP motor is done to investigate the cause for oil leaks. As motor is having history of oil leakage since commissioning, the windings were oil saturated when it is dismantled. Certain design deficiencies are been noticed during dismantling of motor.

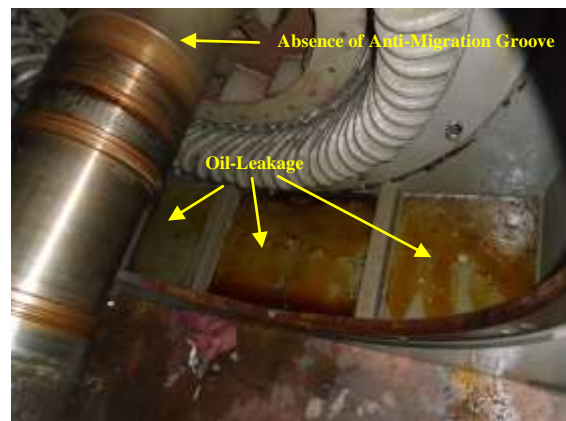
One missed cause of leaks by repairer is absence of anti-migration groove been unnoticed as shown in Fig.1.

Fig -1: Absence of Anti-Migration groove

Anti-migration groove should be machined in the shaft just inside the bearing groove [2]. Centrifugal force prevents oil from migrating past the labyrinth seal while the shaft is rotating. The groove should be just inboard of the labyrinth seal [2] as shown in Fig. 2.

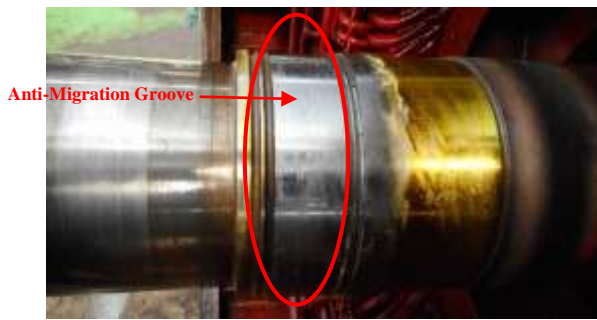
Fig -2: Anti-Migration groove

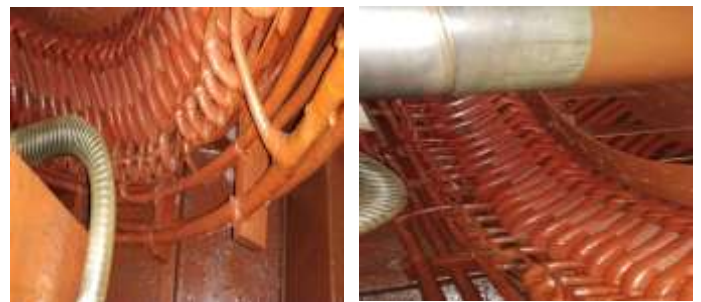
Fig -5: Bottom side of NDE bearing: Minor oil seepage observed

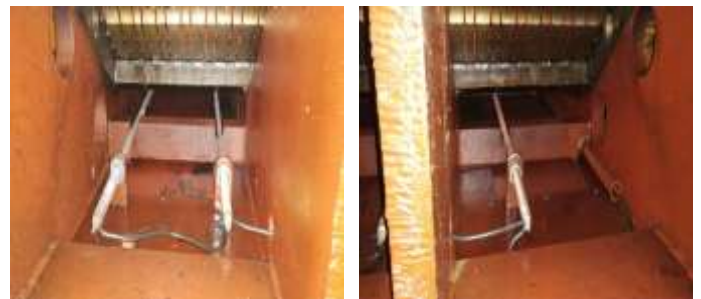
Fig -6: Space heater area: No oil observed in bottom portion

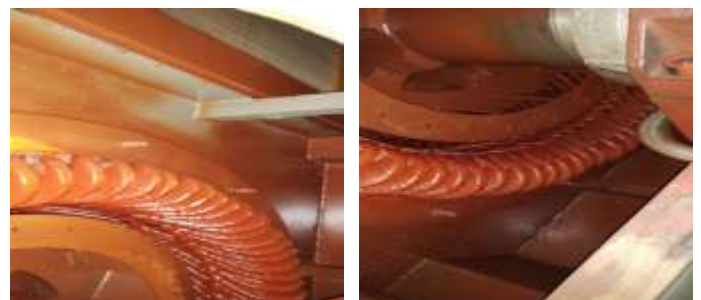
Fig -7: Overhang winding: No oil observed in both side of winding

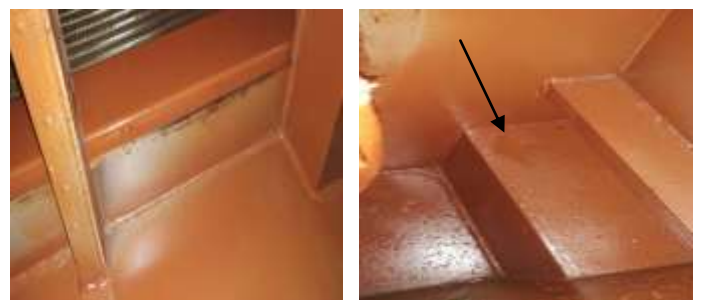
Fig -8: (1) Cooler side: oil not found  
(2) Side portion of NDE Bearing: Few drops of oil found
