SLOPE SUBSIDENCE: EVALUATION OF REASONS AND SUGGESTION FOR RECTIFICATION

ADHIL P¹, ANJANA A², DAMIAN J WILSON³, BINI RAJ B G⁴, Dr.BALU E GEORGE⁵

^{1,2,3,4}Under Graduate Students, Mar Athanasius College of Engineering, Kothamangalam, Kerala, India

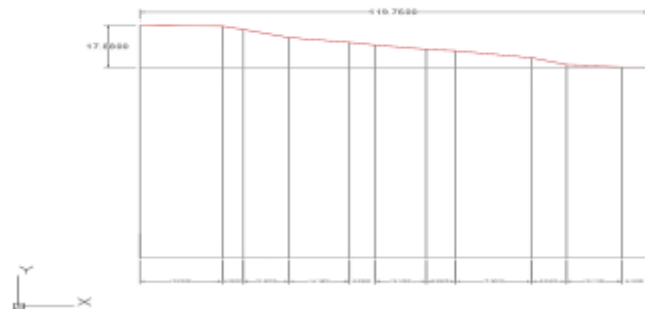
Fig-1: Elevation through the crack line

The gradient of the slope is 1 in 6.77m.

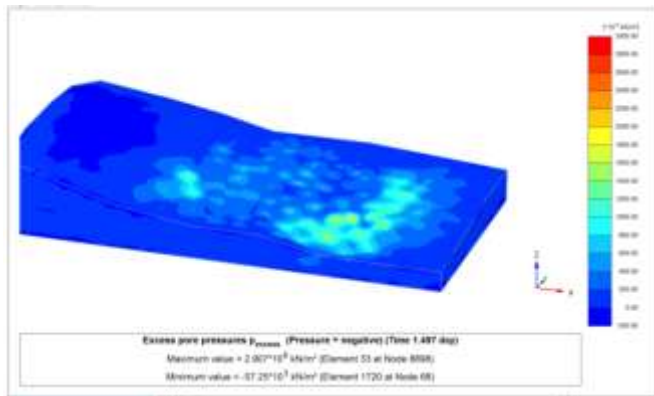
Fig-3: Excess Pore Pressure

Kuttikkanam. The slope subsided when a certain depth of soil layer beneath the slope was washed away by the rain due to the rise in pore water pressure. This might be reason for the occurrence of vertical subsidence in the area.

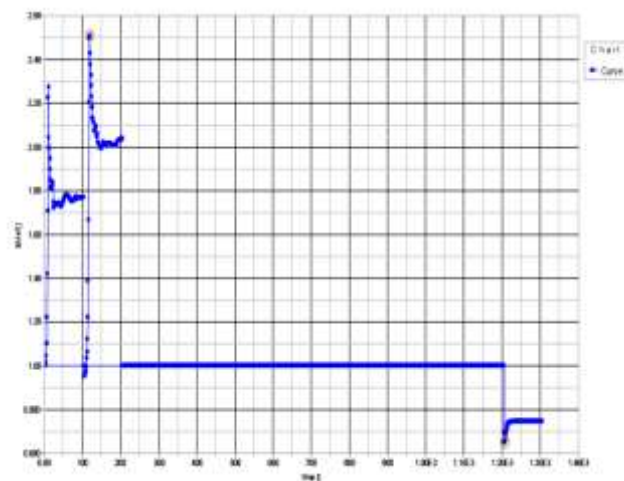
Chart 1 : Factor of Safety

The factor of safety for the slope with and without the certain layer of soil layer was 2.28 and 0.77 respectively.
