Evaluating Structural Integrity of Concrete Structures by using Non-Destructive -Testing

The objective of the investigation was to carry out Non-destructive testing on single storey houses in sector 30 Of Chandigarh so as to assess the present strength of R.C.C members and various masonry structures.

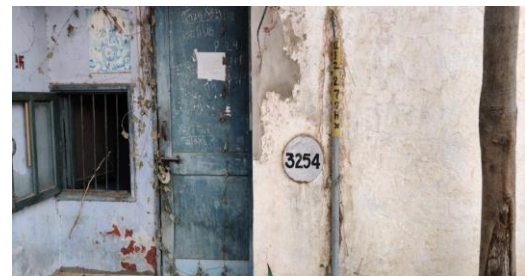
Fig 1 . Residential houses of sector 30

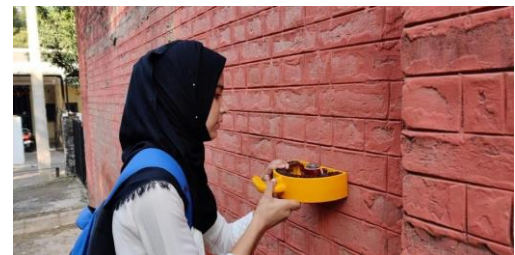
Fig 2 . Conducting Non-destructive testing
