Root Cause Analysis of Glass Fading Issue in Automotive Headlamp and Remedies for Failure Prevention

^{1,2,3,4} Minda Industries Limited, CREAT Division, Pune-India.

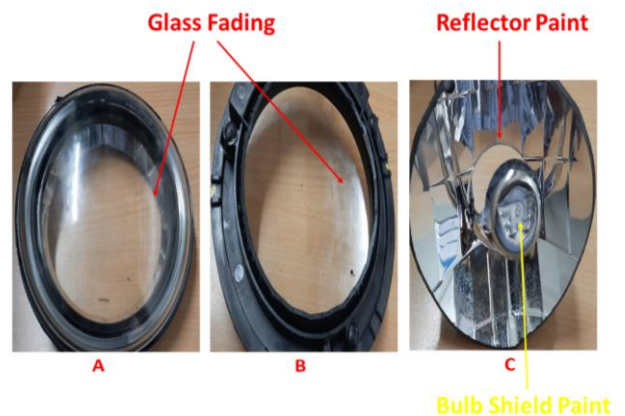
In the present work, we have found out the possible root causes for glass fading issues observed in the headlamp. **Figure 1** shows the photographs of glass faded outer lens, reflector paint and bulb shield paint Minda industries are leading original equipment manufacturer of automotive components. The glass fading issue was observed in the headlamp outer lens and several experiments were implemented to find out the root causes for the failure prevention. In order to avoid this kind of glass fading we have carefully observed the individual headlamp component more over polymeric material, which has possibility to release the volatile gases. Table 1 shows the different components of the headlamp assembly along with fabrication material. We have done the petri dish thermal box test of the individual headlamp component to observe any release of gases from the plastic parts mounted onto the backside of the lens. Differential scanning calorimetry (DSC) and thermogravimetric analysis (TGA) has been done in order to confirm the gases released from child parts like. We have also run the SEM-EDS analysis to check the ash recovered from the TGA analysis for better understanding on the filler side.

Figure 1: Headlamp assembly components (A) Outer Lens, (B) Inner Lens (C) Reflector Paint and Bulb Shield Paint.

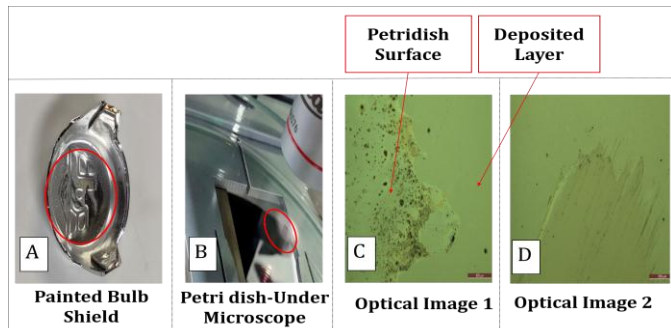
Figure 3: Optical Microscopic Imaging (A) Painted Bulb Shield (B) Petri dish Under Microscope (C) Optical Image 1 (D) Optical Image 2

Morphological analysis of the paint coated bulb shield samples and petri dish samples were carried out using optical microscopy. Optical microscopy test was employed to check the surface roughness of the petri dish after the heating and VOC deposition. Along with the petri dish, painted bulb shield surface was also captured using optical microscopy. The glass fading in headlamp is majorly due to deposition of the VOC onto inside surface of the headlamp. It was difficult to put the headlamp for optical microscopy test hence we have taken some of the scratch out some of the painted material and kept it into petri dish. Further, the petri dish was heated about 180 °C for 4 h. The lower temperature VOC got deposited and tested for optical microscopy. Figure 3 (C) and (D) demonstrates the optical microscopy images of the petri dish after heating at 180°C. It can be seen from Figure 3 (C), surface roughness with some black marks are observed which signifies that some gases were released during heating process and got deposited onto the inside surface of the glass headlamp and fading was observed. Figure 3 (d) shows the micrographs of the petri dish sample after heating process with 5 g of sample and checked the gases deposition onto the petri dish layer. It was observed that with highest amount of material the gas released at lower temperature got deposited and formed the uniform layer onto the inside surface of the petri dish and fading was noticed. Figure 3 (B) displays the petri dish under the microscope lens. Further this VOC released was confirmed by TGA and DSC analysis.

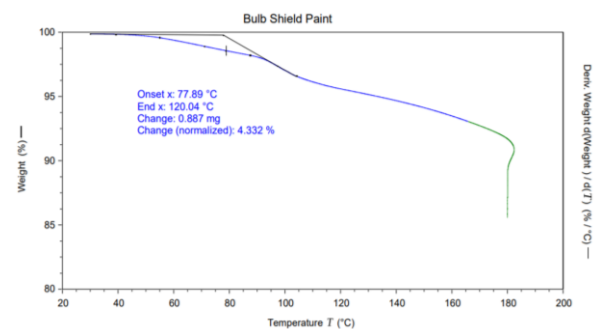
Thermal stability of the reflector paint and bulb shield paint was determine using thermogravimetric analysis. As from the petri dish, it was noticed that some gases were getting deposited after heating above the 150 °C. In order to the check the temperature at which thermal degradation occurred, we have analyzed dust cap and paint samples. Figure 4 shows the weight loss graph of bulb shield painted

sample. It can be seen form the figure that bulb shielded paint sample shows two step thermal degradation. The very first step thermal degradation started at around 80 °C and ended at 120 °C with weight loss nearly 9 %. TGA was carried out at isothermal condition at 180 °C for 3 h. It can be seen from the results that some low molecular weight compounds got released in the given temperature range (80-120 °C) and got deposited onto the inside surface of glass headlamp. This deposited VOC results in the reduction in transparency due to the fading mechanism. The visibility of the glass headlamp can reduce if deposition of any volatile organic compound take place onto the transparent surfaces. Headlamp is closed assembly and evaporation of any volatile compounds may deposits onto the inside of the outer lens. Figure 5 displays the reflector paint sample. It can be seen form the graph that 0.085 % weight loss observed in the isothermal conditions which is negligible in the tested temperature range. This reflector paint was also heated up to 180°C for 3 h at isothermal conditions. This concludes that volatile organic compounds got released from bulb shield paint and deposited onto the inside surface of the outer lens. This deposition results in the glass fading and reduction in the transparency of the headlamp outer lens.

Figure 4: TGA thermograph of bulb shield paint sample

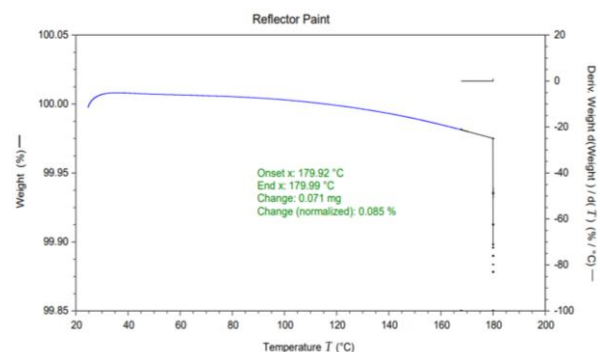
Figure 5: TGA thermograph of reflector paint sample

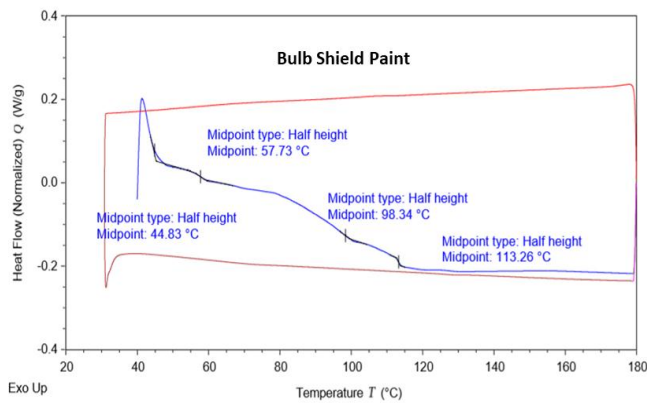
thermoset category which upon curing mechanism got crosslinked network and does not change its size and shape. From the TGA and optical results it confirms that some of lower molecular weight compound got evaporated and deposited onto the inside surface of outer lens. In the DSC analysis we have observed that no exothermic and endothermic peaks were present which signifies that no melting and crystallization were observed during the heating and cooling cycle. During the first heating cycle the slight transition in the heat flow curve was observed at 58 °C, 98 °C and 113 °C temperature. This can be attributed to the different paint layers of the coated materials. In the second heating cycle (red line curve), no transitions were observed around 58 °C, 98 °C and 113 °C temperature which clarifies that volatile compounds got released during the first heating cycle only. This confirms that volatile got deposited onto the inside layer of the headlamp outer lens and resulted in the glass fading issue.

Figure 6: DSC graph of bulb shield paint material

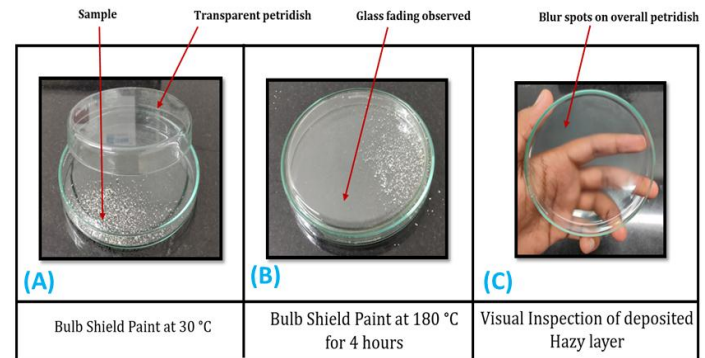
Figure 7 shows the petri dishes before and after the thermal box test. Two petri dishes were used for the analysis. Bulb shield paint sample was scratched and put into the first petri dish. The second petri dish was used to cover the first petri dish as shown in Figure 7 (A). These two-petri dishes were kept in the heating box and the box temperature was raised to 180 °C and kept it for 4 h and this is shown as Figure 7 (B). During the heating cycle, it can be seen that some of the lower molecular weight compounds got deposited onto the inside surface of the second petri dish. This is due to the liberation and evaporation of the volatile organic compound (VOC). It is confirmed from the petri dish thermal box test that in temperature range of 30-180 °C, some of the VOC got released and as the system is enclosed, it got deposited onto the inside layer of the petri dish. Coating paint consist of the number of additives like fillers, antifoaming agents, biocides, wetting agents, extenders. Impurity of these additives may result in the release of lower molecular weight substances. In the Figure 7 (C), it can be seen that after cooling also

deposition and black spots were observed onto the inside layer of the second petri dish. This test resulted that fading of the glass surface is caused by the deposition of the volatile organic compound. This glass fading also resulted in the reduction in the headlamp visibility.

Figure 7: Petri dish thermal box test of bulb shield paint

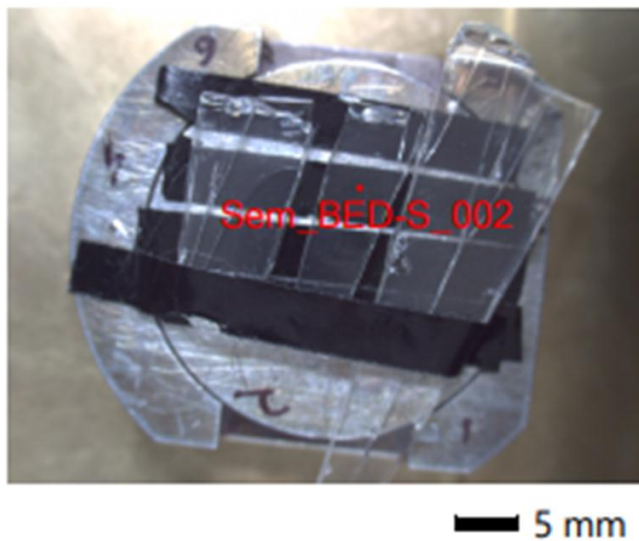
The received two-wheeler headlamp assembly part were difficult to place in the SEM assembly. For this attempt, we have carried out the heated petri dish test. The bulb shield paint sample were scratched and put into the petri dish. The petri dish was covered by the second petri dish and heated at 180 °C for 4 h. The volatile organic compounds got deposited onto covered petri dish material and cut into the small pieces for the SEM characterization. Figure 8 and 9 represents the petri dish small pieces placed for the characterization and deposited micrographs of the released gases. It can be seen from Figure 8 that volatile compounds onto the petri dish sample have been placed on the SEM sample holder. Figure 9 (A and B) shows that samples at different magnification and can be easily seen that particles after releasing got deposited onto the petri dish surface. The same observation was observed in the headlamp assembly. Figure 9 (A) shows the small black dots of the deposited volatile compound whereas at higher magnification it can be seen that (Figure 9B) glass surface got completely covered with the gas surface.

Figure 8: Petri dish pieces after heating at 180 °C for 4 h

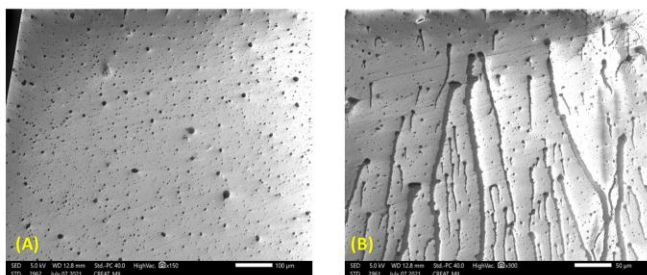
Figure 9: SEM micrographs of faded petri dish sample.
