FORENSIC ANALYSIS OF COLLAPSE OF SURFSIDE CONDOMINIUM, MIAMI

Alessandro Anil Mathew¹, Er.Gopika Moorthy²

¹Department of Civil Engineering, Saintgits College of Engineering, Kottayam

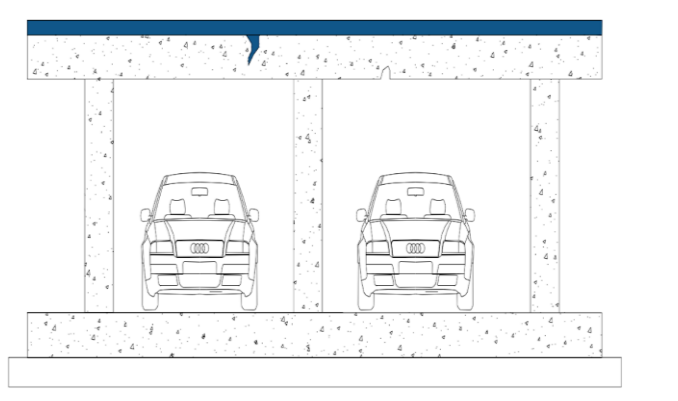
Miami faces hurricanes, storms and heavy rains every year. In a place where is plenty of rain, if proper drainage is not provided it will very detrimental for any infrastructure. In this case, the pool deck didn't have proper drainage which caused ponding of water. This water will enter into the crack of concrete which will cause rusting of reinforcements. This cause leakage cause dripping water from the ceiling of the garage as shown in Fig. 5.

Fig -5: Leakage of water in the cracks of concrete from the pool deck.

Morabito Consultants who did the 40-year re-certification process in 2018 claimed that if this kind of leakage is not solved immediately concrete deterioration will expand exponentially.

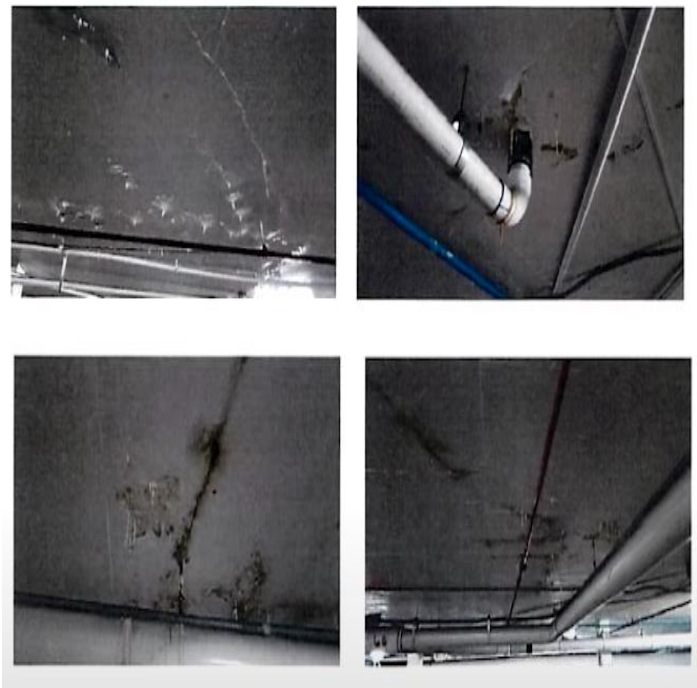
Fig -6: Dripping water from the ceiling of the garage.

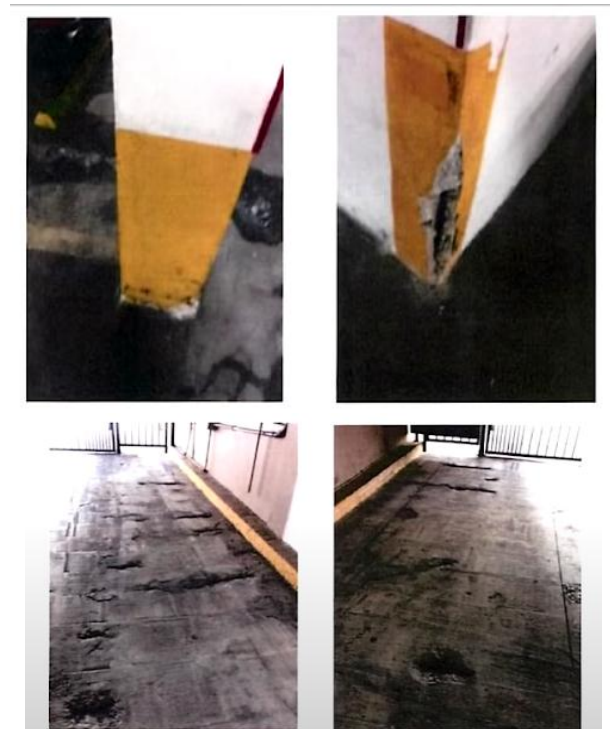
Due to this leakage, there were spalling of concrete which was pointed out in the re-certification report like in Fig. 6 and Fig. 7.

Fig -7: Spalling of concrete from garage columns and garage floor.

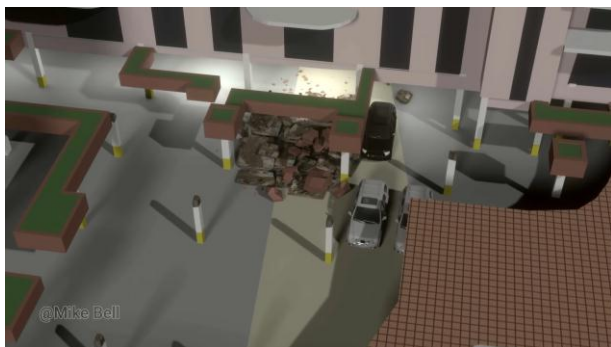
There are many planter boxes in the compound of the building which provide good aesthetics. If proper waterproofing is not done in these boxes can cause unseen deterioration also it will be very difficult to predict or detect any corrosion underneath those plants as shown in Fig. 4.4.

Fig -8: Planter box under columns 13 and 14.

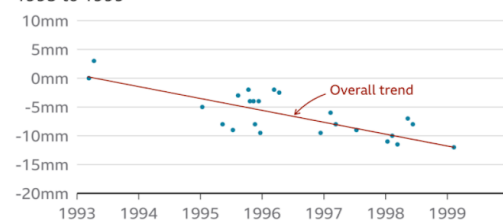
The study from a researcher at Florida International University found that the area around the building as in the graph shown in Fig. 10 constructed on reclaimed wetlands had been sinking at a rate of two millimetres per year for the last three decades. There is the possibility to cause a differential settlement.

Fig -10: Vertical displacement near Champlain Towers.

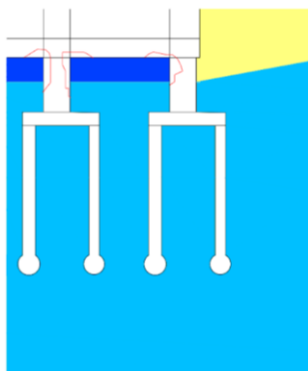
This waterlogged in this area can cause deterioration of concrete as shown in Fig. 14. Further causing to form sinkholes.

Fig -14: Possible deterioration of concrete.

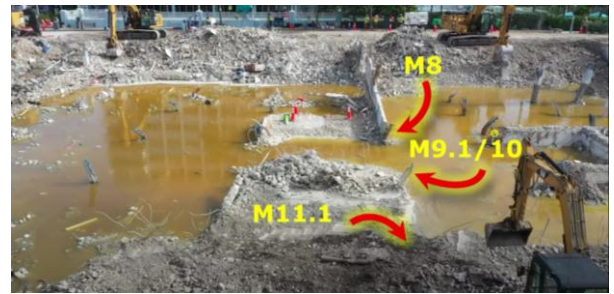
Fig -15: Waterlogged beneath the floor of the garage.

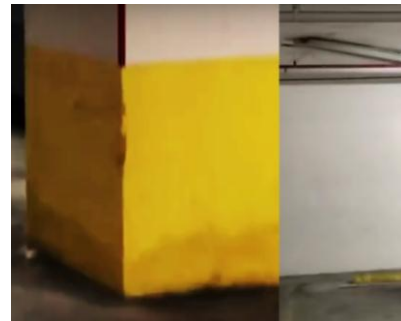
Columns in this area where water get logged, column pulls water up like sponge cause rusting of reinforcements as shown in Fig. 15 and Fig. 16.

Fig -16: Enhanced image of water pulling into columns.

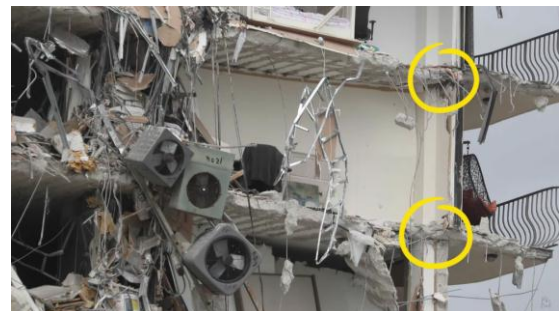
The tower is constructed in a flat slab construction method. In the collapse of the building, it revealed that there were not any punching rebars present in the building. Punching shear happens when high localized forces on RCC slab, there high proximity for high localized loads on flat slab structure. The failure is due to shear. This type of failure is very dangerous as it cannot be known or seen before failure, so for safety contractors provide punching rebars. The absence of punching rebars is shown in Fig. 17.

Fig -17: No punching rebars

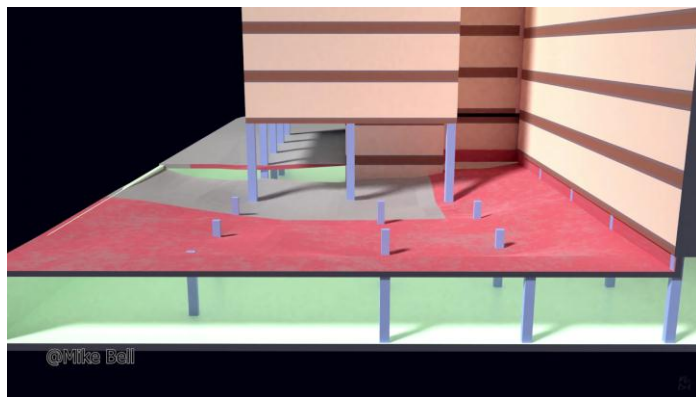
The first area to collapse is the pool deck. This column punched through the pool deck. This is due to corrosion in the pool deck mentioned in the earlier chapter.

Fig -18: Punching of columns at the pool deck.

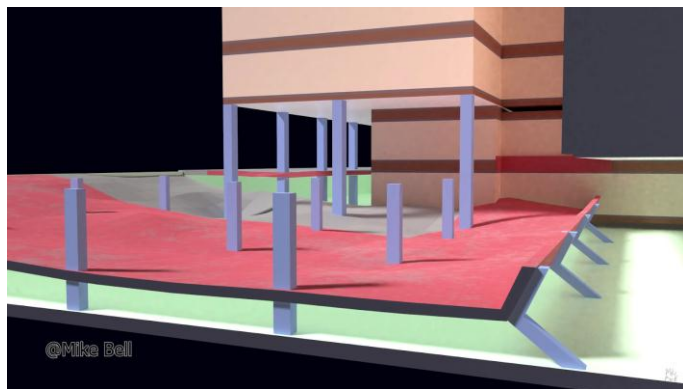
This is punching caused the sinking of the pool deck slab along with its beam. Hence pulling a main structural member as shown in Fig. 18.

Fig -19: Pulling of slab from the columns.

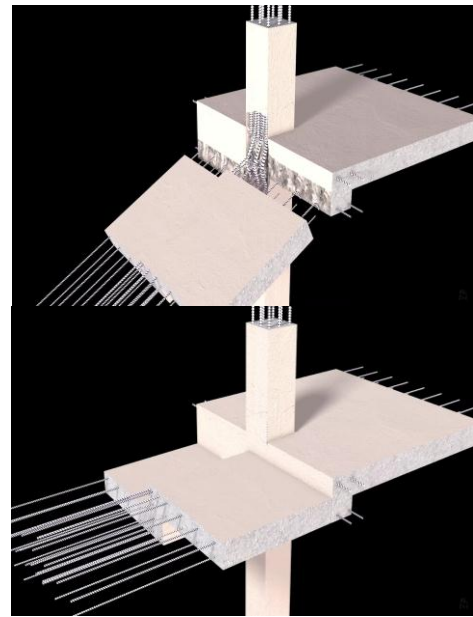
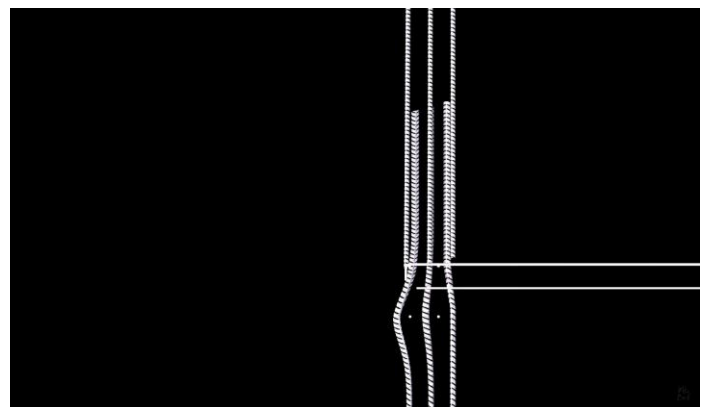
The corresponding beams connected to columns of the building which already lapped into the columns get pulled off or ripped off the columns, hence causing buckling of columns. The first two columns to collapse is column 13 column 14. Rest of the building collapse like a chain reaction as shown in Fig. 19 and Fig. 20.

Fig -20: Buckling of column.

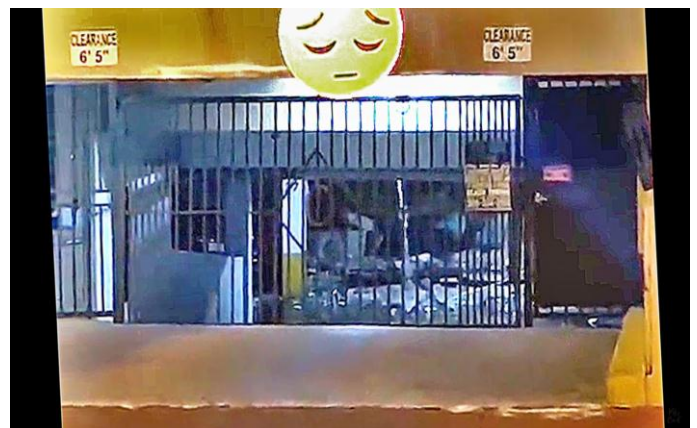
Moments before the collapse of the building, a bystander was able to capture a video of the collapsed roof of the garage and a broken pipe with water falling. The extent of the collapse is still unknown as shown in Fig. 21.

Fig -21: Big chunks of concrete on the floor of the garage.

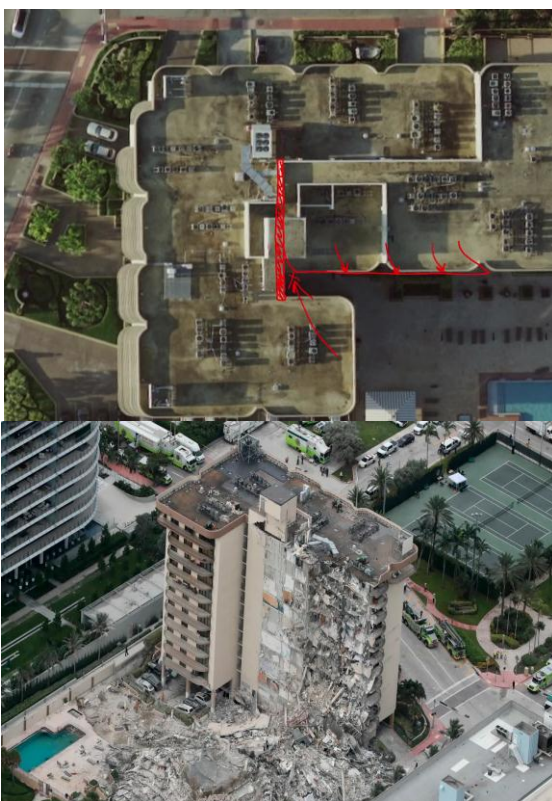
The main reason why the rest of the building didn't collapse is that the west section of the building consists of shear walls containing the elevator shaft. This wall protected the rest of the building as shown in Fig. 22 This wall is a strong element, when the rest of the building collapses, it is simply torn off from the shear wall.

Fig -22: The shear wall is shaded in red colour in the right picture, the left picture shows the aerial view of the shear wall.
