CASE STUDY ON A EXISTING STRUCTURE BY USING NDT TECHNIQUES

K.Rohini^{*,a} and K. Sai Abhinav^a

^aDepartment of Civil Engineering, Annamacharya Institute of Technology and Sciences, Tirupati,

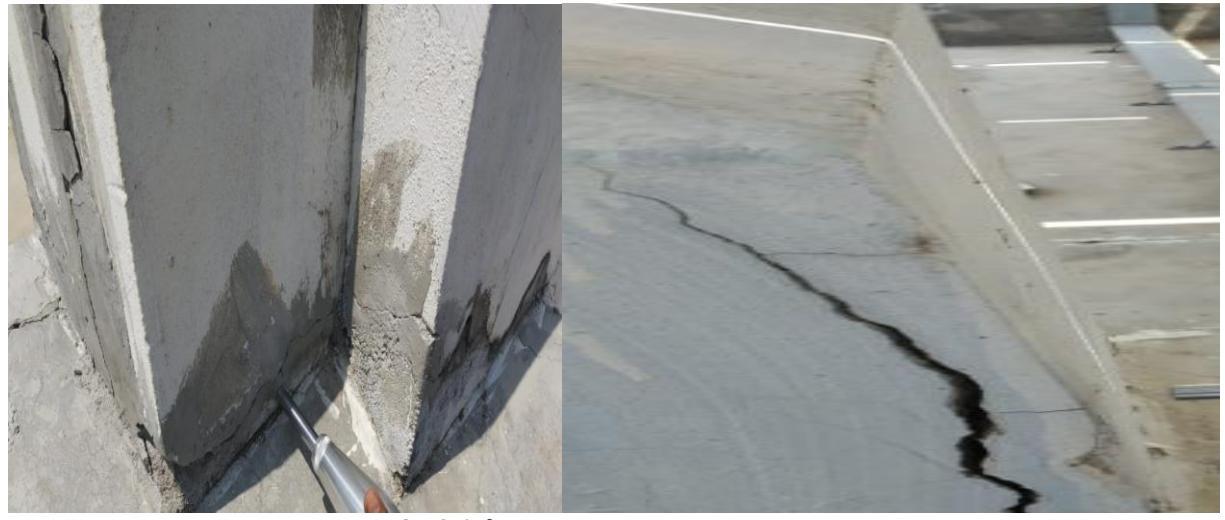
Fig.3.1 damages on a existing structure

From the external appearance of structure pealing, cracking status, corrosion and the like can be surveyed. The corresponds to the daily and periodic inspections performed for ordinary structure. It also conducted as needed before performing a detailed inspection. Preliminary qualitative data is obtained through this type of survey. It would be most effective if this data could be reflected in performance evaluations of the structure as shown below table

•
Class of Damage	Repair Classification	Repair Requirements
0	Decoration	Redecoration if required
1	Superficial	Superficial repair of slight damage not needing fabric reinforcement
2	General repair	Non-structural or minor structural repair restoring cover to reinforcement where this has been partly lost.
3	Principal repair	Strengthening repair reinforced in accordance with the load-carrying requirement of the member. Concrete and reinforcement strength may be significantly reduced requiring check by design procedure.
4	Major repair	Major strengthening repair with original concrete and reinforcement written down to zero strength, or demolition and recasting.

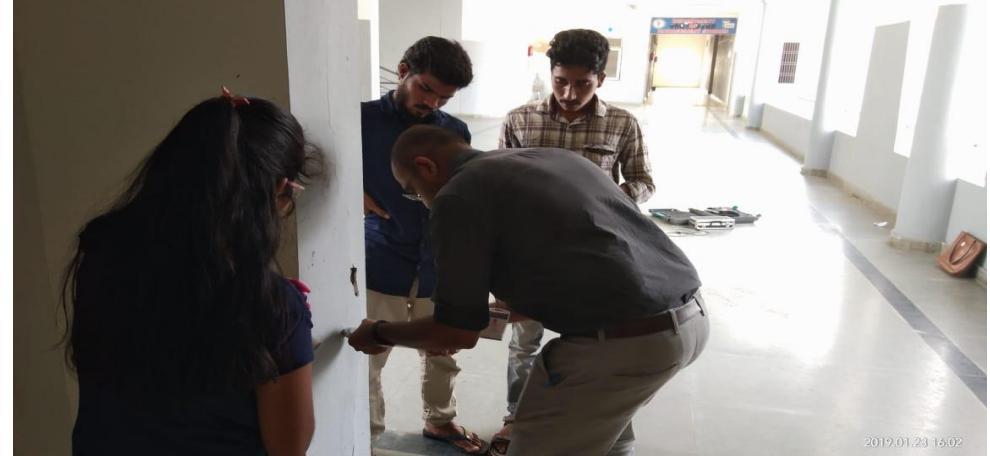
Fig 3.2 Conducting rebound hammer test

From Table it shows less than that of rebound number 20 quality of concrete for column beams and slab gives very poor and loss of integrity exists

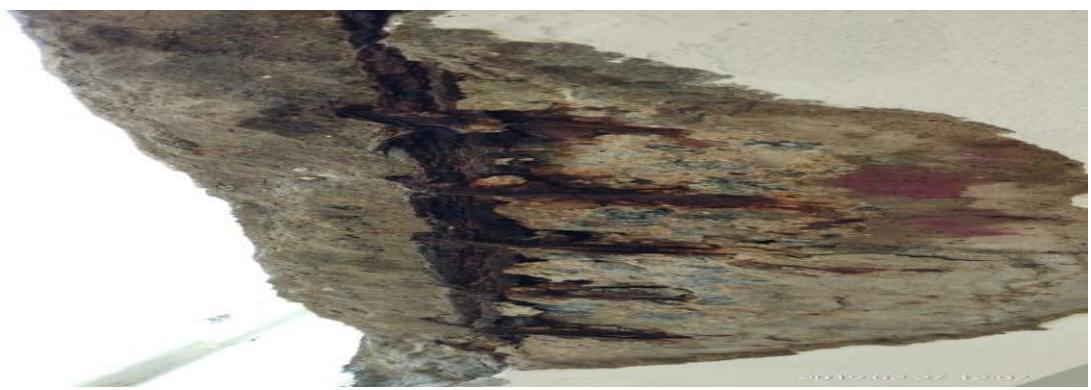
Fig 3.4 Applied phenapthelene indicator on a exposed reinforcement

The phenapthalene indicator test and pH test is also conducted at the places where reinforcement is exposed. The CO₂ penetration level can be identified by doing phenapthelene test as shown table below. Actually pH of concrete is equal to 13 but carbonated concrete pH value after testing is equal to between 7 to 8.

The results suggest that some structures has been subjected to carbonation
