STUDY ON STRUCTURAL COLLAPSE BEHAVIOUR OF REINFORCED CONCRETE BUILDING COLLAPSE STUDY

Abstract

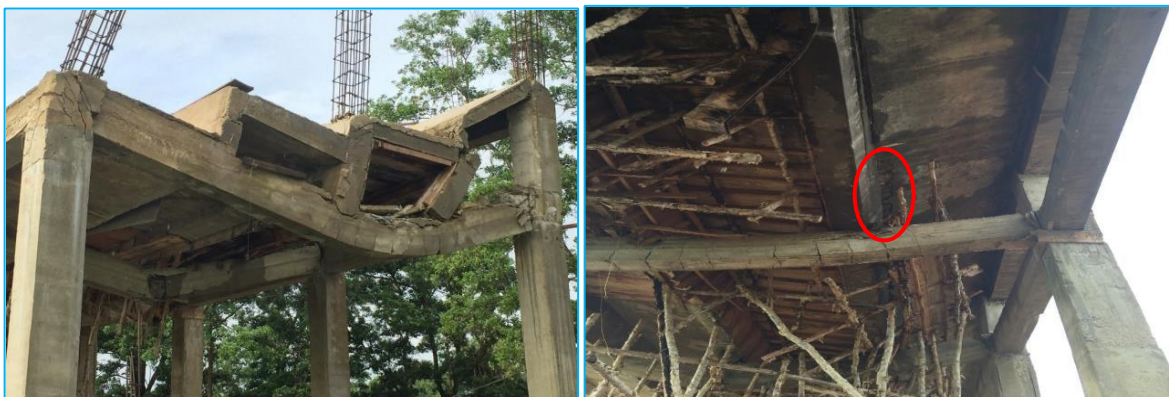
Figure 1. Structure of concrete beams and floor slabs-1

- The quality of concrete was not tested because the beam structure collapsed.
- All beams on the 1st floor have undergone deflection that exceeds the allowable deflection ($L/180$), and cracks that are parabolic on the pedestal and field (middle of the span) so that they are categorized collapsed (see Figure 1).
- No concrete blanket should be seen by at least 40 mm, this can reduce the durability of the concrete (see Figure 2.a).
- The steel reinforcement that is fixed on the pedestal of the beam is too small (only 2 visible pull reinforcement) (see Figure 2.b).
- The dimensions of the beam, the number of bending and sliding reinforcement attached have corresponded to the working drawing.

- The quality of concrete was not tested because the floor slab structure collapsed.
- All concrete slabs on the 1st floor have undergone deflection that exceeds the allowable deflection ($L/180$), and severe cracks in the pedestal and field (middle of the span) so that categorized collapsed (see Figure 1).
- No visible concrete blanket should be at least 20 mm, this can reduce the durability of the concrete (see Figure 1).
- The suitability of the dimensions of the floor slab, the number of bending reinforcements that is attached has matched the working drawing.

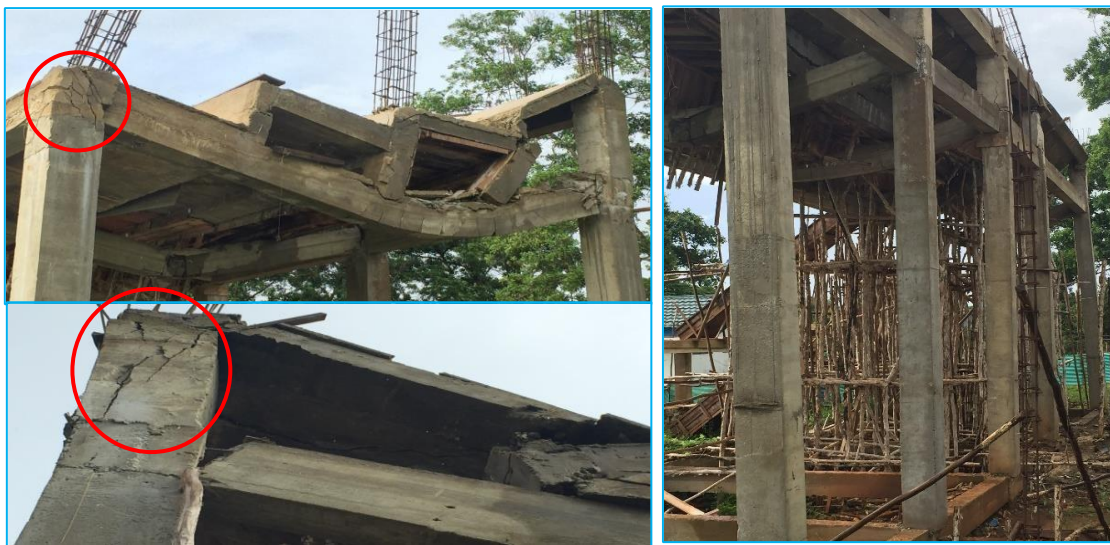
Figure 3. a. Concrete Column Structure the top cracks and crumbles, b. Concrete Column Structure central section and the bottom is still good not to have cracks

- The concrete quality of each column is tested with the Hammer Test tool.
- There were 4 columns that experienced a slope due to being pulled by concrete floor blocks and slabs that had collapsed.
- The upper concrete at the confluence of beams and columns is severely cracked and crushed (see Figure 3.a), while the concrete in the middle and lower parts is still good not to have cracks (see Figure 3.b).
- The dimensions of the column, the number of bending and sliding reinforcement attached have corresponded to the working drawing.

This can be seen with the condition of the concrete column at the bottom which is still good (minor damage only occurs to the top of the column due to being pulled by beams and slabs collapsed concrete) (see Figure 3.a and 3.b), and the dimensions of the concrete columns that meet the minimum size t (30 /30) in withstanding a load of 2 floors with a minimum capability $P_u = 86,160$ tons per column, so with 10 parts. The total load that the Column can withstand is 861,600 tons compared to the total weight of the building of 186 tons.

The column reinforcement from the software design to carry the dead load alone is at least 8D12 (see Figure 10), while in the working drawing and installed condition is 12D12 (see Figure 3.a), this means that the reinforcement of the terracing column is sufficient to carry the dead load of the structure.

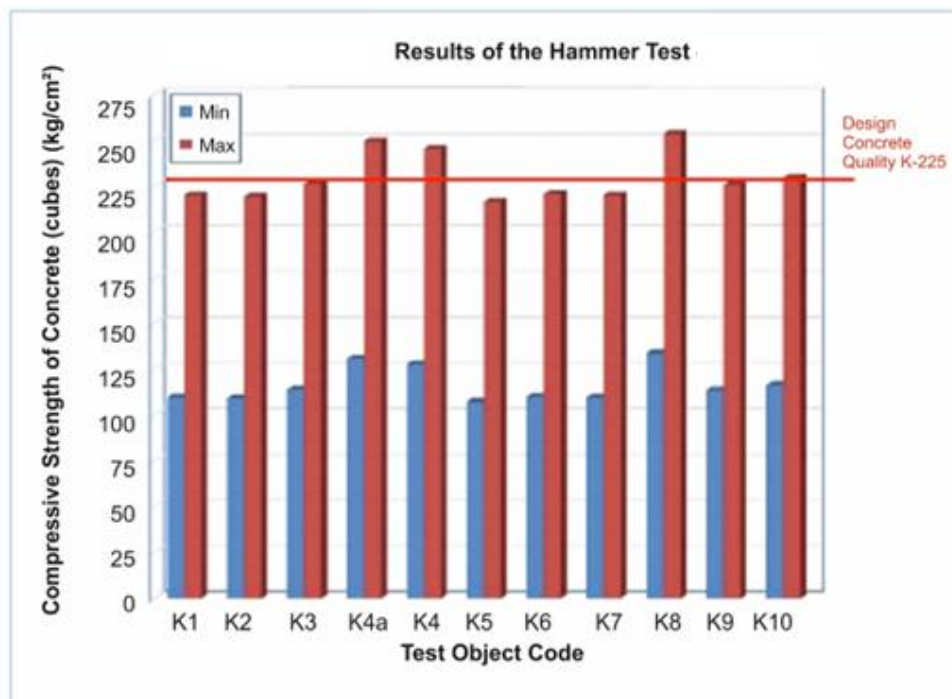
Figure 4. Concrete Hammer Test Results

Testing the quality of concrete in the field is carried out using the Hammer Test tool. The result of the rebound value was 33,355 and the quality of concrete ranged from 116,640 kg / cm² sd. 229,780 kg / cm², this means that the quality uniformity of concrete quality on the column can be is estimated to be quite good according to the K225 (225 kg/cm²) (see Table 1 and Figure 4) [4]. For concrete on beams and floor slabs, hammer test is not carried out .

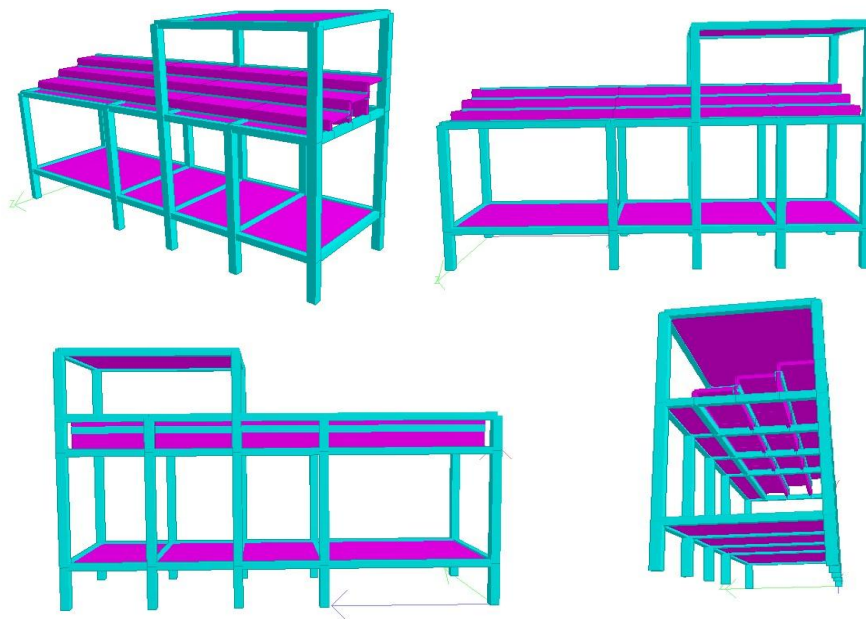
Figure 5. Concrete Tribune Structure Modeling with Staad Pro V8i Software

To further examine the collapse of the Tribune structure design, modeling was carried out using Staad Pro V8i Software (see Gambar 6), with the following results:
