# Ensuring Safety for the Construction Workers involved in Metro Tunnelling Projects

Ar. Govind Raguram Rajan<sup>1</sup>, Prof. Ar. K. Indrapriya<sup>2</sup>, Prof. Ar. Fathima Taskeen<sup>3</sup>

<sup>1</sup>Post-Graduate Student, M.Arch Construction Project Management, Faculty of Architecture, Dr. M.G.R Educational and Research Institute, Chennai.

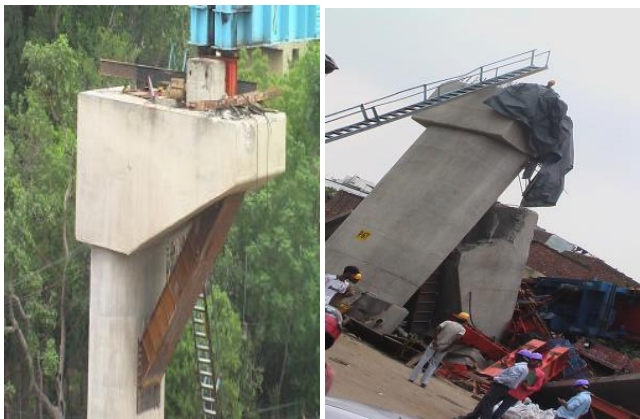
**Fig -1:** Delhi Metro Project Accident on July 12 2009

On July 12, 2009, an accident occurred in the Badarpur - Secretariat section close to P-67 while lifting superstructure segments as part of the construction of Delhi Metro Rail Project's Phase II. The pier cap of pier P-67 collapsed, which led to the subsequent collapse of : the erected and pre-stressed Launching Girder, the span between P-66 and P-67,

and segments of the superstructure for the span between P-67 and P-68.

Six people died and many others were hurt in the incident. Initially the support system for viaduct was designed as portal pier till the casting of the pier was over. The shop owners in the nearby area put up resistance against casting of the other leg of the portal and it was subsequently decided by DMRC that this would be changed to a cantilever pier, similar to P-68. The top reinforcement of the cantilever beam did not have any development length into pier concrete. As learned from the sources, the top reinforcement of the cantilever beam had an “L” bend of 500 mm only.

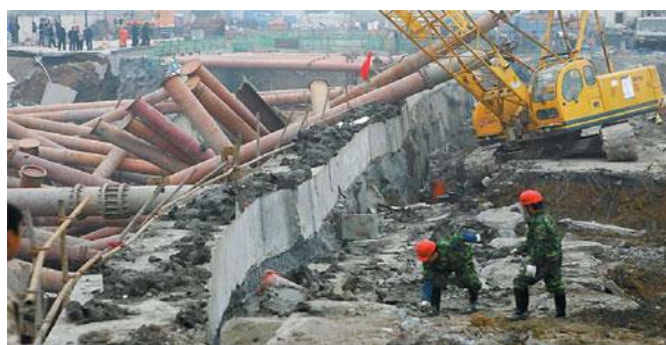
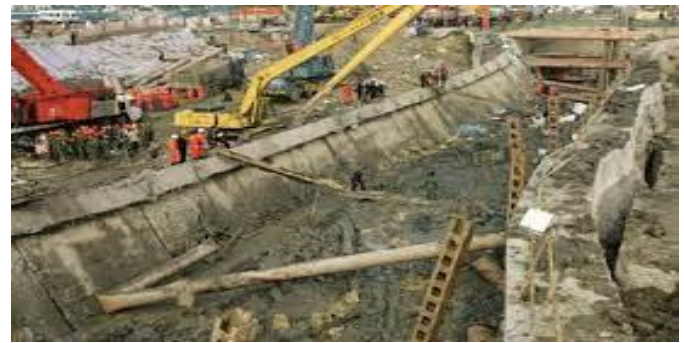
Fig -4: Shanghai Metro Rail Accident on June 2019

Beijing, June 2 2019 (IANS) Five workers, trapped in a collapse at an under-construction Metro tunnel site in Qingdao, China's Shandong Province, have been confirmed dead, according to the project management company. With the problems of existing safety standards, safety accidents often occur in construction projects. According to the statistics of the Ministry of Housing and Urban (Ministry of Housing and Urban Rural Development of People's Republic of China, 2017), nearly 80 accidents took place from 2011 to 2016 during metro construction, including high falling and other types of accidents. Among them, the high falling, collapse and object strike were the most frequent types of accidents, accounting for up to 66% of the total accidents; vehicle injury, electric shock and lifting injury respectively took an identical proportion of about 6% which was slightly lower than that of mechanical injury, 7%. Wuhan, Beijing and Shenzhen ranked the top three.

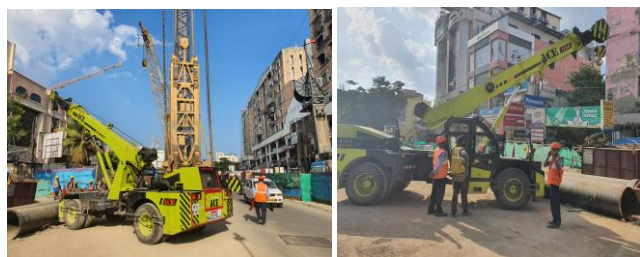
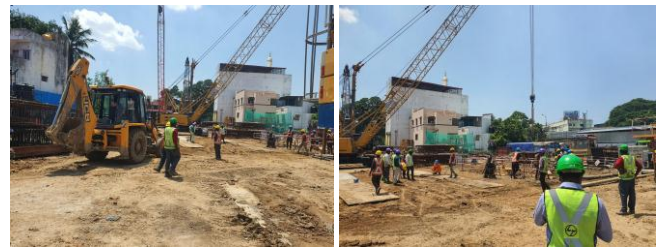
**Fig -5: Chennai Metro Rail Works ( Purasaiwakkam )**

First aid room is provided for the workers in case of any emergencies. PPE equipment were not followed by some workers on the site. There are no safety persons present on the site and there is no proper monitoring of the works and workers. Many places did not have any proper security and the workers were not present there so that anyone can access the place and also to some equipment. Workers does not seem to be productive as there is no proper supervision in the site. Fire evacuation place for the site was not provided by the safety management. No proper space for workers training.

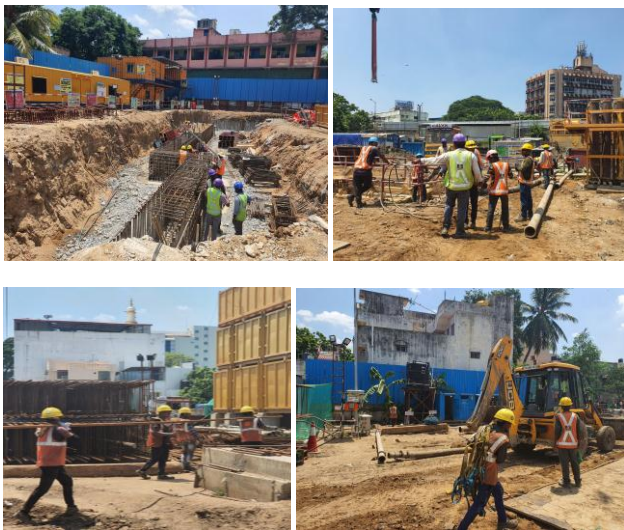
**Fig -6 :** Chennai Metro Rail Works ( Chetpet )

First aid room is provided for the workers in case of any emergencies. All the workers in the site were strictly following their rules by wearing PPE equipment (helmets, jackets, boots, gloves, etc.). All the workers in the site were found productive in their work. The safety monitoring persons were present at the site Fire Evacuation Plan was clearly marked and provided at the site.
