# Case study: Widening an existing bridge structure Challenges and solutions

**Abstract** - This paper is a study that summarizes, the procedure used to increase the capacity of an existing concrete bridge in the UAE. Traffic congestion is a severe problem in modern life. Severe congestion can negatively impact the country's economy, environment, and the health of road commuters. The increase in trip duration due to traffic congestion will result in consuming more fuel which results in a higher cost of trip and more emissions which affect both the economy and the environment. Moreover, the road commuter will be traveling for a long time which can affect their sleeping hours and mental health. Constructing more roads, and bridges and encouraging people to use public transport are some of the measures taken to reduce traffic congestion. To evaluate the effectiveness of an existing highway, certain parameters such as traffic quantity, type of vehicles in the traffic stream, speed of traffic stream, and the density of traffic stream will be measured and assessed to determine the need for increasing the road capacity.

This paper considers the structural part and challenges faced durin

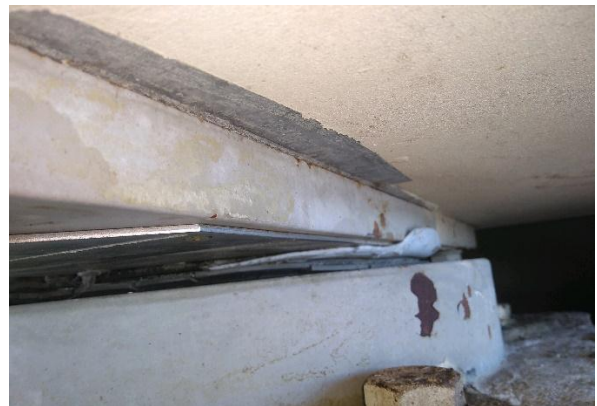
Figure 1

- The existing pot bearing age exceeds 25 years whereas the service life of pot bearings is 25 years.
- The sliding material (PTFE) of bearings is severely deformed as shown in Figure no:01
- The capacity of the existing bearing is insufficient to accommodate the expected increase in load and movement due to bridge widening.

The replacement of bearings was performed by lifting the existing bridge by 10 mm. Hydraulic jacks were used to gradually lift the bridge for the required duration to replace the existing bearing with new bearings. A few obstacles were encountered during the process of replacing bearings, the main obstacle was the clashing of bearing sole and masonry plate shear studs with existing reinforcement. To overcome this issue, existing reinforcements were cut and new dowels were planted in the bridge soffit and abutment seat as shown in Figure no:02.

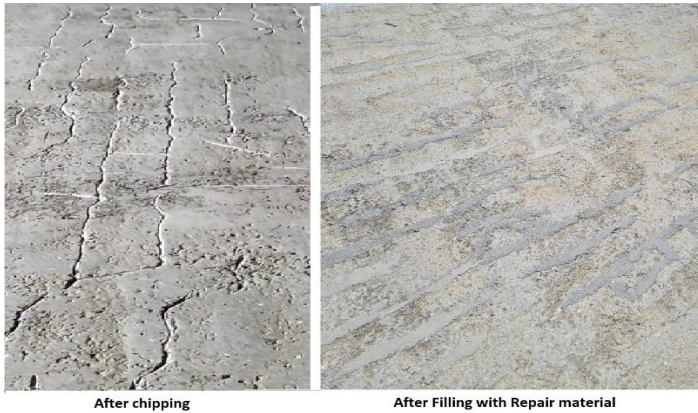
Figure 4

Some defects were not identified during the condition survey due to traffic above the bridge. few defects were identified after diverting the traffic. The overlaid asphalt above the bridge deck and ramps were removed and an enormous number of cracks were found at the existing concrete top slab. Fortunately, the cracks were narrow and shallow and don't threaten the structure's integrity or stability. However, the presence of cracks is not preferable and sealing of these cracks is very important to prevent the ingress of harmful chemicals. The ingress of chemicals can result in unwanted subsequences such as corrosion of reinforcement, disintegration, and spalling of concrete. The repairing of cracks method involves the following steps:

- Determine the location of cracks.
- Determining the size and depth of cracks.
- For non-structural cracks which shallow and narrow in size, the crack is chipped preferably into a V shape notch to allow proper filling and bonding of repair materials with the concrete surface.
- Before filling the cracks, the chipped area should be cleaned from dust and any debris to ensure proper bonding between repair material and concrete

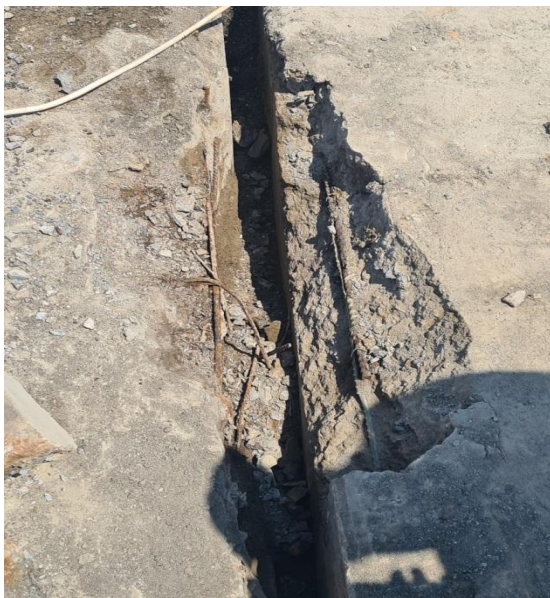
Figure 5

The removal of the existing expansion joint unveils serious defects as shown in Figure no:05, existing reinforcements were rusted and concrete disintegrated at the expansion joint. The primary cause of these defects could be the use of a non-watertight expansion joint which results in damaging the concrete and reinforcement around the expansion joint. The damaged area is determined by the sounding test. A hammer was used to determine the location of the delaminated concrete. The repair of this type of defect involves removing damaged concrete, replacing rusted reinforcement, and casting concrete. In order, to prevent the occurrence of similar defects in the future, a watertight expansion joint is used to drain the water away from the structure.

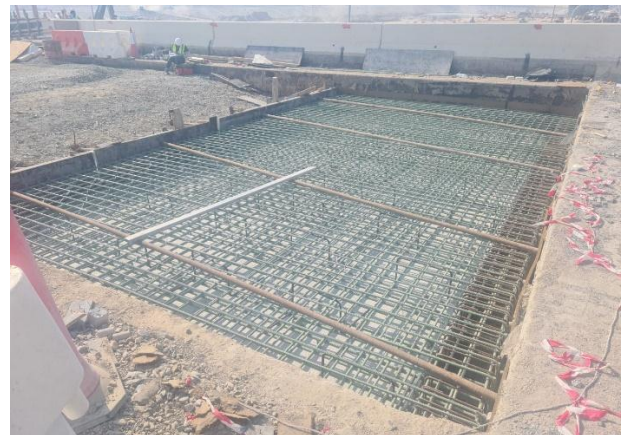
Figure 7

The site verification shows the absence of an approach slab for the existing bridge. Therefore, Engineers decide to construct a new approach slab at both ends of the bridge. Constructing a new approach slab for the existing bridge will reduce the differential settlement and prevent the formation of cracks in the pavement.

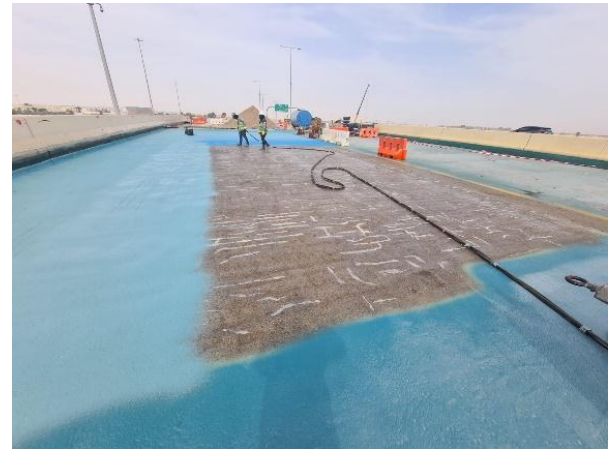
Figure 9

Protecting existing and new concrete structures from chemicals will increase the structure's durability and reduce the defects during the service life of structures. Therefore, the outer surface of the existing bridge is repainted. Also, the bridge deck is protected with waterproofing to prevent the penetration of chemicals carried by stormwater. Spray waterproofing was used to seal the deck surface below the pavement asphalt. Two layers of spray waterproofing were applied with a total thickness of 4 mm.

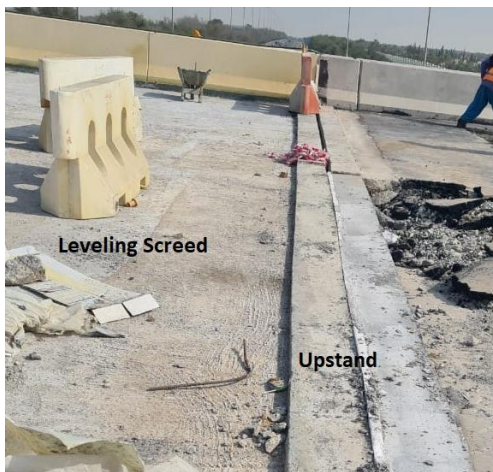
Figure 13

The problem faced during the installation expansion joint is the leveling screed used to adjust the difference in level between existing and new structures. The thickness of leveling screed at some locations was almost 35 cm, installing the bolts in leveling screed is not recommended because the screed is weak and there is a high possibility that it will break due to dynamic loads generated by passing vehicles. Therefore, a reinforced concrete upstand was constructed at the location of the expansion joint to allow the installation of expansion bolts inside the hard substrate which prevent early damage to the expansion joint. Moreover, the constructed upstand ensures a uniform and aligned gap along the existing and new structures.

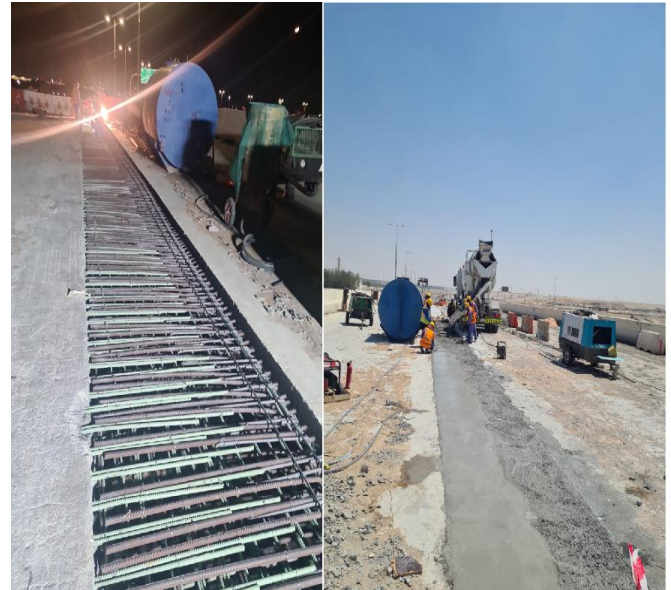
Figure 14

The implementation of these precautions prevented the falling of concrete into the live road and eliminated any hazard associated with the stitching process. Another concern was to prevent damaging the existing bridge deck during the breaking. To prevent damaging the existing bridge deck, a small breaking equipment (electrical compressor) was used to break the stitching portion. Also, the boundary of the stitching zone has been observed during the breaking process to identify any possible concrete defect formed during the breaking such as cracks.

The casting of the stitching area should not be done immediately after the construction of the new structure. Casting the stitching area immediately may result in the formation of cracks due to differential deformation between the old bridge and the new bridge. we should note that the new structure will undergo a higher deflection due to concrete shrinkage and creep.
