GEO-HYDROLOGICAL STUDIES FOR THE REVIVAL OF 15TH CENTURY KAVOOR LAKE FOR MANGALORE SMART CITY SUSTAINABILITY

Shamanth Kumar Hosabettu¹, Rasikh Mohammed Kazi², Dr. Radhakrishnan K³.

^{1,2}Student, Department of Civil Engineering, NMAM Institute of Technology, Nitte, Udupi, Karnataka, India.

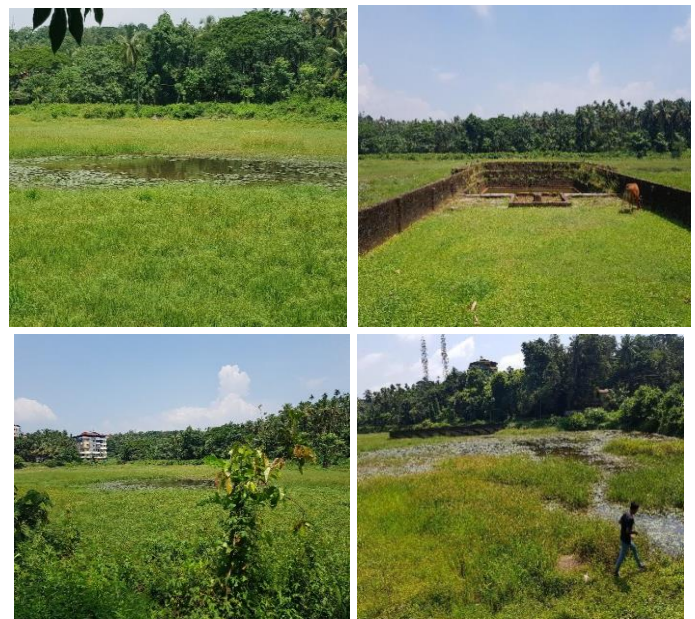
Fig 2.2: Present Lake condition

The lake is located at an altitude of 38m from the mean sea level. Mahalingeshwara temple lies on the north-west bank of the lake which has a history of 15th century. Hence, it is estimated that this lake was built during that period. The lake has a gradient towards the north-west region. During heavy rains, a large amount of silt and soil as well as other solids flow into the lake. They get accumulated on the banks year by year reducing the area of water shown in Fig 2.2.

Based on the site conditions study, the lake is covered with vegetation and silt. De-siltation is a must for any undertaking to improve the lake. Inlets are in very poor condition and need to be repaired. The concrete has cracks with vegetation growing in them. The channel bed is irregular and needs to be reconstructed with proper slope. The outlet sluice gate has been damaged due to poor maintenance and needs to be repaired too.

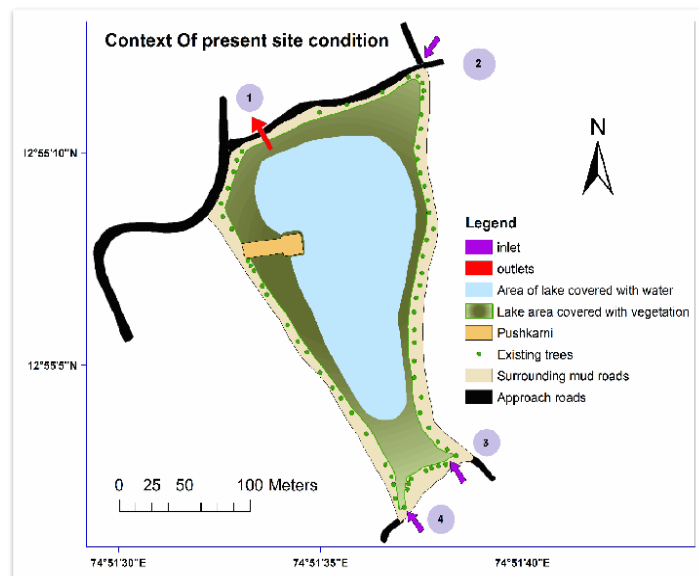
Fig -2.3: Lake Representation

The boundary of the lake as well as other features like the temple tank and the surrounding mud roads are delineated using Google Earth and Bhuvan and then mapped in QGIS. Fig. 2.3 shows the delineated lake and lake area giving a context of the present site situation, showing the inlet and outlet locations. GIS analysis shows the area of the lake to be about 6.2 acres. This was also verified using Google Earth and Bhuvan. The whole Lake area is approximately 6.8 Acres (estimated from latest Sentinel-2 satellite imagery in QGIS and also Google Earth) which is surrounded by residential built up structures and abundant greenery, providing the perfect opportunity of rejuvenating and redeveloping it as a means of a reliable water resource significant for the improvement of the recreation and water harvesting options for the residents of the city and beyond.

There is a total of three inlets into the lake (points 2, 3 and 4 as shown in Fig 2.3), through which water flows in, while there is only one outlet (point 1 as shown in Fig. 2.3), through which the water flows out. Major drains are present on the north eastern side of the lake. A step well is situated on the western side of the site, jutting out into the lake. Fig. 2.4 shows the photographs of inlets and outlets with reference to Fig. 2.3. The inlet/outlet will be referenced in the order as in Fig. 2.3 for every further analysis in the report.

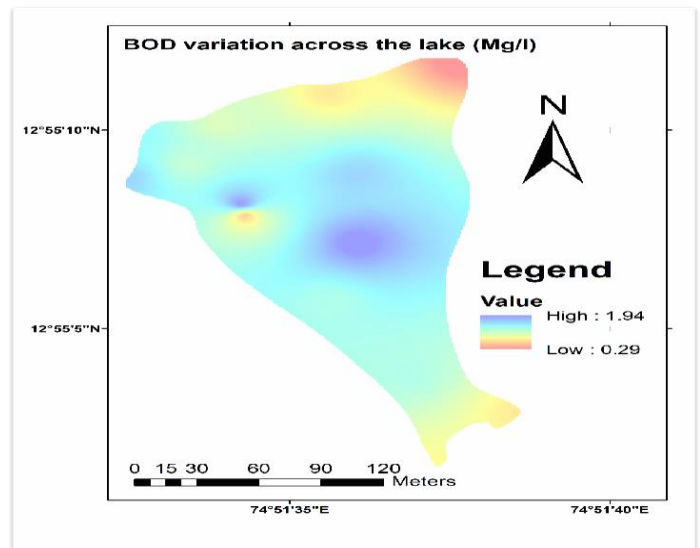
Fig -4.4: BOD₅ variation across the lake

The variation of BOD, DO and Turbidity are visualized using ISO-variation maps made in QGIS.

- The water flowing out the outlet needs to be coagulated to bring the turbidity within the permissible limit.
- The BOD₅ of the effluent is close to the permissible limit and can be used for drinking. The maximum BOD value recorded is in the stagnant waters at the centre of the lake. This value, 1.87 indicates only a slight contamination of the lake water.
- The alkalinity is within the permissible limit of 20-200 Mg/L.
