SEISMIC BEHAVIOUR OF RC FRAME WITH AND WITHOUT MASONRY INFILL

K.Kalaipandian¹, R.Amuthaselvakumar²

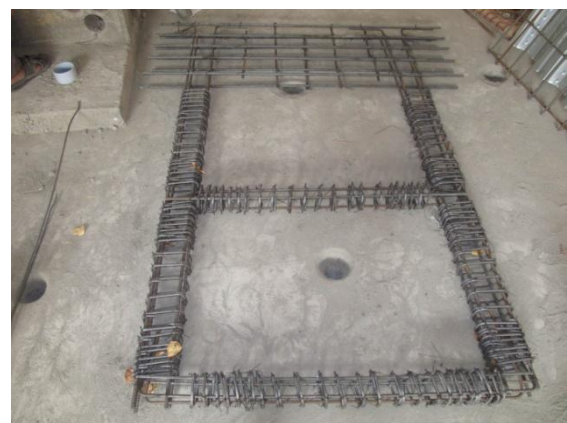
Fig-2: Reinforcement Grill for the RC Frame

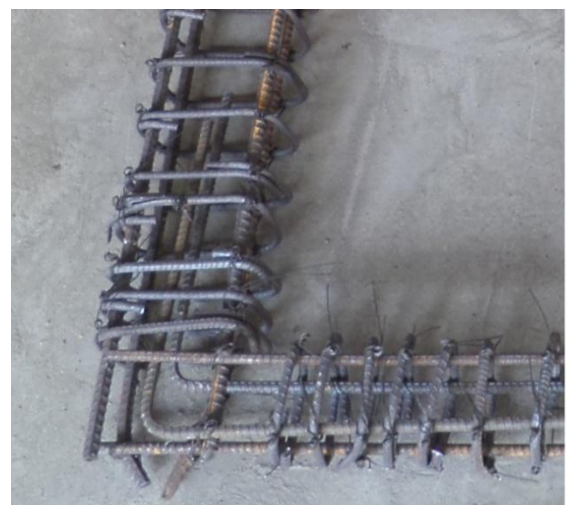
Fig-3: Closer View of Beam-Column

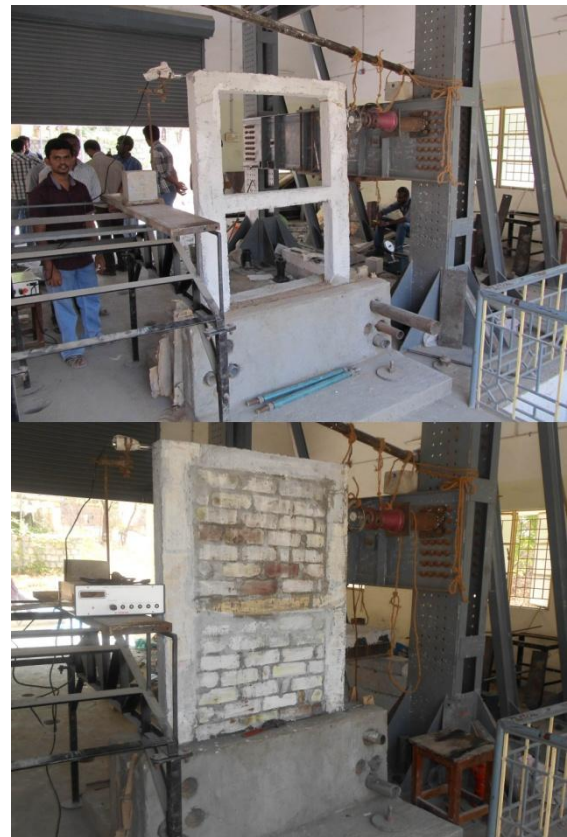
FIG – 5: Test setup for both frames

Figure 4 shows the test setup adopted for testing all the frame specimens. The effectiveness of instrumentation setup and the loading were checked in the beginning by loading and unloading the frame with small loads (of the order of 1.5 KN at the two load points) till all the readings was repeatable. The two frames were tested under uni-directional lateral loads in a quasi-static pattern simulating seismic action. In the experiments, the lateral load called base shear was applied at the beam levels using screw jack and the applied load was measured using proving ring. Since the main purpose of the experiment was to observe the frame's behaviour under lateral loading, no vertical load was applied on the specimens except for the self-weight of frames and walls. Initially a base shear of 15 KN was applied and the loading was progressively increased by 10 KN base shears in successive cycles until the maximum load-carrying capacity of the specimen was reached.

During the tests, storey displacements and the lateral loads were monitored. After each cycle, new initiated cracks and crack propagations were marked on the specimens and failure mechanisms were observed. The deflectometer readings for calculating the error due to rigid body rotation of foundation block were also recorded.

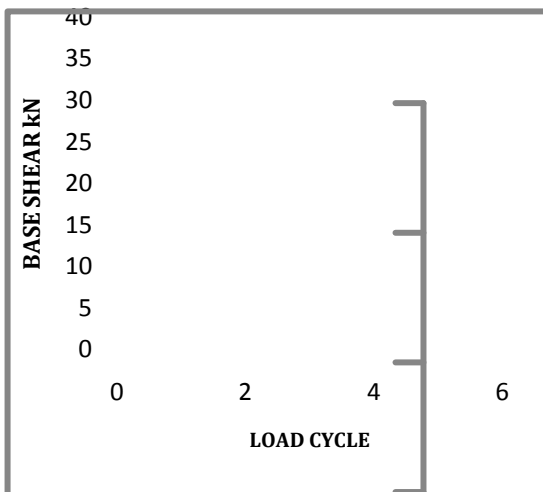
Fig-6: Sequence of Loading for the bare Frame

The frame was subjected to lateral loads in a quasi-static pattern simulating seismic action. The history of sequence of loading for the bare frame is shown in Figure 6. The load carrying capacity of the specimen was named as ultimate load. The ultimate load of 39 KN was reached in the fifth cycle of loading. The load-displacement response of the bare frame was recorded as plotted in Figure 7. At the ultimate base shear, the top-storey deflection was found to be 28.5 mm. The displacement due to rigid body rotation of the footing and the foundation block were incorporated in the calculation of net deflection.

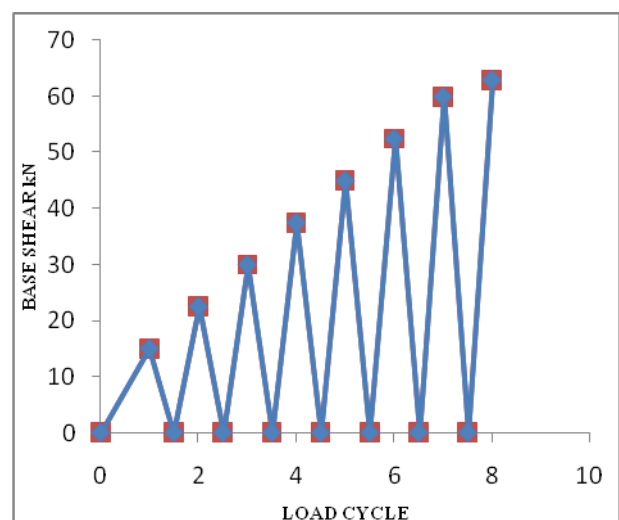
Fig-8: Sequence of Loading for the masonry in filled Frame

The frame was subjected to lateral loads in a quasi-static pattern simulating seismic action. The history of sequence of loading for the masonry infilled frame is shown in Figure 8. The load carrying capacity of the specimen was named as ultimate load. The ultimate load of 63 kN was reached in the fifth cycle of loading. The load-displacement response of the masonry infilled frame was recorded as plotted in Figure 6.2. At the ultimate base shear, the top-storey deflection was found to be 38.51mm. The displacement due to rigid body rotation of the footing and the foundation block were incorporated in the calculation of net deflection

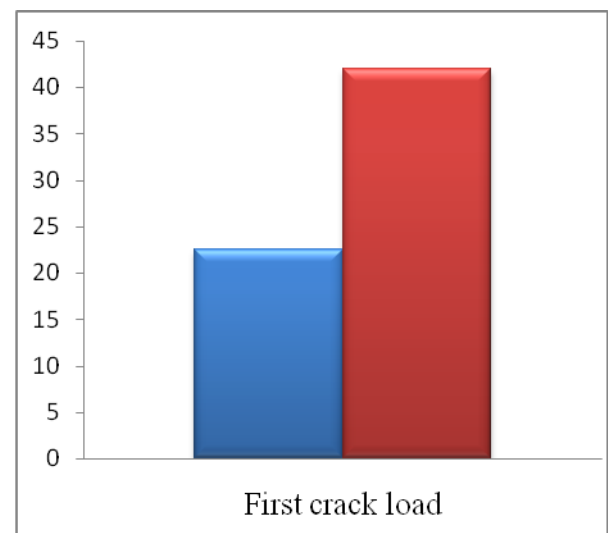
The first cracks observed in the experimental results of the bare frame model were compared with brick infill frame model results as shown in the figure

Fig-10: First Crack Load of with and without Infill
