# Defects in Cast-in-situ Ballastless track

**Abstract** - It is a well-known fact that ballastless tracks have proved to be effective alternative to the tracks with ballasts and hence they have been adopted in India a decade ago. The conventional ballastless track are cast-in-situ types, in which the pre-cast concrete sleeper are embedded in the Cast-in-situ concrete slab thereafter rails and fastener are provided. The present work focus on the various type of defects found in Cast-in-situ ballastless tracks along with their and countermeasures. Causes of defects is analyzed, according to corresponding quantitative equation, affective technical measures of concrete are put forward. The best alternative for conventional ballastless tracks i.e. "Pre-stressed bi-block sleeper ballastless track" has also been proposed.

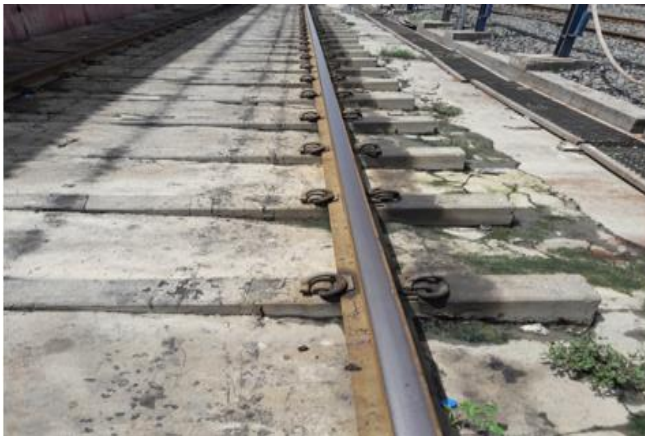
**Fig.2** Cast-in-situ Ballastless track

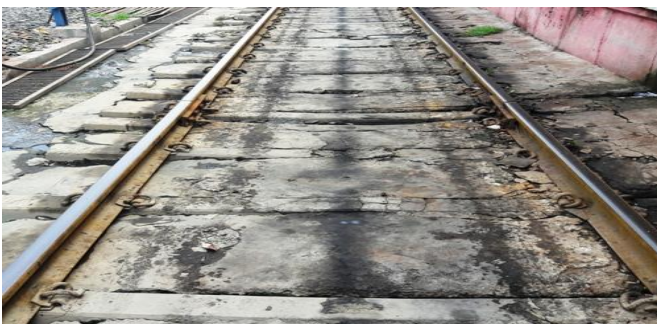
**Fig.3** Deterioration of Cast-in-situ BLT

Main defect which have been observed in cast-in-situ ballastless track is deterioration of concrete of track slab. The service life of concrete structures is reduced drastically because of the deterioration of concrete. Deterioration of concrete takes place due to many reasons such as poor quality materials, degradation due to environmental effects, design and constructional errors or an adverse combination of these factors.

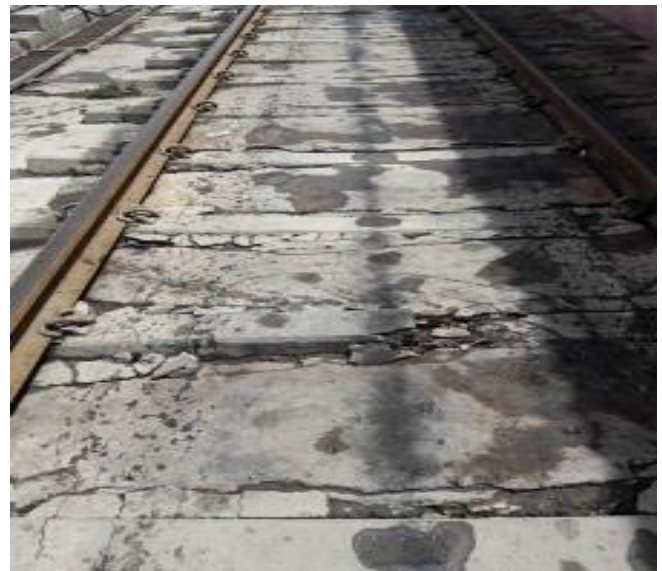
**Fig.4** Deterioration of Cast-in-situ BLT

Longitudinal crack which is induced by the non homogeneous stress easily appear in the range of fastener. There are many cracks in the inner side of frame track slab, and some cracks run through the total depth of track slab. Some cracks were developed due to Non-linear and irreversible behavior of concrete material. Sometimes cracks are also caused by freezing and thawing of saturated concrete, or corrosion of reinforcing steel. However cracks from these sources may not appear for years.

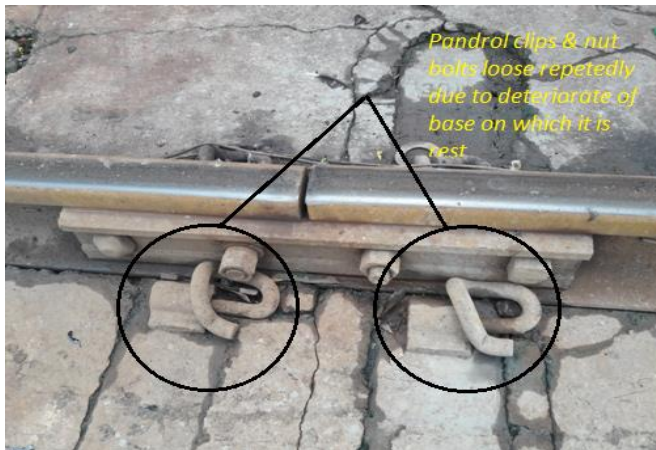
**Fig.7** Repeatedly loosened fastener due to the deterioration of base on which it is rested upon.

Concrete crack were lie in the range of fastener, and in base slab on which rail joint fitted with fastener rested on it also. Base slab concrete below rail joint is completely deteriorated. Some cracks are also developed in this area. In fastener, pendrol clip are loosened often due to vibration of joint and Nut-bolt of fish plate is also loosened, when load action is more. At some places concrete crust is peel off in the range of fastener. Concrete crack were also developed due to water accumulation in base slab of ballastless track.

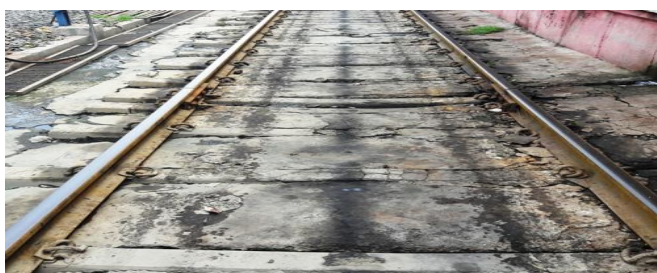
**Fig.5** Cracks in frame of track slab

Cracks in the track slab will become entryway of the corrosion substances, Under the  $Cl^-$  or  $CO_2$  environment. The steel in the slab will be corroded and the resulting expansion will aggravate the cracking of the concrete, sequentially reducing the durability of the concrete structure. Under movable load, concrete of track slab is easy to disintegrate and the sleeper rap, which affect the safety of the train. Some cracks lie in the range of fastener; leading to the loosening of the fasteners, thus affect track stability. In addition, there may be potential incipient fault of travel.

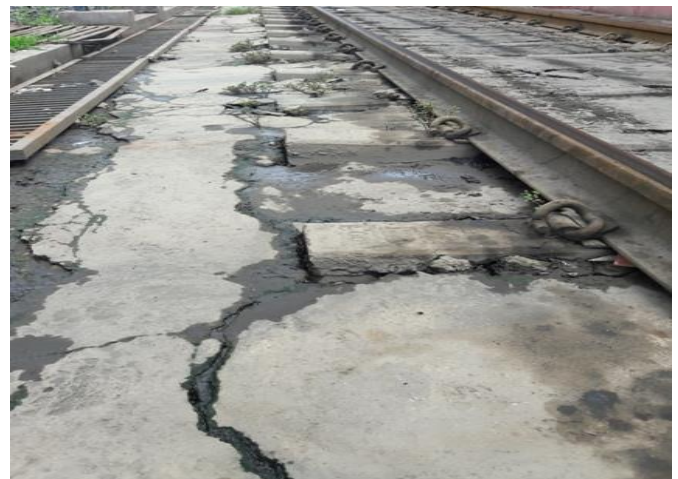
**Fig.6** cracks in base slab of ballastless track

For Cast-in-situ BLT structure, concrete cracks not only harms the concrete, but also harms the conterminal part. Cracks in base slab is pathway to the water, immersing the water for a long time, the superstructure accelerates falling in, at the same time increase sedimentation value of base, thus affect the stability of base and reduce the durability and bearing capacity of base. Moreover, the cracks in base concrete aggravate corrosion of its steel.

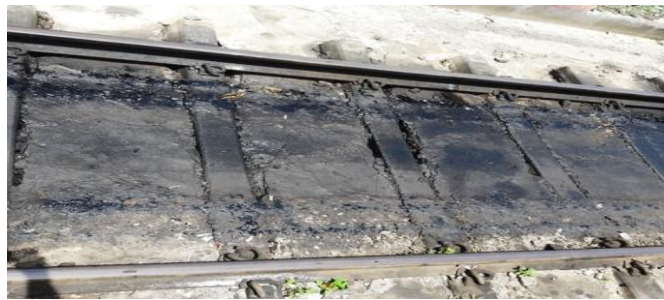
**Fig.8** Oil and chemical attack on concrete

The chemical cause of concrete deterioration includes carbonation; sulphate attack and steel corrosion. Other factors contributing to concrete degradation include high structural stress, thermal stress, and shrinkage, poor quality of materials and workmanship and poor maintenance.

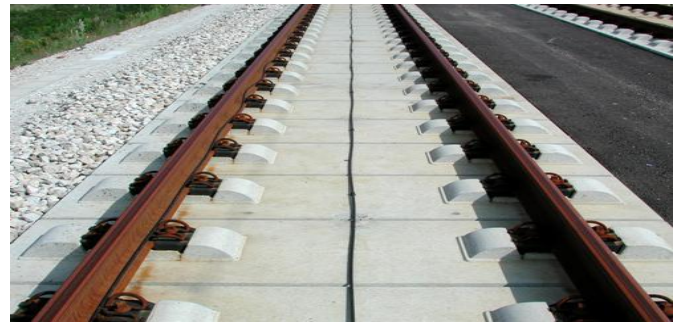
**Fig. 9** Pre-stressed concrete Bi-block sleeper ballastless track system

Now a day's High speed railway is the future of whole railway system. There are best alternatives of Cast-in-situ ballastless track are Pre-stressed concrete bi-block sleeper ballastless track system. The basic system structure, however, always consists of modified bi-block sleepers which are securely and reliably embedded in a monolithic concrete slab. Highly elastic rail fastenings are essential to achieve the vertical rail deflection required for load distribution and for smooth train travel. The concrete track-supporting layer is the major load-distributing element of the system. Since it is cast-in-place, it can be individually adapted to any substructure type and condition. For embankments, it is designed as a continuous slab with free crack formation.
