Breakage Analysis of Aluminum wire rod in Drawing Operation

Bhimsen Moharana¹, Bashishth Kumar Kushwaha²

Abstract - Commercial aluminium rod and wire for electrical cable manufacturing involves different operations, such as a long square ingot is heated, progressively reduced in cross-section by passing it through a series of rolls and then coiled. The coils are then pulled through smaller and smaller dies in wire drawing operation to obtain the required wire size.

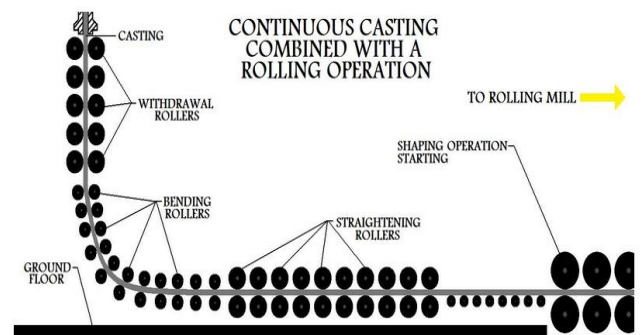
Commercial manufacturing of aluminium cable starts with melting the billets in furnace and alloying if required. Then liquid aluminium is taken into a stilling furnace to provide stability of flow and casting continuously. After this stage liquid aluminium is cooled on casting wheel and aluminium bar is forced into rolling machine to shape 7.6mm, 9.50 mm or 12mm wire rod. The wire rod so produced is packaged in 1-2 tons on tight coiled pallets for further operation. Quality controls like checking the diameter, resistivity, strength and shape of rod and chemical composition are to be carried out to meet international standards.

Fig. 1: Continuous casting process [1]

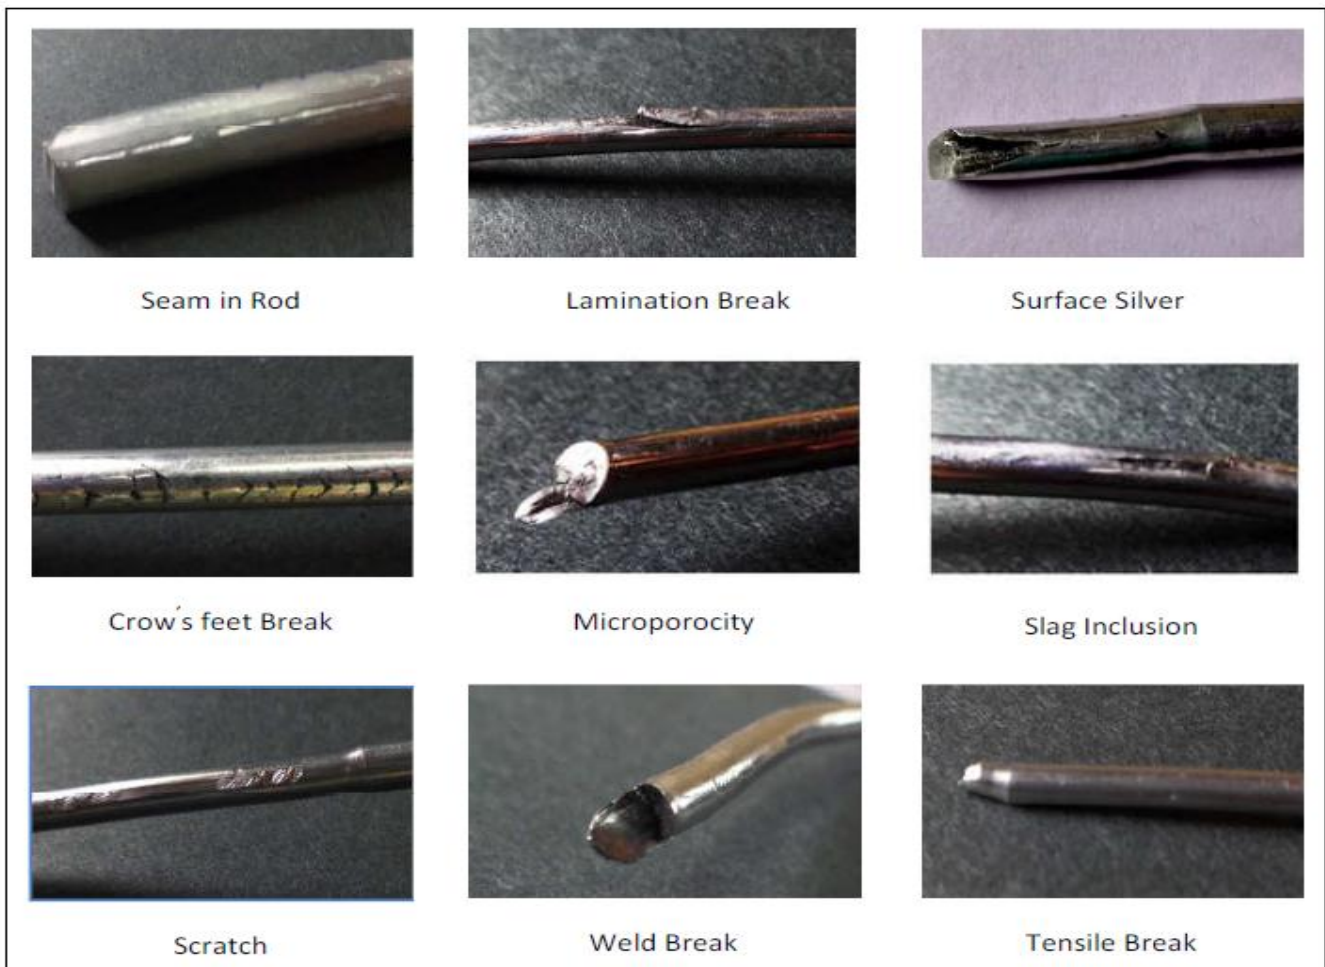
Visual inspection of breakage samples are shown in fig.8. Surface defects such as laps, seams, and fins and silver were observed in wire rod samples. Prominent surface scratches were also observed in breakage samples. The lack of proper lubrication between the wire and the die was observed. With the high die pressure and the continued appearance of unreached, nascent metal at the wire surface, a relatively strong bond develops between the wire and the die. Thus the

metal sticks to the die, and the shearing action between the wire and the die involves a shearing off of the wire surface, leaving wire metal stuck in the drawing channel. In effect the emerging wire surface is a ductile fracture surface.

Crow's feet marks observed on the surface near the breaking ends of the wire causes catastrophic breakdown of the drawing operation. This is due to marginal lubrication leads to local sticking, typically long strings of chevron-like shear fractures in the wire surface commonly called "crow's feet." As this condition of local sticking become more pervasive, involving patches of shear fractures and crow's feet. During subsequent drawing operation as crow's feet marks exceed the critical limit, the wire breakage may be noticed.

Fig. 8: Wire Breakage Samples

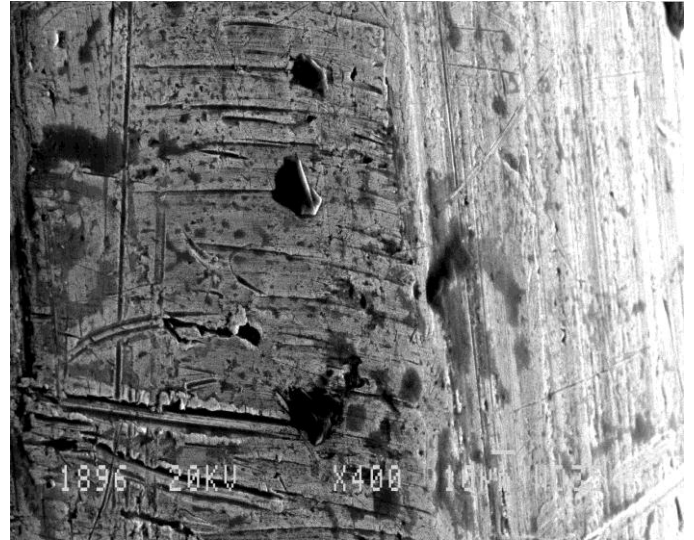
Un-etched surface of the wires were also observed with voids and micro cracks as in specimen No.5, 6, 7 and 8 as shown in fig. 11-14. Prominent surface scratches were observed leading to crow's feet marks in the drawn wire and the consequence of wire breakages. This indicates the lack of proper lubrication during the drawing process. These surface irregularities lead to sticking friction and cause of wire breakage

Fig. 14: Un-etched surface of wire Φ 3.15mm Specimen 8

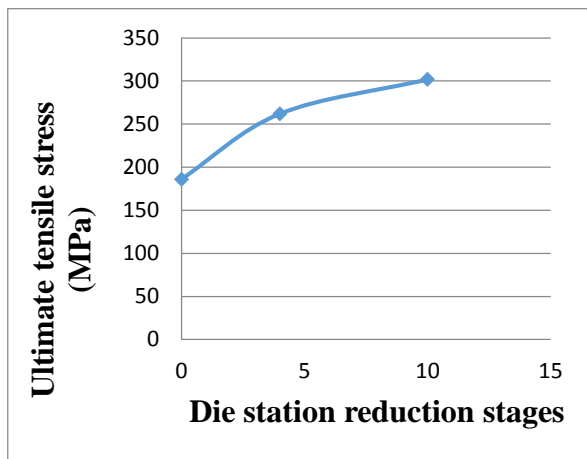
The ultimate tensile stress observed during tensile test in table 3 for sound wires quality go on increasing from initial die station to final die station. It is because of work hardening of the material during cold working. The fig.17 shows the strength variation in wire rod.

Fig. 17: Strength Variations in Sound Wire Sample

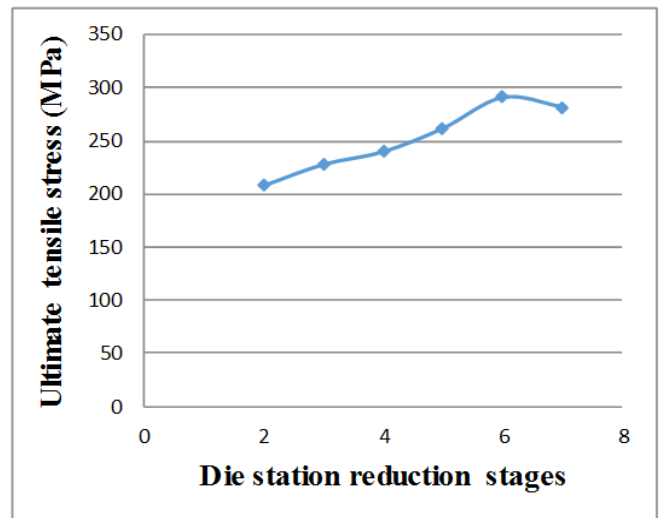
However uneven tensile strength development in between wire samples was observed during the tensile test as noted in table 3. This was due to flaws and inclusion present in the wires. Fig. 18 shows the strength variation in wire rod of samples.

Yielding and breaking are generally associated with the instability created by plastic stretching of the wire between dies. The drawing force may exceed the tensile fracture strength due to wire cross-over, misalignment between the wire and the draw die, poor lubrication, dies packed with fines or due to broken dies.

FIG. 18: Strength variations in breakage wire sample

In such cases, when the ratio of draw stress to flow stress is equal to one, wire vibration and lubricant fluctuation will be expected in the drawing operation. The co-efficient of friction between the die-wire interference will vary considerably and changes the draw stress to flow stress ratio, which should be as low as 0.7 because of anisotropic behavior of the wire material in order to prevent breakage of wire [35].
