ANALYZING THE EFFECT OF DIFFERENT PROCESS PARAMETERS ON TOOL WEAR, CHIP FORMATION AND SURFACE INTEGRITY DURING CNC MILLING OF HASTELLOY C-276

Abstract—The paper presents the three main process parameters such as cutting speed, feed rate and depth of cut were selected for experimentation. Machining parameters have predominant effect on the tool wear, chip formation and surface integrity for that the manufactures needs the optimal values of operating parameters in order to reduce the experimental as well as the minimizing simulation in order to reduce machining cost. The experiments were carried out on a CNC Milling machine under dry conditions and wet conditions using PVD coated inserts and tool wear, chip formation and surface integrity is studied in process. SEM-EDS analyses were performed at different cutting conditions. The results of experiment have showed that the flank wear has most common type of wear occurred during milling of nickel based alloy. During the machining of Hastelloy C-276 high pressure and temperature was generated, micro chipping and buildup edges generated even at low cutting speed. It was evident that, when the cutting speed increased the buildup edges was

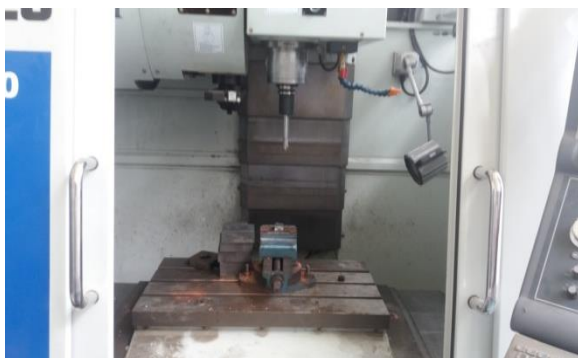
Figure 1 Schematic of end milling

The experimentation was performed on CNC milling machine (Hurco VM10) as shown in Figure 1. The work material used for experimentation was Hastelloy C-276 (Ni-Cr-Mo-W) having hardness 87 HRC. The chemical composition of the Hastelloy C-276 is shown in Table 1 given below [8].

The experiment had performed on three axis CNC milling machine centre with spindle speed 10000 rpm. End milling operations were performed under dry conditions and wet conditions.

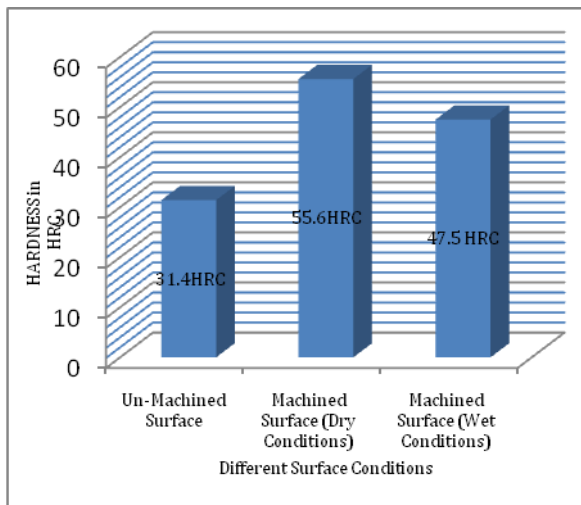
Figure 6 Effect of different machining conditions on Hardness

According to the result shown in the Figure 6 the average Viker's micro hardness of un-machined surface was 31.4 HRC where as Viker's micro hardness of machined surface in dry conditions was 55.6 HRC and for wet conditions was 47.5 HRC at 1 kgf load.
