Identification and Improvement of Accident Black Spots on N.H.86 District Sagar, Madhya Pradesh

The present study aims to identify accidental black spots on a section (sagar to shahgarh) of NH-86 by studying the accidental data provided by Police station during last five years. In this study identification of black spots by using weighted severity index {WSI} and Accident Density method {ADM} and during this study basic causes of accidents were found out and suitable remedial measures were also provided for a particular spots.

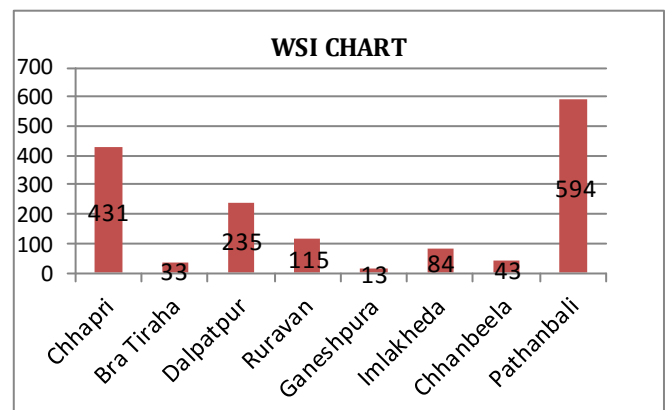
Fig 01. Weighted Severity Index value Chart

Sample calculation of location wise accident data by using WSI formula, Accident data put in formula from table no(1) than we determine WSI value of each location.

WSI value in 2012 = (41 x 5) + (4 x 20) + (1 x 7) = 292
 WSI value in 2013 = (41 x 2) + (4 x 11) + (1 x 8) = 134

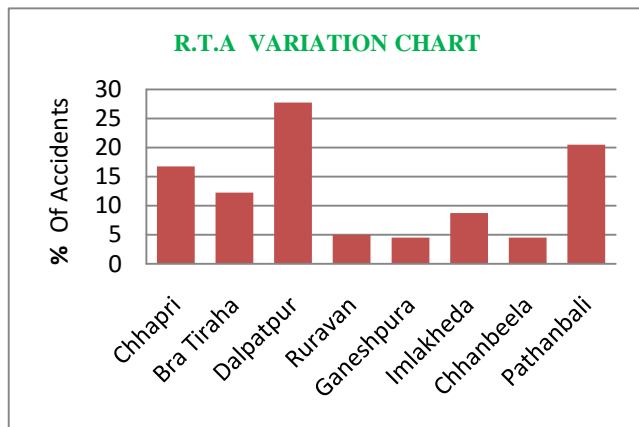
Fig 02. Road Accident Percentage (%) share Chart

A comparison was made based on the Road Traffic Accident {RTA} occurrence between Sagar to Shahgarh study stretch of NH-86. based on the findings of this research study. There were 111 (27.75%) out of 400 accidents occurred in Dalpatpur Gram and its extension from 2012 to 2016. Pathanbali Ghat and Chhapri Turn had shared 82 (20.50%) and 67 (16.75%) accident respectively. The most vulnerable location of road traffic accidents happened in the mountainous and escarpment due to road design problems such as insufficient sight distance and width of road, sharp curve, Poor condition of carriageway, missing sign board, missing and uneven shoulder, cattalos at road, deficient and damaged road pavement marking.

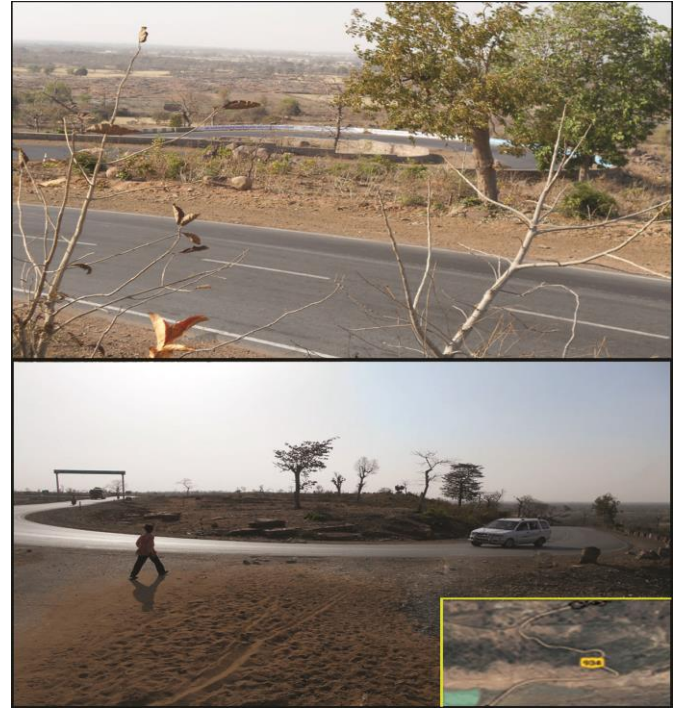
Fig1.1 Pathanbali Accident locations.
Source: Site visit photography.

This is identified as the most vulnerable accident stretch on Sagar-Sahgarh (N.H-86) in dist. sagar, This stretch under uneven Mountain terrain ,One side of this stretch deep ditch and other side large stones of mountain. This existing road was constructed on sidle of mountain, there have a following some deficiency:-

- 1) At this High Gradient which cause Break down/ Break fails and other mechanical problem cleat in heavy vehicles, vehicle uncontrolled them.
- 2) There have a very sharp curve.
- 3) No Guard rail & improper sign board. Improper retaining wall at curves also no Extra winding.
- 4) No proper Marking, road delineators and lighting.
- 5) No drainage system which causes rain water flow over to carriageway than create in this condition stripping and slipping, Damage shoulder.

1. Maintain Gradient according to NH IRC standards.
2. Provide Extra winding at Sharpe curve.
3. Remove/Cutting Large & Heavy stone from shoulder.
4. Provide Hard shoulder in Proper width.
5. Increase curve radius.
6. Provide Proper Road marking and road delineators.
7. Provided speed limit, warning and mandatory signal.

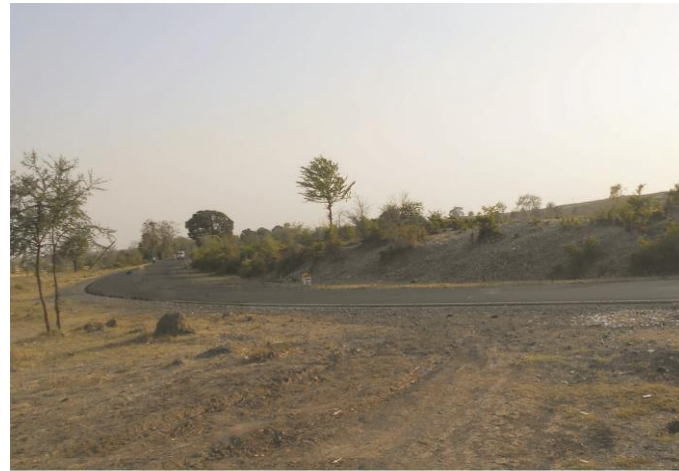
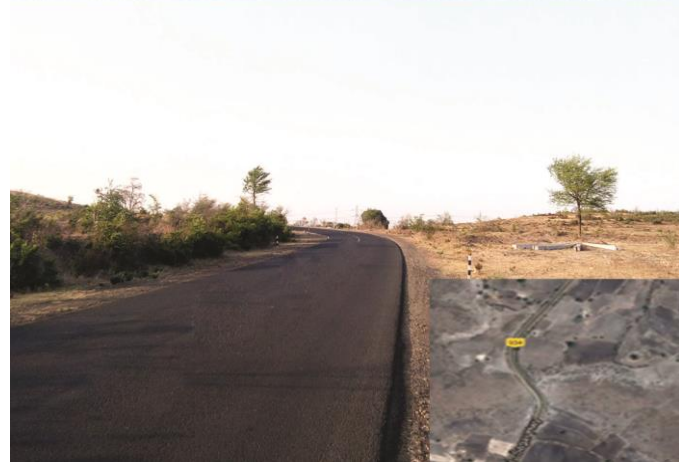
Fig 1.2 : Chhapri Turn Accident locations.
Source: Site visit photography.

This is second top most vulnerable accident stretch on road section, two bland turn very close at this spots and old trees and mountain of road side which cause of other vehicles front rear collusion at turns.

- 1) Uneven shoulder also improper width.
- 2) Inadequate super elevation design at curves.
- 3) No extra winding.

- 1) Remove & Cutting of tree and other obstruction form road side, increase sight distance.
- 2) Provide Hard Shoulder both side of Road.
- 3) Redesign the super elevation because as compare to the left side maintain as per Indian practice the super elevation is limited to 0.07-0.10.
- 4) Also provide extra winding at curve.

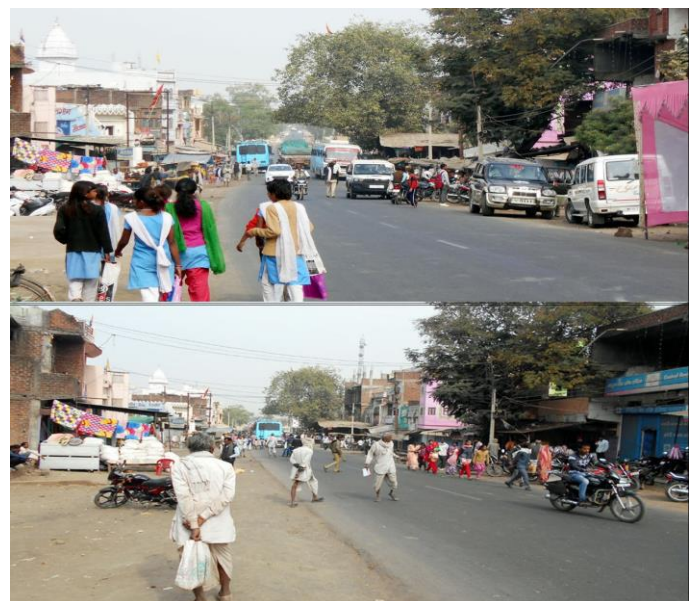
Fig 1.3, Dalapatpur Gram Accident locations.

The accident stretch identified in Dalpatpur village. This stretch under come of NH-86. There have not any other bypass for passing of vehicles. All heavy load passenger vehicle pass into Dalpatpur village and market, shops, schools, bank, office & other public place established both sides of road which cause many accident problem create at this stretched.

- 1) There have not bus stop all passenger bus stay on road and all passengers move over the carriageway i.e. improper bus stop location.
- 2) Improper pedestrian crossing.
- 3) Most of the vehicles are parked on the road itself which leads to traffic jams.
- 4) Footpath is not provided on either side.

- 1) Provide separate bus bay's.
- 2) Provide footpath on both sides of the road for safety of pedestrians.
- 3) Provide the zebra crossing near bus stand. Public place and junction for safe crossing of the pedestrians.
- 4) Provide parking so that vehicles cannot stand on side of road.
- 5) Provide awareness about traffic rules for public

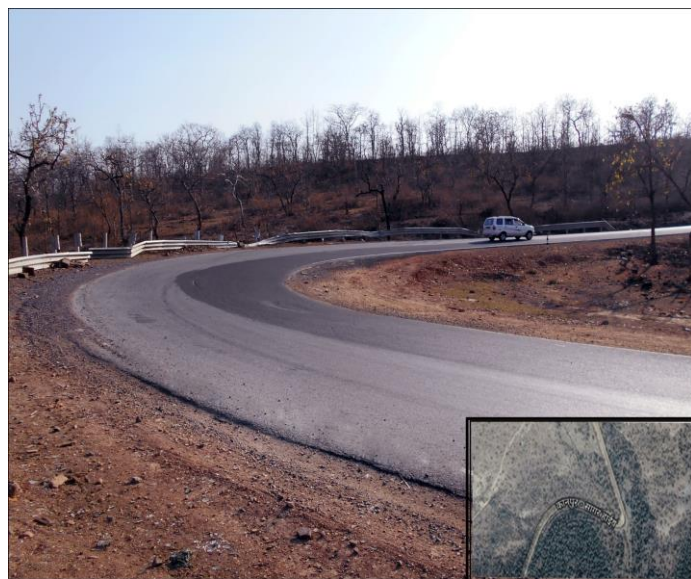
Fig 1.4 Imlakheda Turn Accident locations.
Source: Site visit photography.

At this top vulnerable accident spots, Horizontal curve of very small radius is constructed on the hilly portion of road, which cause loaded and high speed vehicle become uncontrolled at turn,

- 1) Too small radius of horizontal curves.
- 2) Cross barrier to totally damage.
- 3) No proper road marking and road declinator.
- 4) No lighting and sing boards at turn.

- 1) Increase radius of horizontal curves, also maintain super elevation.
- 2) Provided proper cross barrier.
- 3) Provided road marking, and Road declinators.
- 4) Remove & Cutting of tree and other obstruction form road side, increase sight distance.

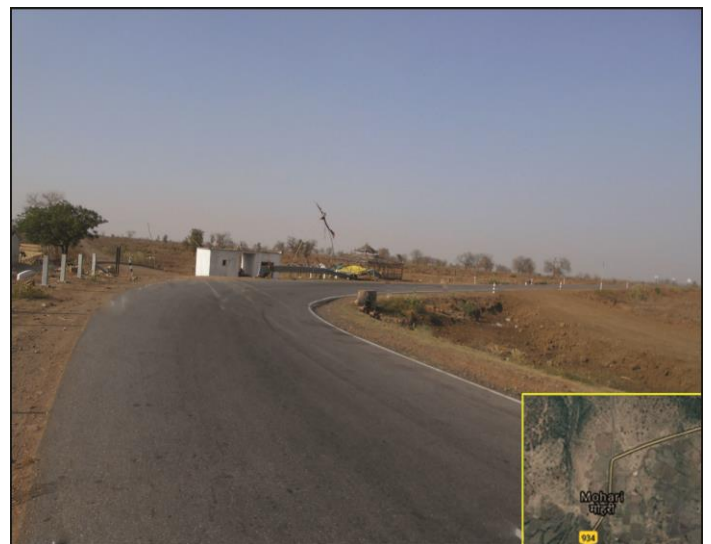
Fig 1.5 Ruravan Turn accident locations.
Source: Site visit photography.

This Black Spots identify near Rooravan village.

- 1) Therefore called Rooravan Turn.
- 2) Inadequate super elevation design at curves.
- 3) No extra winding of both side of Road.
- 4) No Proper cross barrier.

- 1) Increase radius of horizontal curves, also maintain super elevation.
- 2) Provided proper cross barrier.
- 3) Provided road marking, Road declinators.
