The Rehabilitation Techniques for Irwin Bridge

Abstract -- The rehabilitation techniques provide an attractive and economical solution for strengthening masonry arch bridge to increase their stability. Bridges have been important throughout history in connecting cultures, sharing ideas, and providing the backbone of transportation networks. It is necessary to restore and preserve these structures for their particular functionality and cultural heritage value. The focus of this paper is to present and discuss the many ways of strengthening and repairing masonry arch bridge ranging from minimum intervention to complete reconstruction. It is meant to provide a guide for engineers and architects on the methods available and the advantages and disadvantages of these methods, and to assist in their decisions of masonry arch bridge conservation. The main focus is on understanding and comparing different methods of strengthening and repairing masonry arch bridge.

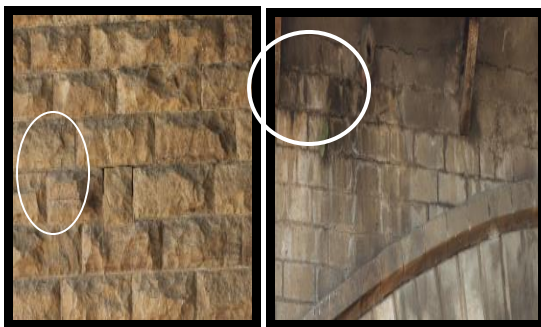
Fig1:-Cracks and loosening of joints

Problem: Areas of cracking to be detected in pier and spandrel wall

Cellular Foamed Cement Grouting

To facilitate grouting, 12-mm (0.5-in.) diameter holes were drilled through mortar joints within the exposed below-grade masonry to terminate within the inner-core rubble. Injection tubes were then installed into the holes and the masonry ‘rough-parged’ to facilitate containment of the fluid grout during the subsequent core stabilization work.

A cellular foam grout was then mixed and pumped through the injection tubes to fill any voids within the inner core rubble of the masonry. This part of the restoration strategy was designed to further stabilize the foundation walls and provide for a more uniform load distribution across the cross-section of the masonry assembly. The cellular grout was selected for its beneficial load absorbing characteristics, as well as its low-strength and lightweight properties.

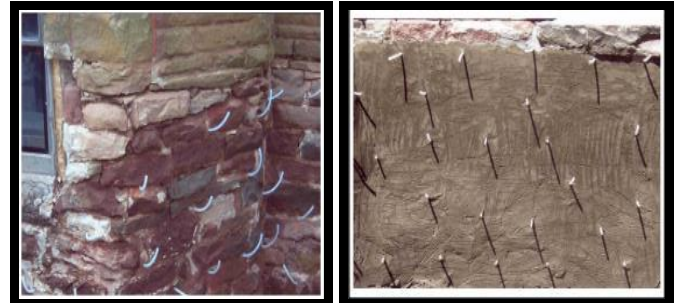
Fig2:- cellular foamed cement grouting

A methyl cellulose-type admixture was combined with the cement/water grout to provide thixotropic properties to the plastic grout, minimizing leakage to the interior through cracks and gaps. To generate the foam, a proprietary surfactant-type admixture was diluted in water

and forced through a nozzle when fed from a pressurized steel cylindrical tank. The nozzle end was fitted with a pressure gauge, shut-off valve and a return line, which allowed control of the flow of grout and pumping pressures at the grout injection point.

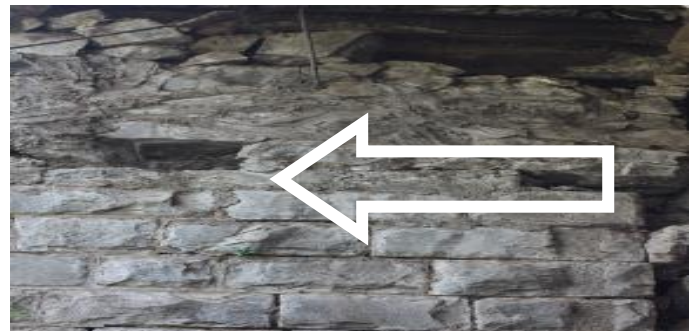
Fig3:- Delamination of stones in abutments

Problem: The most common problem observed during inspection of abutment are vertical movement, scour and under mining of the foundation, drainage system malfunction, materials defects, presence of excessive or unexplained moisture at or behind the abutments etc. Also, it is most affected part of bridge.

the delaminated stones are replaced using new stones. They are properly fixed by using concrete masonry with adding admixtures to it. The joints are filled properly with concrete mortar. Proper finishing is provided to surface of abutment.

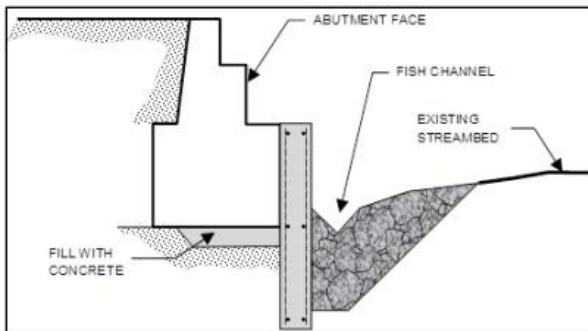
Fig5: - Concrete apron wall

A concrete apron wall can be utilized as a permanent structural repair for abutments that have experienced scour. For this repair, a concrete wall is cast against the stream side of the abutment and extended down at least eight feet. Riprap is typically utilized as another means of protection against future scour. Special attention should be paid to the riprap placement. The riprap will help to ensure that the new apron wall is not undermined due to scour. The lost soil below the abutment should also be filled with concrete in order to reintroduce bearing capacity.

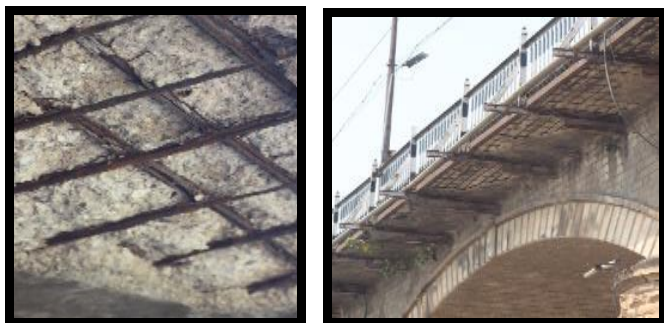
Fig.6:-Spalling of concrete of deck slab

The bottom joint of deck slab is damaged and loose joint sections. There is deteriorated mortar at the edges of the joint of deck slab and spandrel wall. Stones are loosening at joint section decreasing bonding between deck & wing wall.

All loose, disintegrated and unsound concrete shall be removed from portions of the deck slab. There shall be take care not to damage reinforcement bars or expansion joints which are to remain in place. Any damage to reinforcement bars or expansion joints shall be corrected.

Areas to be repaired will be determined and marked. A concrete saw shall be used to provide vertical edges approximately 3/4 in. (20 mm) deep around the perimeter of the area to be patched when a concrete overlay is not

The loose and unsound concrete shall be removed by chipping, with power driven hand tools or by hydro-demolition equipment. All exposed reinforcing bars and newly exposed concrete shall be thoroughly blast cleaned. Where the bond between existing concrete and reinforcement steel within the patch area has been destroyed, the concrete adjacent to the bar shall be removed to a depth that will permit new concrete to bond to the entire periphery of the exposed bar. A minimum of 1 in. (25 mm) clearance will be required. There may be require enlarging a designated removal area should inspection indicate deterioration beyond the limits previously designated. In this event, a new saw cut shall be made around the extended area before additional removal is begun. The removal area shall not be enlarged solely to correct bonded reinforcement or deficient lap lengths.

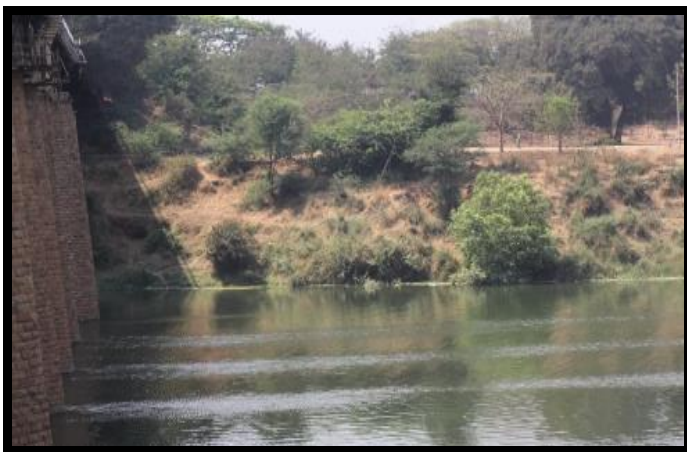
Fig7:- absence of training wall in river bed

The size of the river bed goes on increasing due to absence of training wall on western side.

The purpose of river training is to stabilize the river channel along the certain alignment with a certain cross section. we suggest the following methods for Krishna River Bank.

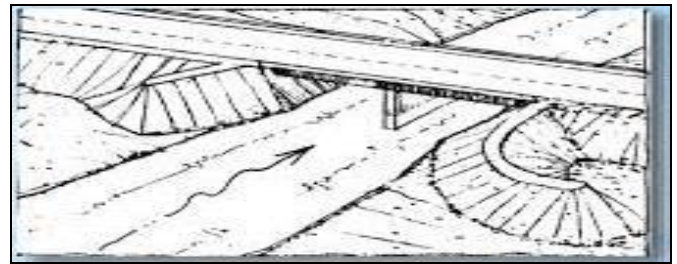
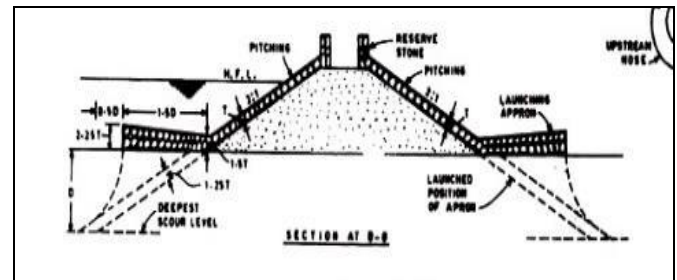
Fig 8:- Guide Bank

Guide banks are artificial embankments constructed along the flow direction both upstream and downstream of the abutment on one or both sides of the river for guiding the river flow past a bridge (or other hydraulic structures, such as weirs or barrages) without causing damage to the bridge and its approaches.

The overall waterway between guide banks is obtained by adding thickness of piers to the clear waterway. Figure 9.4 shows the plan and section of a typical guide bank. The elevation of the top of the guide banks is kept 1.5 to 2.5 m above the HFL of 100-year flood.

The top width of guide banks is generally kept between 6 and 9 m. Locally available earth materials are used for

constructing guide banks. To prevent erosion of the material from the river-side surface of guide bank, the surface is stone-pitched.

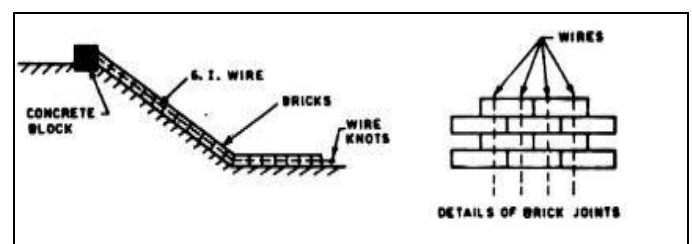
Fig10:-Bank Protection

Riprap of hard angular rock fragments (or concrete blocks) laid on a thick layer of rubble or quarry chips is cheap and durable method of bank protection. Another way of providing bank protection is by means of flexible brick pitching

For this purpose, bricks having a pair of holes across their full width are laid on the bank slope and for some distance on the river bed at the toe of the bank. A G.I. wire passes through the brick holes. The wires are knotted at their ends and suitably anchored so that the bricks are held together and also small movement of bricks is possible.

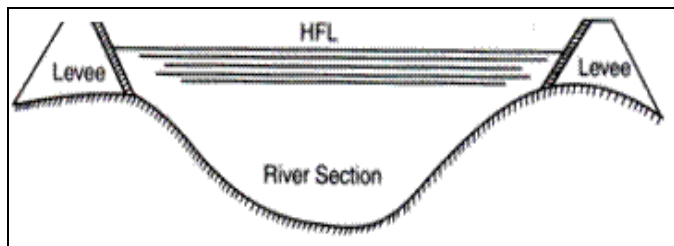
Fig9:- Marginal embankments or levees

The marginal embankments are constructed as close to the banks as possible to restrict the flood water from submerging the area behind them. Figure shows the position of marginal embankments. They are designed to hold up the water up to a maximum anticipated HFL without the possibility of overtopping and with a view to withstand all external pressures. This condition is met with by providing sufficient freeboard, bed width, top width and stone protection on adequate slopes.

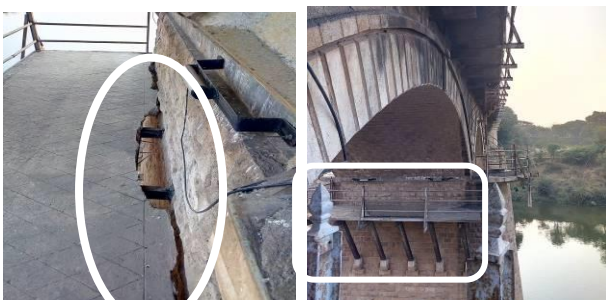
Fig11:-Gallery of bridge

The components of gallery of bridge gets eroded. There is corrosion formed at stairs of gallery. Erosion and loosening of joints in gallery of bridge.

The rehabilitation techniques or repairs for gallery are not suitable due to very severe damages are occurred. So, it is necessary to reconstruct the gallery of bridge.
