# Mechanical Characterisation of the Coated Roller Bearing

**Abstract:** In the present day generation focus is done on the elements which support the moving elements. Since the supporting member is rolling bearings hence in this work we are trying to improve the performance by analysing the structure of the material present in the bearing, type of optimised coating i.e by polytetra fluoroethylene coating. Coating an optimum layer of 0.01mm thickness and checking the performance at different speeds and various load conditions is examined. The surface topography after coating is checked using SEM technique and the discussions are made. Comparison of different types of grease for the coated bearing material. Capturing these vibrations of the bearing using vibrometers and accelerometers and improving the remaining useful life of the bearing by changing the type of coating material.

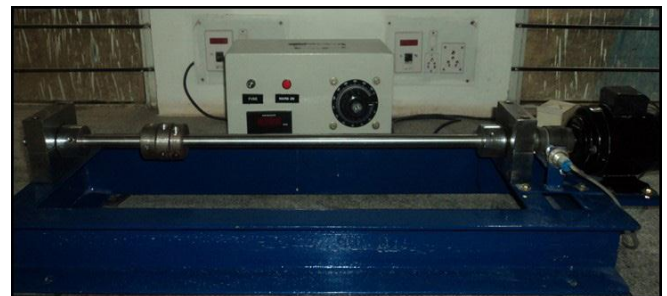
**Fig-1:** Experimental Set up for testing coated bearing

The above figure shows the mounting of a coated bearing on a suitable test rig with load varying from 500N to 1000N in incremental value of 100N. The overall dimensions of the equipment is 600mmX700mmX500mm. The motor capacity used is 1.5HP motor at a maximum speed of 2000rpm. In this set up a voltage of 200V 50 Hz supply is given to motor to start the set up.

There are supporting legs mounted on the bottom of the frame for arresting vibrations. These supporting legs will also act as vibration absorber to arrest the vibrations of the system

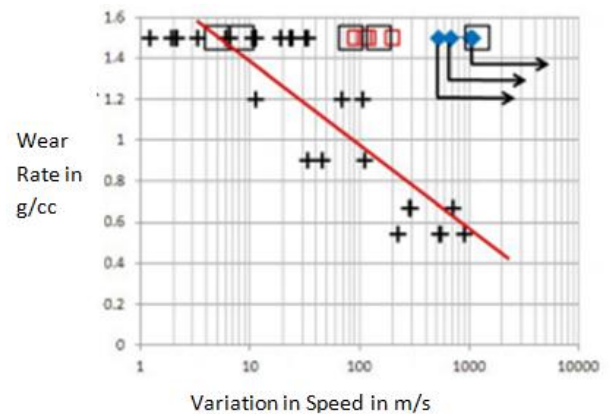
**Fig-5:** Variation of wear rate v/s variation of speed in m/s

The bearing after coating with polytetra fluoro ethylene with varying speeds ranging from 10m/sto 100m/s in increments of 10m/s observed a decrease in wear rate for increase in speed. We observed that wear rate was decreasing from 1.6g/cc to 0.4g/cc

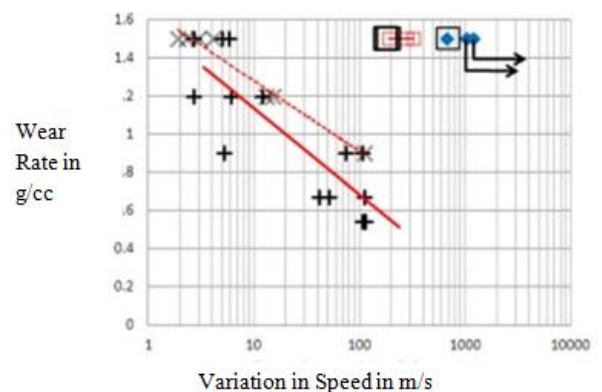
**Fig-6:** Variation of wear rate v/s variation of speed in m/s

When a coating thickness was increased to 0.14mm we observed that well below 1000m/s speed the wear rate was almost stagnant without gradual decrease in the wear rate of the specimen under consideration

We found that at 0.12mm thick and at 1200m/s the wear rate was reduced. But as the coating increased to 0.14mm thick before the speed reached 1000m/s the wear rate was almost zero. Thus on repeated trials the optimised coating obtained was about 0.15mm thick.
