Review on Performance of Polypropylene Band –Retrofitted Masonry: Evaluation of Seismic Behavior

Abstract - Masonry structures have exhibited their extreme vulnerability even in event of the past minor to moderate earthquakes. This paper investigates a recently developed retrofitting technology specifically aimed at preventing or prolonging the collapse of the masonry buildings under strong earthquakes. On the other hand, the retrofitting technique proposed in this paper is economical and easy to apply polypropylenely. This paper aims at examining the performance of retrofitting technique using the polypropylene (Polypropylene) band. In this paper the monotonic load displacement behaviors of a URM wall and the wall retrofitted with Polypropylene band are compared. It was observed that the Polypropylene band-retrofitted masonry building survived, whereas many nearby buildings experienced severe damage and some of them collapsed. This study demonstrates the efficacy and practicability of use of Polypropylene band for improving seismic resistance of a URM structure.

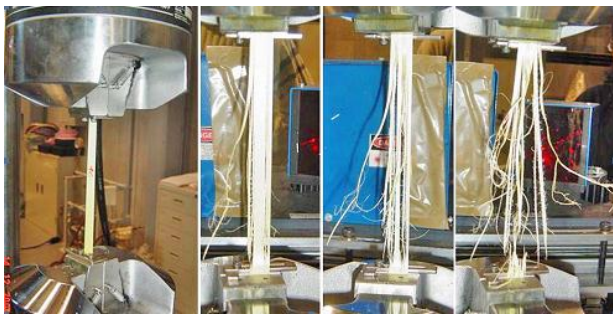
Fig. 3: Tensile test setup and failure pattern

The test was carried out under displacement control method.

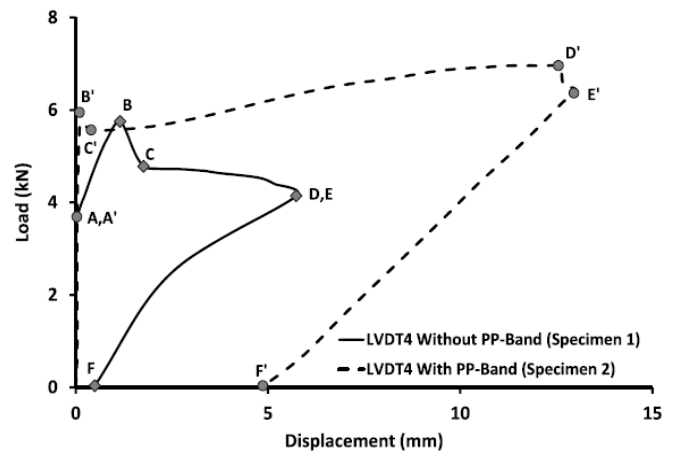
Fig. 5: Load-displacement behavior.

The load-displacement behavior for both wall specimens is shown in Fig. 5. Such load- displacement behaviors for masonry are extremely rare in the literature, although these curves are important for understanding the structural behavior, failure mechanism, and ductility in seismic action. In Fig. 5, the curve indicated by Points A–F and a solid line is for the Specimen 1 (URM wall specimen), whereas the curve shown by Points A0–F0 with a broken line is for Specimen 2 (retrofitted specimen). The load data were collected using the load cell connected to the loading jack. The displacement data were collected using four LVDTs located at four different heights (LVDT 1–4 in Fig. 4). LVDT 1 and LVDT 4 were located at 300 and 1,500 mm above the top of the foundation, respectively. The displacement reported in Fig. 5 was acquired through LVDT 4, which was located at 1,500 mm above the top of the foundation. Digital image correlation (DIC) technique was used to monitor crack initiation, crack growth, and strain distributions.

3. Exhibited a maximum load of approximately 5.75 kN, a maximum displacement of 5.74 mm, and the specimen separated in two parts along the bed joint between the third and fourth courses.	3. Each wall was 2,000 mm (10 courses) high, 1,600 mm (four block lengths) long, and 200 mm (one block width) thick.

4. Specimen 1 was a Unreinforced masonry (URM) wall or control specimen.	4. Exhibited maximum load carrying capacity of 7 kN, and the test was discontinued when the displacement reached 12.9 mm

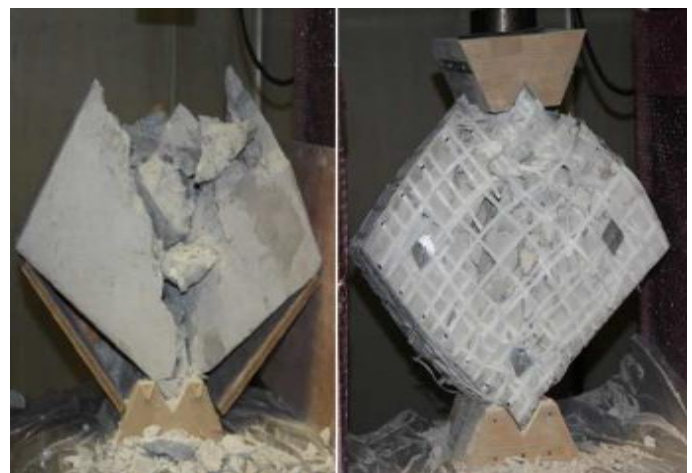
Fig -6: Non retrofitted specimen failure pattern and Retrofitted specimen failure pattern

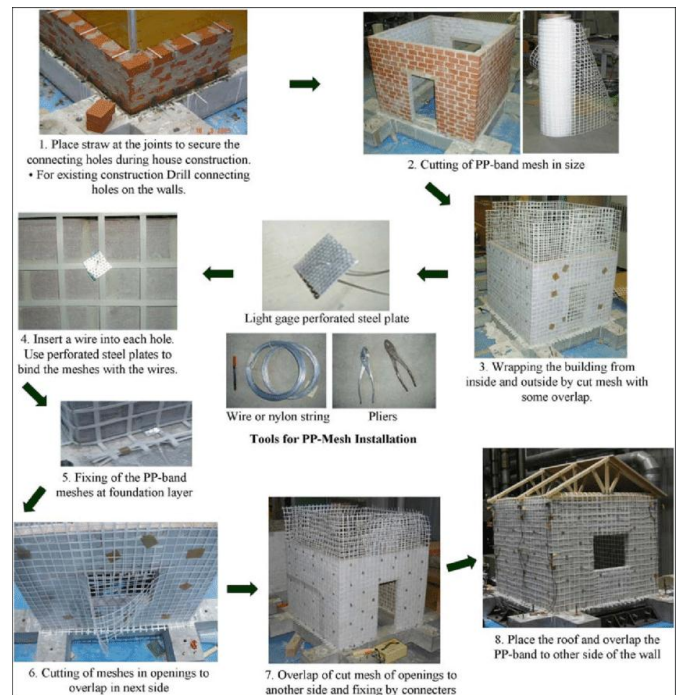
The procedure presented below is illustrated with photos in Figure 7 taken during the preparation of the experimental program.

Fig. 7: PP-band mesh Retrofitting procedure for masonry house

1. PP-bands are arranged in meshes and connected at their intersection points using a portable plastic welder.
2. Structure walls are cleaned and any loose pieces of brick should be removed.
3. Straw, which placed in holes are removed. In case of existing structures, holes can be prepared by drilling through the wall.
4. Walls are wrapped by meshes around the corners and wall edges. The overlapping length should be long enough to accommodate sufficient wire connectors as this is the only system used to connect meshes to the structure.
5. Wires are passed through wall holes and used to connect the meshes on both wall sides. In order to prevent the wires from cutting the PP-band meshes, a plastic piece or any other stiff element is placed between the band and the wire. It is desirable to have connectors as close as possible to the wall intersections and corners.

6. The top/bottom mesh edges are connected with steel wires. The bottom edge should be connected to the structure foundation as much as possible. In installing the PP-band mesh on existing houses, it was considered that it would be hard to excavate the ground to bury and fix the mesh bottom to the foundation of the house.
7. Fixed connectors around the openings after the mesh was cut and overlapped on the other side.

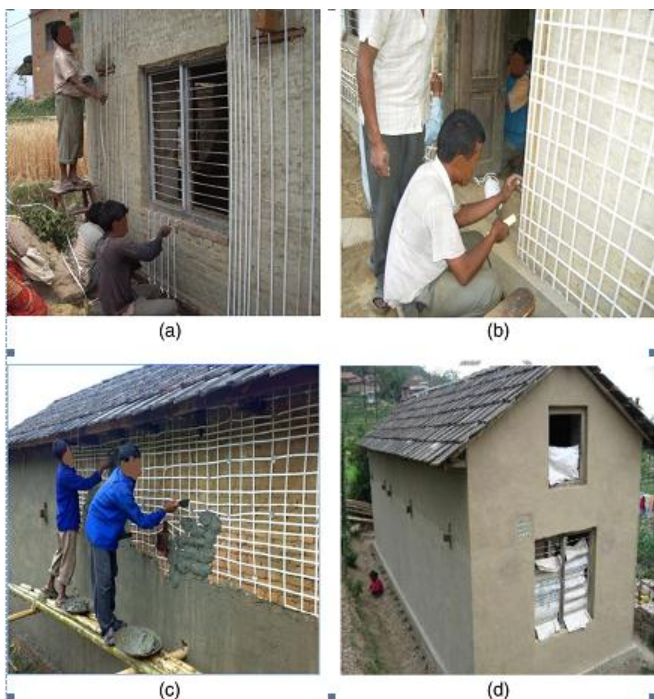
Fig. 9: Different stages of reinforcing the masonry building with PP band: (a) wrapping near window; (b) wrapping near door; (c) plastering after wrapping; and (d) completed PP band-retrofitted building
