# Study on Failure of Interlocking Pavements

**Abstract** - Interlock pavements are a modern day solution for less cost outdoor applications and fast modes of construction practices. Interlocking concrete pavements are mostly used in countries where conventional type of construction is less durable due to several physical and environmental constraints. But the pavements are not lasting up to its desired life span due to various reasons which mainly includes improper laying of the paver blocks, insufficient sub base and base course thickness, improper compaction of sub grade etc. Generally, interlocking pavements are expected to have a lifespan of almost 20 years with proper maintenance after the first 15 years. Paver blocks were tested for the specified compressive strength, abrasion test, water absorption, visual inspection requirements as per IS 15658:2006. Bedding sand and filler sand are two major important constituents of interlock pavements. Bedding sand helps in transferring load to the sub base and base course whereas filler sand helps in completing the interlocking nature of the pavement. In the present day paver blocks can also be modified to improve its compressive stre

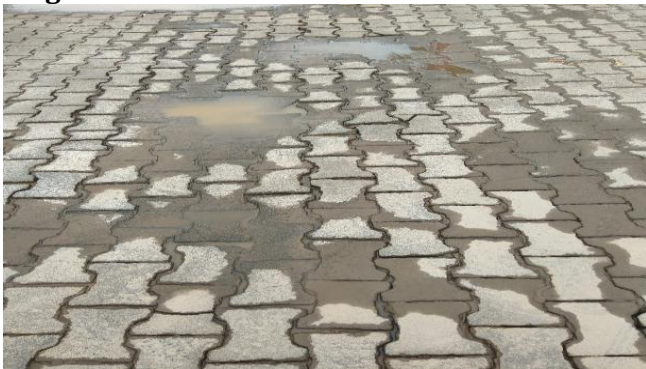
**Fig-1:** Pavers uneven and sitting at different heights

Most often when we find the pavers that are uneven, it's because the base they have been installed on is not deep enough or not of an even thickness. If the existing project site has clay soils, that means they will hold a lot more water than soils that are more sandy

More water in the soil means that when the ground freezes, it will expand more and push the pavers up. When the ground thaws out again, the pavers aren't always able to go back to the way they were, especially if sand or stone has moved under when they were raised and out of line

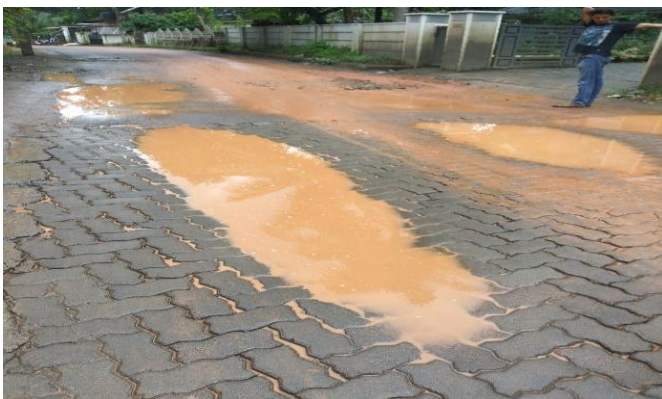
**Fig -2:** Water puddling on pavers

There could be 3 things that happened here. If water is puddling, the base may not have been installed at the proper pitch and may have had a slight low spot or the base was not compacted enough, and it has settled over time or the bedding sand layer might have got washed off due to improper drainage.

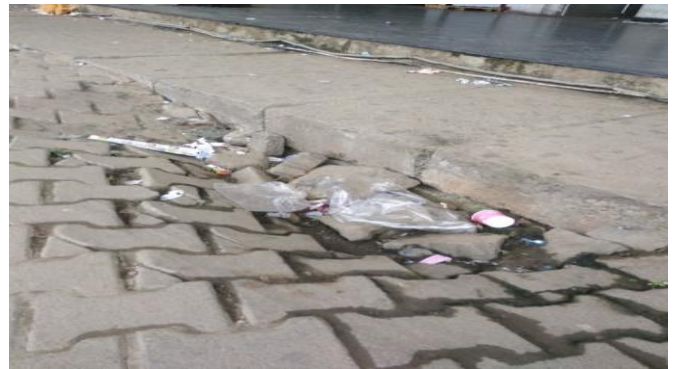
**Fig-3:** Border pavers are falling off

This mode of failure of occurs when there is no proper edge restraints provided to hold the pavement tightly together or if there is any leak in the underground pipe drains provided in that area, the bedding sand and base course will get washed off and the pavers will fall off.

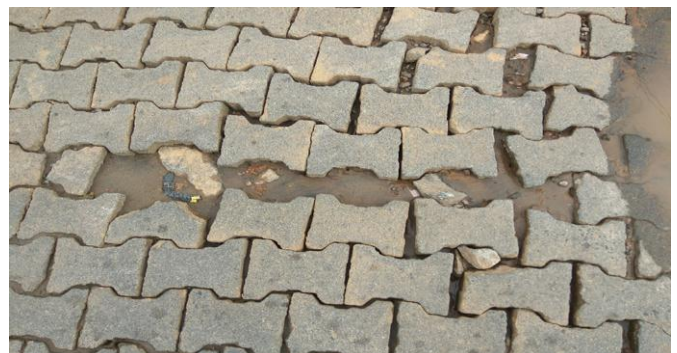
**Fig -4 :** Individual pavers separating

This occurs when filler sand is not swept in between all the joints of paver blocks. Filler sand is very important in completing the interlocking pattern of the pavement and also for load transfer throughout the pavement. Heavy rain can wash off the filler sand in between the paver blocks. Filler sand helps in holding the pavement together.

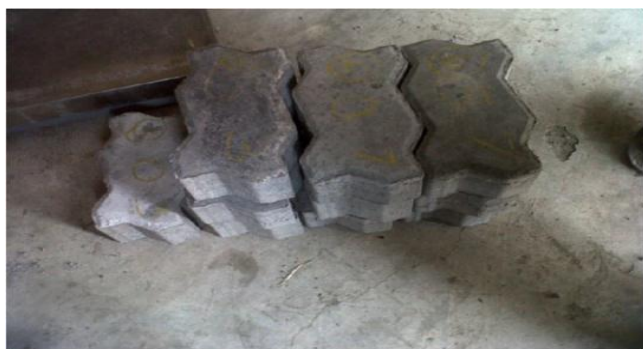
Fig 6 : Casted paver block

Steel slag is a byproduct, mainly produced in iron and steel manufacturing industries. Compressive strength test were conducted on steel slag reinforced paver blocks in accordance with IS 15658: 2006. Steel slag was added in small percentages replacing fine aggregates.

Both 25% and 50 % steel slag additions showed increase in compressive strength but a greater increase in

compressive strength was shown in 25% addition of steel slag. Much more increase in compressive strength will be obtained if the blocks were tested after 28 days of curing.
