# Non Destructive Testing of Old R.C.C. Framed Structure

Dipali M. Kukade<sup>1</sup>, Apoorva Kitey<sup>2</sup>, Dr. Dilip P.Mase<sup>3</sup>

The objective of present case study is to obtained the Non Destructive Testing of 30 years old R.C.C. Framed structure with Rebound Hammer Test to know the probable Compressive Strength, Ultrasonic Pulse Velocity Test for access the condition of structure & Half cell Potentiometer Test to know the availability of corrosion in reinforcement and visual inspection.

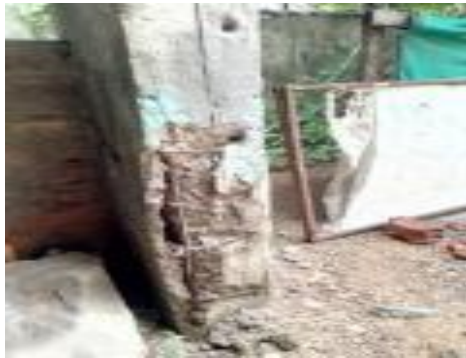
Visual inspection is the first step in NDT method to evaluation of concrete structure that are visually accessible, it gives an idea about overall condition of structure when investigate thoroughly. The detail visual inspection were carried out on different members of the structure and we have observed Reinforcement exposed at various location, corrosion, major and minor cracks, honeycombing, deterioration of concrete etc.

Fig -1: Reinforcement exposed, corrosion, cracks observed in Column.

As per the visual inspection, Rebound Hammer test & Ultrasonic Pulse velocity test results it is observed that various columns readings whose strength and quality of concrete is doubtful for such columns jacketing should be done.

Test results Conclude that Repairs and Retrofitting should be done as per the specification to maintain the existing structure in good condition.

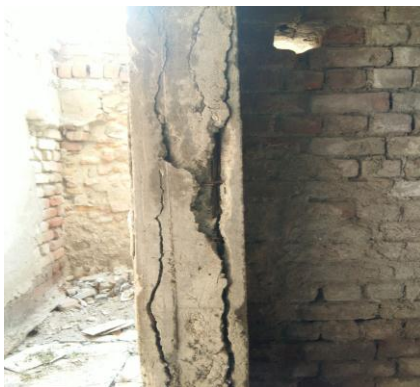
Fig -2: Reinforcement exposed, corrosion, cracks observed in Column.

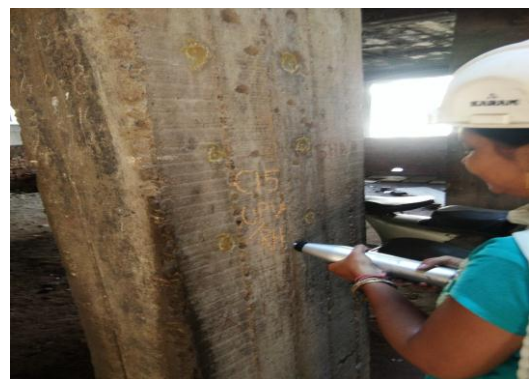
Rebound hammer test is the surface hardness test when the plunger of rebound hammer pressed against the concrete surface it gives the probable compressive strength of concrete.

Fig -4: Rebound Hammer Test.

As per Rebound Hammer Test results it is observed that maximum readings are confirming to M10 to M15 grade of concrete that indicated the poor quality of concrete.

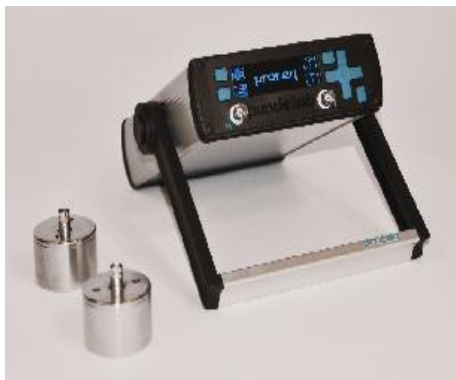
The instrument used for testing is Pundit Lab (30610001) UPV Instrument (Proceq) (Made in Switzerland).

**Fig -5** Ultrasonic Pulse Velocity Test Machine.

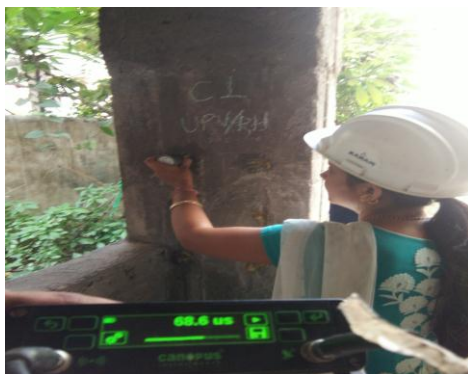
This is one of the most commonly used method in which the ultrasonic pulses generated by electro-acoustical transducer are transmitted through the concrete & measuring the time taken. Distance of path length divided by the transit time gives the pulse velocity of concrete member being tested. The ultrasonic pulse velocity is influenced by path length, lateral dimension of specimen tested, presence of reinforcing steel, and moisture content of the concrete.

**Fig -6** Ultrasonic Pulse Velocity Test.

As per Ultrasonic Pulse Velocity test results it is observed that maximum readings are below 3.0 Km/sec that indicated the quality of concrete is doubtful.

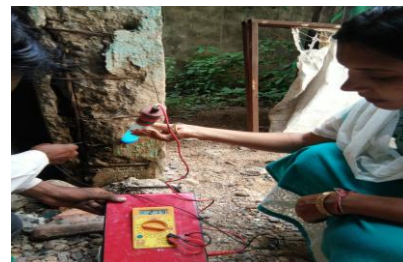
Half cell makes electrical contact with concrete by means of porous plug and sponge. One end of wire is connected to steel reinforcement and other end is connected to standard electrode and readings are noted as seen on voltmeter. More negative value indicated the higher is the bar corrosion.

**Fig -8** Half Cell Potentiometer Test.

As per Half cell Potentiometer Test results maximum readings are in between -262 and -407 that indicate there is severe corrosion at most of the locations.
