Productivity Improvement of Assembly Workstation in a Small Scale Industry

Abstract: Line balancing (LB) is useful tool to make production line stretchy enough to absorb external and internal indiscretion. LB is the problem of assigning operation to workstation along an assembly line in such a way that assignment is optimal in some sense. This paper mainly focuses on improving overall efficiency of single model assembly line by reducing the non-value added activities, cycle time and distribution of work load at each work station by line balancing. The methodology adopted includes calculation of cycle time of process, identifying the non –value-added activities, calculating total work load on station and distribution of work load on each workstation by line balancing, in order to improve the efficiency of line.

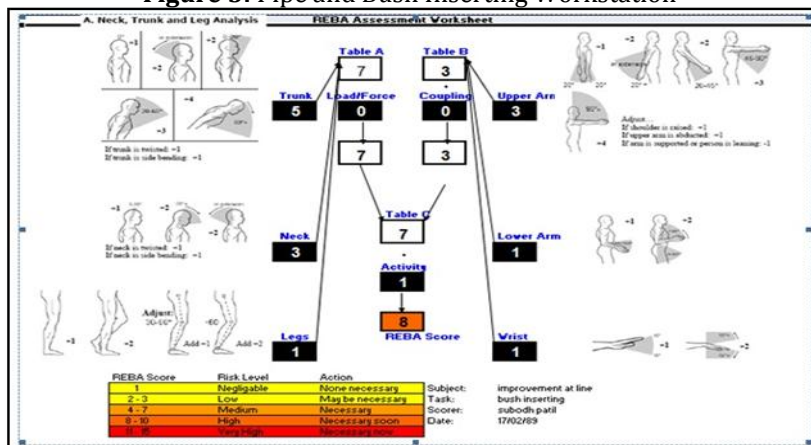
Figure 4: REBA Assessment Worksheet for operator (Before Improvement)

From the video, the study has done on assessment of REBA scores and got the score as 8. To avoid excessive bending and twisting of operator, a rack was provided for storing the silencer spacers. There were also improper provisions for bushes at workstation no.1. A plated bin was welded to workstation no.1 (having 2000 bushes storage capacity). This enabled operator to easily pick the bushes for inserting in pipes. REBA score was reduced to 2.

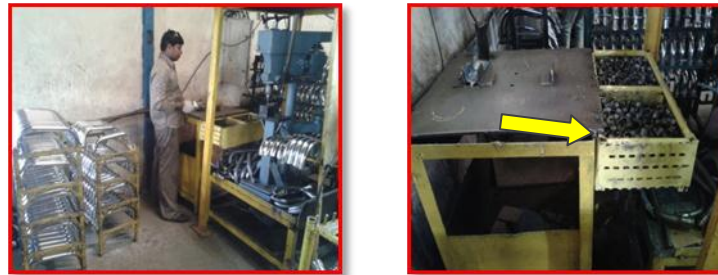
Figure 6: Workstation No.1 Rack and Bush Inserting Table

Figure 6(a) and 6(b) shows Racks for storing Silencer spacers and Plated bushes boxes respectively.

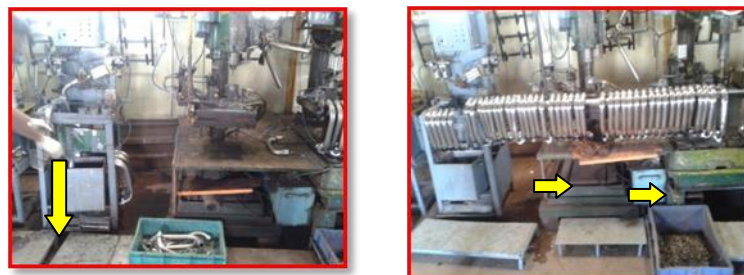
Figure 7: Workstation No.9 drilling machine

Operator at workstation no.9 had to bend on the floor to pick a pipe for drilling. Since pipes were stacked on floor, operator had to bend excessively causing back strain. To avoid this excessive bending, long pipe was welded horizontally from workstation no.7 to workstation no.9 and bin was removed from workstation as shown in figure 7 separately in part (a) and part (b).

Total time of workstation no. 9 was reduced to 13.14 sec, which is below the takt time. All the pipes are now closer to operator and parts being forward for next operations from left to right as shown in figure 7 part (b). Horizontal long pipe helped to avoid the unnecessary bending, twisting movements. REBA score is reduced to 2. Thus, after studying and analyzing initial state, bottlenecks were identified on the assembly line.

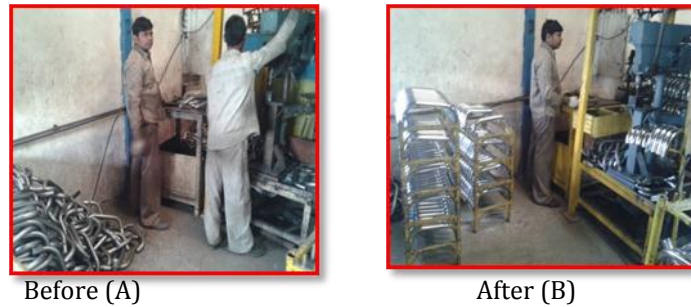
Before (A) After (B)
Figure 8: Bush Inserting and Drilling Workstation

At workstation no.2 drilling operation was carried out on the bush and pipe with 6mm drill. The total time at combined w/s was 10.12 sec, which was well below the takt time and NVA time had been removed. Clubbing of workstations 1 and 2 eliminated one operator. Figure 8(a) shows two workstations with two operators and 8(b) shows combined stage of two workstations with one operator.

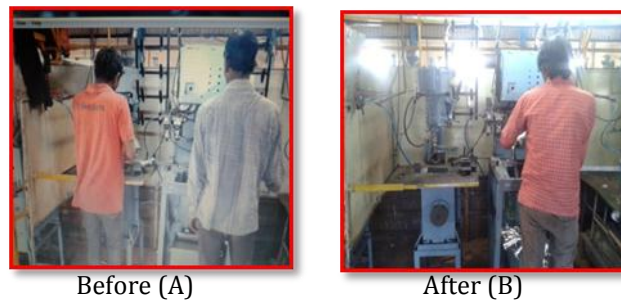
Figure 10: Clubbing of Workstation

Figure 10(a) shows Drilling and Leakage testing workstations with two operators and 10(b) shows combined stage of two workstations with one operator.

The total time at combined workstation is 14.58 sec, which is well below the Takt time. Clubbing of workstations 6 and 7 had eliminated one operator and unnecessary bending was avoided.
