# Influence of Temperature on Tensile Properties and Fracture Behavior of High Strength Stainless Steel

Koteswara Rao Kondisetti<sup>1</sup>, Dheeraj Kondisetti<sup>2</sup>

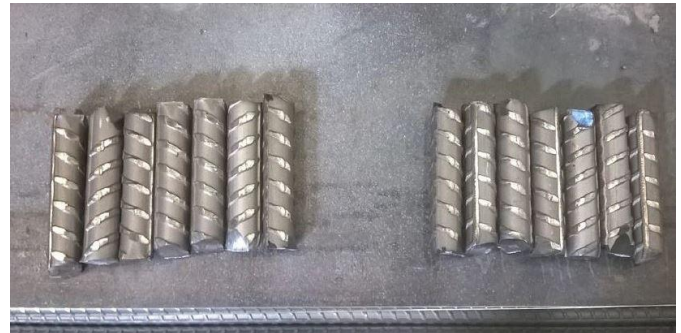
**Fig -3.1:** Rebar cut pieces before machining to desired shape

pieces, each of size 2.5 inches, as shown in Figure 3.1. The cut samples were sent to a professional machining facility based in Pennsylvania for the purpose of machining in conformance with standards specified in ASTM E-8, as shown in Figure 3.2. The machined test final specimen is shown in Figure 3.3.

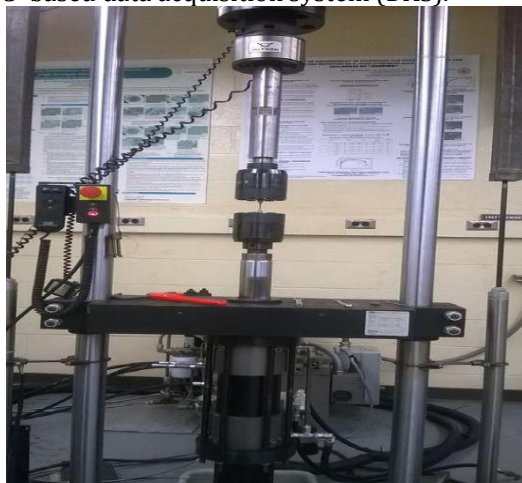
Fig -4.2: Test setup for tensile testing at room temperature

Uniaxial tests were conducted on an INSTRON-8500 plus, a closed loop, fully automated servo-hydraulic mechanical test machine, using a 100 KN load cell. The tests were performed both at room temperature and at an elevated temperature in the laboratory air environment [Relative Humidity of 55%]. Test samples of the chosen steel were deformed at a constant strain rate of 0.0001/sec. An axial 12.5mm gage length clip on extensometer was attached to the test sample, utilizing rubber bands for tests at room temperature and steel springs for tests at the elevated temperature, to provide a measure of strain during uniaxial stretching. The stress and strain measurements, parallel to the load line, were recorded on a PC-based data acquisition system (DAS).
