Road Blockage due to Slope Failure in Flood

Abstract -The slope stability is considered during construction of road but it get failure during flood condition because unaccepted amount of water comes in contact for long period with sub structure. Such condition interfere the sub-structure material and result into failure of slope.

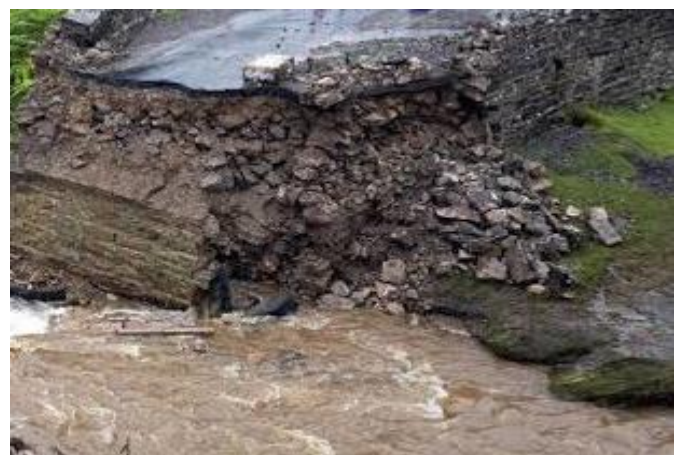
Fig. 1.5 Slope failures due to hammering of flood water

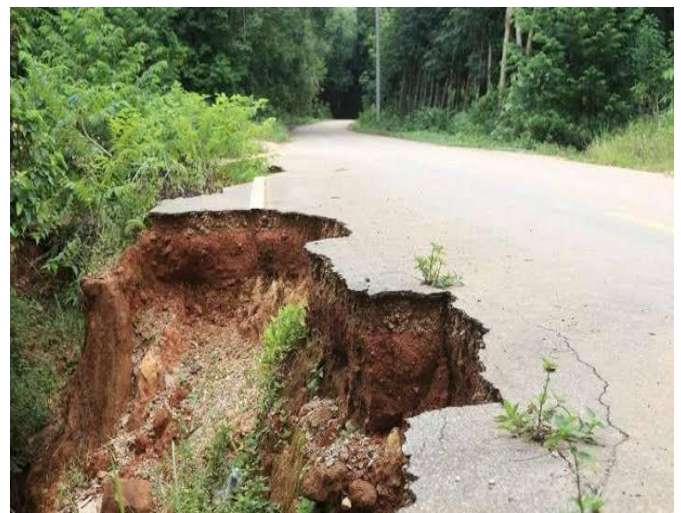
Fig 1.6 slope failure at side of road

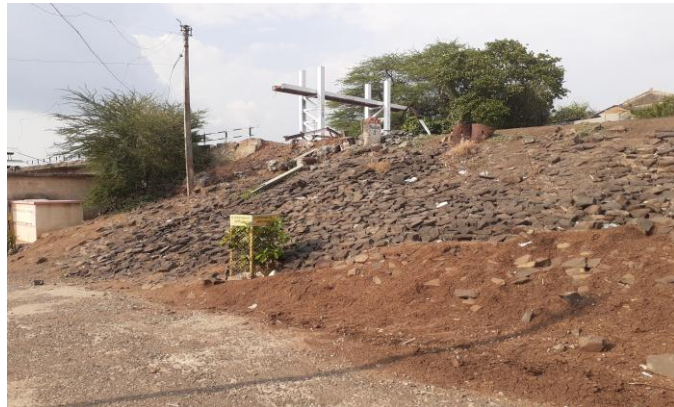
Fig.1.7 This image is of the Krushna Bridge of village Rethare BK, Tal.Karad, Dist. Satara, and Maharashtra, India. The affect of flood water is seen on the side pitching of the road.

Fig 1.7 Erosion of side slope of road

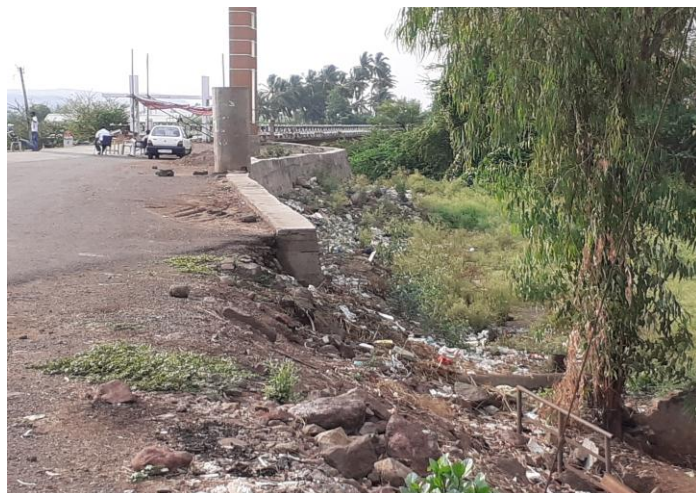
Fig 1.8 Shows the prevented area from failure of slope which is provided by RCC structure on other sides of road. The image also represent that as soon as the RCC work stopped from that point sliding of slope is started because of incomplete work.

Fig. 1.8 Side slope failure of road belongs to Krushna Bridge

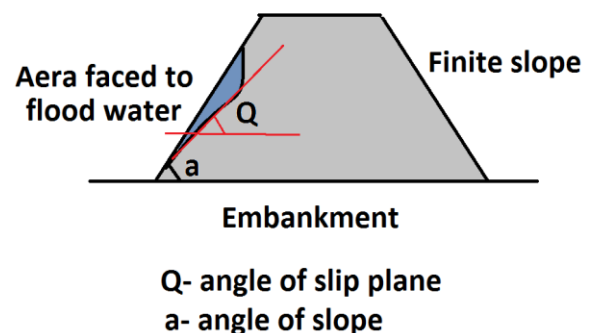
Fig 1.9 Block diagram of embankment
