“AN INVESTIGATION OF CAUSES OF FAILURES OF INDUCTION MOTORS IN STONE CRUSHER APPLICATIONS AND TO IDENTIFY REMEDIES TO OVERCOME FAILURES”

Abstract – The squirrel-cage induction motor remains the workhorse of the manufacturing region because of its versatility and ruggedness. However, it has its boundaries, which if passed will reason premature failure of the stator, rotor, bearings or shaft. A tiny disorder or a easy crack may additionally result in intense damages to rotating machines. As a end result, it is crucial to reveal the fitness situation of rotating machines thru lively diagnostic and prognostic technologies. For all styles of industry, a machine failure escorts to a diminution in production and cost will increase. The circumstance monitoring of the electric machines can appreciably lessen the prices of preservation through permitting the early detection of faults, which might be highly-priced to repair. On this paper various reasons, its effect & treatments of mechanical failure of stone crusher software induction motor are recognized.

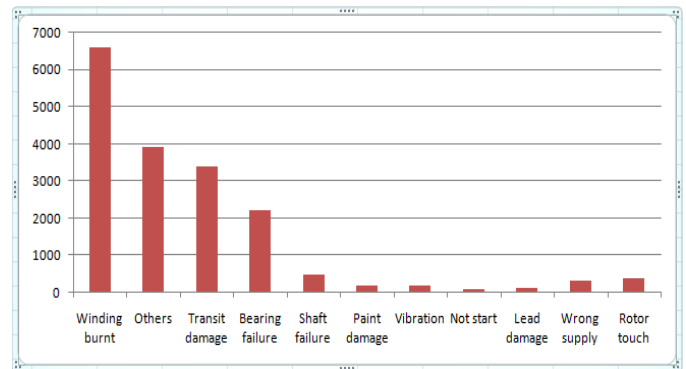
Fig. 3.1.1 Customer complaints (Apr 2017-Mar 2018)

Data of failure of motors from April 2017 to March 2018 is analyzed for different complaints received from different customer. Results obtained is as follows:

After studying client court cases, it's miles determined that, complaints acquired are majorly of winding failure, excessive body & winding temperature, bearing failure, shaft breakage or crack development in shaft, paint harm, and so forth. So, after this analysis & discussions, place of awareness for improvement in motor are decided, that are:

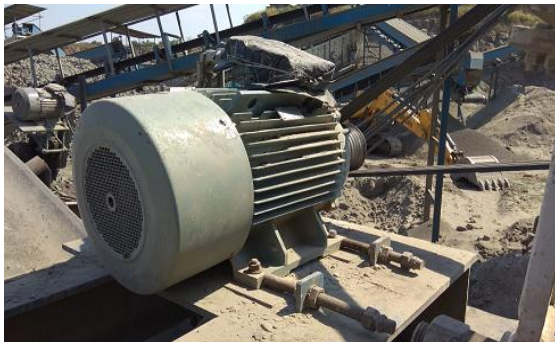
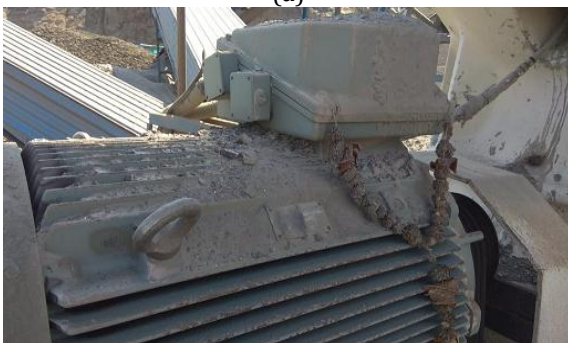
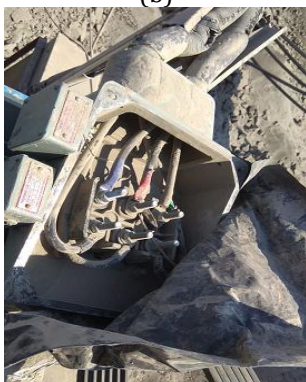
Fig. 3.2.1 Site visit to different customers

After site visit observations, some problems observed which may be the reasons for failure of motor.

1. Blocking of path direction between fins due to dust and stones particles blocked in blank spaces.
2. Open terminal box
3. Excess vibration
4. Inefficient V seal protection for bearing

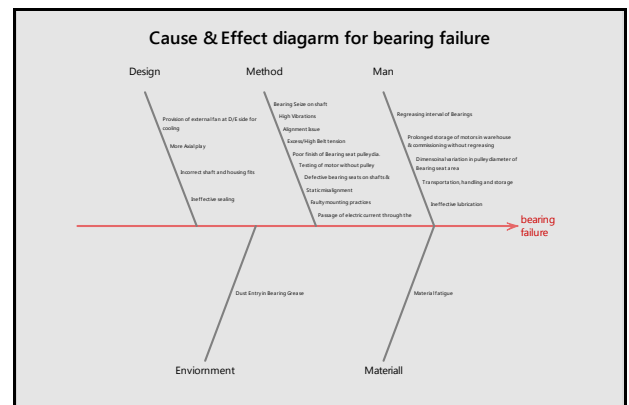
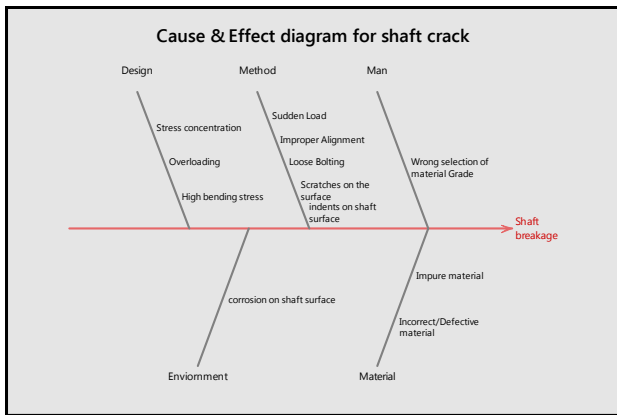
Fig. 3.3.1 Cause and Effect diagram for motor failure

Sr. No.	Critical Xs	RPN
1	Gap between cable outside dia. & terminal box gasket	576
2	Stone dust entry to winding overhang through gap between v seal & bearing cover	576
3	Less contact area due to shorter length studs	256
4	Loosening of studs in stator body	256
5	Less number of fins near base area	256
6	Measures to avoid coil insulation not followed	256
7	Inadequate strength of shaft material	128
8	Crack development due to stress concentration	128
9	Increased temperature on DE side	128
10	Lack of education to operating people at site regarding greasing of bearing	128

1. To prevent ingress of stone dust inside motor body, sealant is applied against mating surfaces of DE/NDE endshield and stator body, terminal box and stator body, terminal box and terminal cover, bearing cover and DE/NDE endshield, etc.
2. Use of barrier plate between terminal box and stator body with both side locking rubber grommet
3. Application of RTE sealant on TB inside facing
4. Increased foot supporting rib thickness and foot
5. Radius at shaft corners instead of undercut to reduce stress concentration
6. Replacing V-seal with oil seal
7. Use of EN24 forged material over EN24 rolled material.

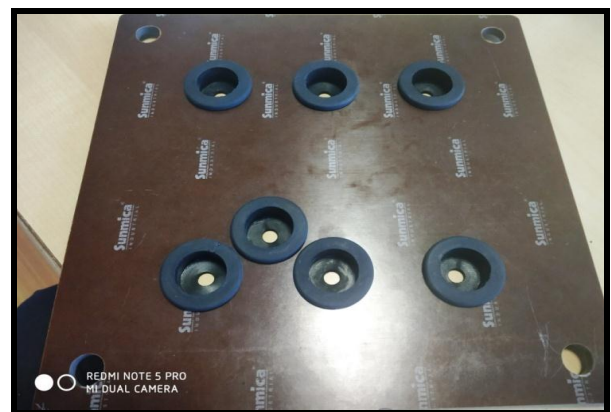
4.1.1 Barrier plate with rubber grommets

To restrict ingress of stone dust inside body on overhang, some modifications done in construction of terminal box for dusty environment.

1. Application of silicon sealant between mating faces of endshield, stator body, terminal box and cover improved degree of protection against ingress of dust as well as water.
2. Use of barrier plate with both side locking rubber grommet and application of sealant inside terminal box improved leakage property. Pouring water inside TB and observing for 08 hours, there is no leakage found.
3. Increased foot supporting rib thickness and foot thickness resulted in reduced stresses near foot area. Increased foot thickness resulted in reduced vibrations of motor.
4. Applying radius at shaft corners, stresses developed in shaft get reduced.
5. Replacement of V-seal with oil seal & proper re-greasing of bearing improved bearing life and reduced bearing failure.
6. Use of EN24 forged bar for crusher application improved impact resistance and tensile properties of shaft.

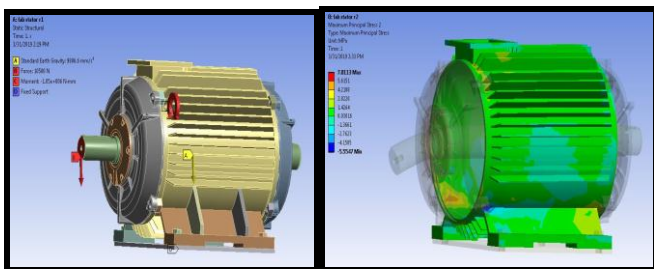
Fig. 4.2.1 Analysis of stator body in ANSYS

During analysis in ANSYS, some stress concentration observed near foot and foot supporting rib and body. So, to reduce this stress, foot and foot supporting rib thickness in increased from 15mm to 18mm and foot thickness increased to 25mm from 20mm.

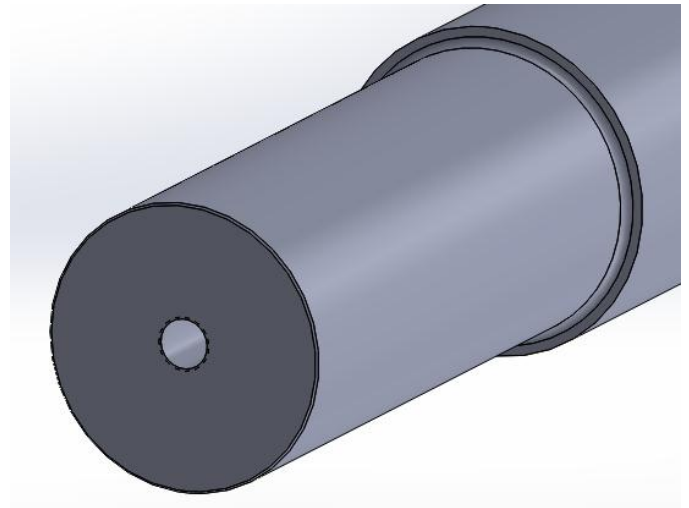
Fig. 4.3.1 Fillet at shaft corners

To reduce stress concentration at shaft corner, instead of undercut, fillet of 2mm is given.

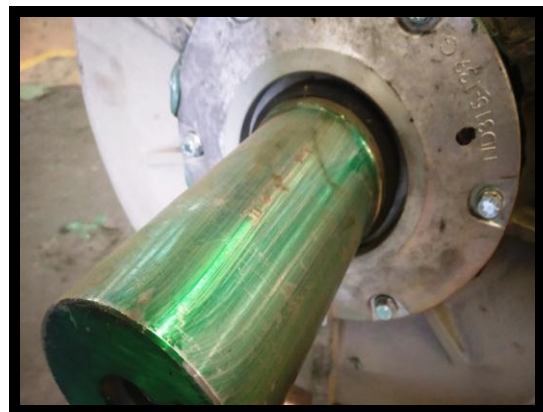
Fig. 4.1.1 Oil seal at DE side

Oil seals have the capability to work under extreme duress in terms of temperature. This makes them perfect for fluid environment applications. Sealing materials such as PTFE and fluoro elastomer ensure that the oil seals can be used for long periods of time.

The strength, flexibility, and durability of oil seals provide a number of benefits to various industrial applications.

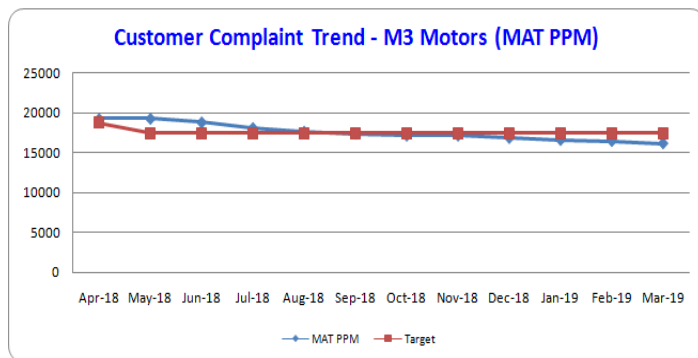
Fig.5.1 Customer complaints trend (2018-19)

After implementing design changes, taking some preventive actions and after giving training of assembly practices to assembly people customer complaint trend found reduced as compared to previous year.
