# A STUDY ON COASTAL EROSION MITIGATION ON ODISHA COASTLINE

**Shashanka Sekhar Palai<sup>1</sup>, Pranjal Mandhaniya<sup>2</sup>**

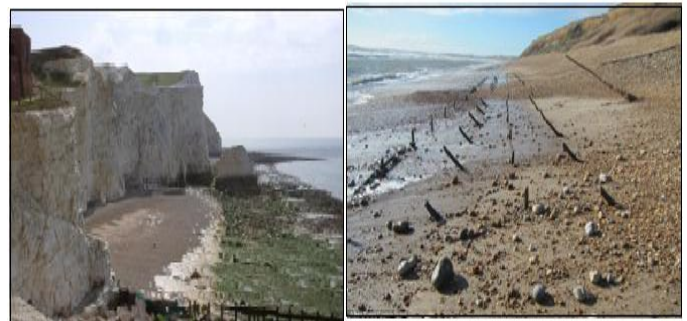
**Fig -1:** Cliff coast

There are two types of coast which affect our coastal erosion. They are cliff coast, muddy coast, clayey bank coast. Cliff Coast are known as hard coast because it was formed from resistant material such as sedimentary or volcanic rock. Storm and Tsunami will have a less erosive effect on this type of coast. The Figure 1 and 2 represents the Cliff coast and Clayey bank coast respectively. Clayey Bank Coast are known as "semi hard coast". It consists of cohesive soil and its height near about 15m. It is compared to hard coast because it is compose of weaker and lesser existent material.

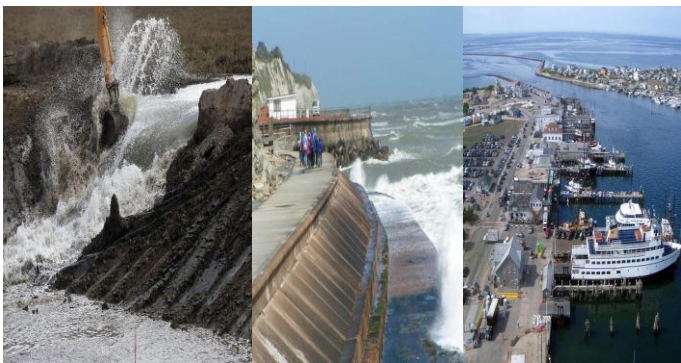
Fig -5: Levee Fig -6: Seawall Fig -7: Ports

Levee is elongated naturally occurring ridge or artificially constructed fill or wall which regulates water level. It is usually earthen and often parallel to the course of a river in its food plain or along two-lying coastline. Seawalls are vertical or near-vertical shore parallel structure designed to prevent erosion and flooding. Seawalls are generally massive concrete structure a turban beaches. Seawalls can mitigate erosion and defend against the natural elements to improve the safety of their homes and buildings. Like a groyne, the port acts as a blockage of the littoral transport, as it causes trapping of sand on the upstream side in the form of an accumulating sand file, and the possible bypass causes sedimentation at the entrance. The sedimentation requires maintenance dredging and deposition of the dredged sand. The result is a deficit in the littoral drift budget, which causes lee side erosion along the adjacent shoreline.

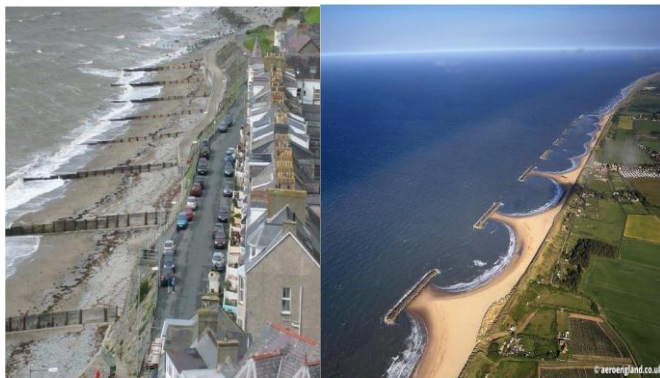
**Fig- 9: Groynes Fig- 10: Off-Shore break water**

**Groynes:-** Groynes may be adopted to stop or decrease shoreline recession and for beach formation. However, extremely adverse effects are observed on downstream side and groynes should be avoided unless their main purpose is to keep a beach at one particular position at the cost of adjoining areas.

**Offshore break water:-** A living shore line approach for sand beach shoreline uses large, gapped stone structures placed offshore. Offshore break water system provide shoreline protection by intercepting incoming waves and creating stable pocket beached between fixed stone structures.

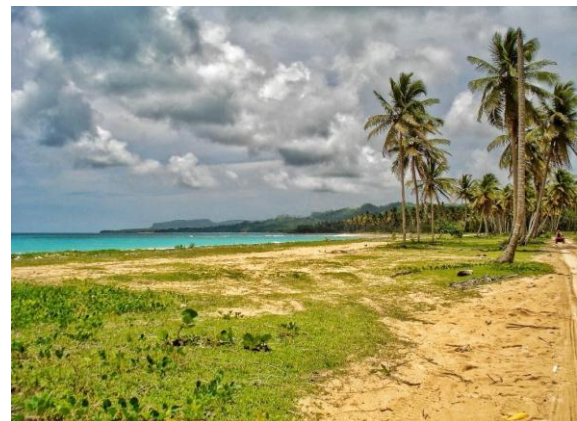
**Fig-11: Palm plantation**

Severe erosion problem has been experienced due to construction of jetties and/or dredged channels. Sand bypassing at tidal inlets problem can be solved by bypassing of material from the up drift side of inlet to the down drift side. Vegetation cover can restrict sand movement and erosion.

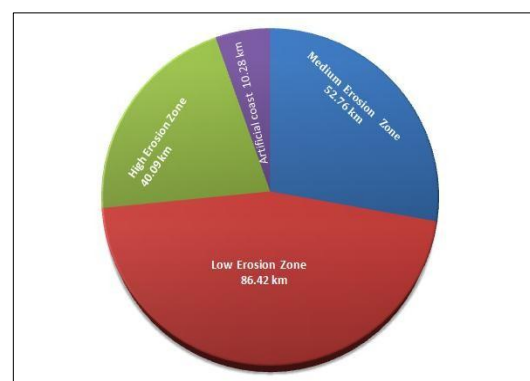
**Graph.1. Erosion Status of Odisha Coast**

Shorelines change pattern for the Odisha coast has been generated with a total of 48 maps using 700 transects at 300m interval and rates of shoreline changes have been computed. In Graph 1 represent the erosion status of Odisha coast with four different zones such as medium erosion zone, low erosion zone, high erosion zone and artificial coast. In Graph 2 shows that % of accretion status of Odisha coast with four different zones. In Graph 3 described the overall shoreline changes (%) for Odisha coast.
