Anthropogenic Activity-Induced Water Quality Degradation in Girital Lake, Uttarakhand

Key Words: Girital lake, water spread mapping, water quality, aquatic weed

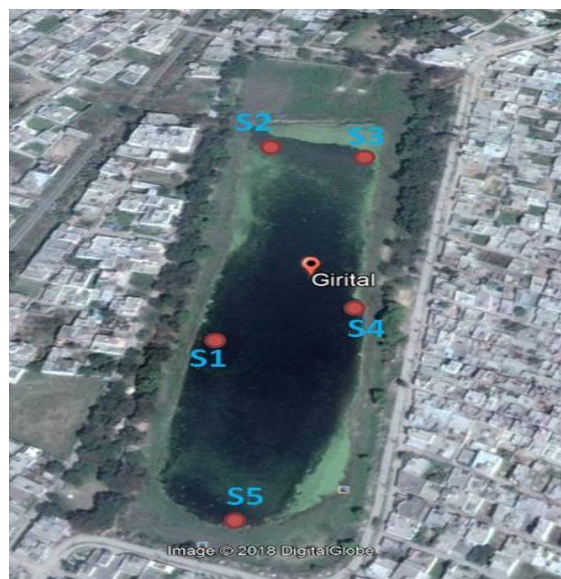
Chart -2: Sampling Locations at Girital Lake, Kasipur

The samples for water quality assessment has been collected from selected locations as shown in Chart 2. The sample locations has been marked as S1, S2, S3, S4 and S5 whose coordinates were 29°13' 8.81" N, 78° 58' 9.10" E; 29°13' 16.28" N, 78° 58' 11.27" E; 29°13' 51.21" N, 78° 58' 14.22" E; 29°13' 9.78" N, 78° 58' 13.56" E and 29°13' 4.39" N, 78° 58' 9.64" E respectively.

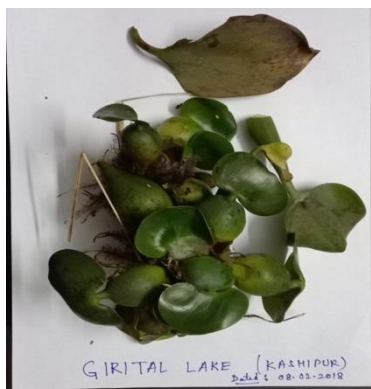
Chart -4: Water hyacinth weed in Girital lake

Due to presence of high concentration of phosphate and nitrate in Girital Lake, eutrophication has taken

place. The weed present in excess amount in this lake is shown in Chart 4. The weed is commonly known as water hyacinth. Its Kingdom is *Plantae*, Family is *Pontederiaceae*, Genus is *Eichhornia* and Species is *Eichhornia crassipes*.

Water hyacinth is a free-floating perennial aquatic plant (or hydrophyte) native to tropical and subtropical South America. With broad, thick, glossy, ovate leaves, water hyacinth may rise above the surface of the water as much as 1 meter in height. The Girital lake was full of water hyacinth.
