# Condition Assessment and Evaluation of Concrete Structures by Advanced Non-destructive Methods

<sup>1,2,3</sup> UG Students, Department of Civil Engineering <sup>4</sup>HOD Dept of Civil Engineering  
ISL Engineering College, Hyderabad, Telangana, India

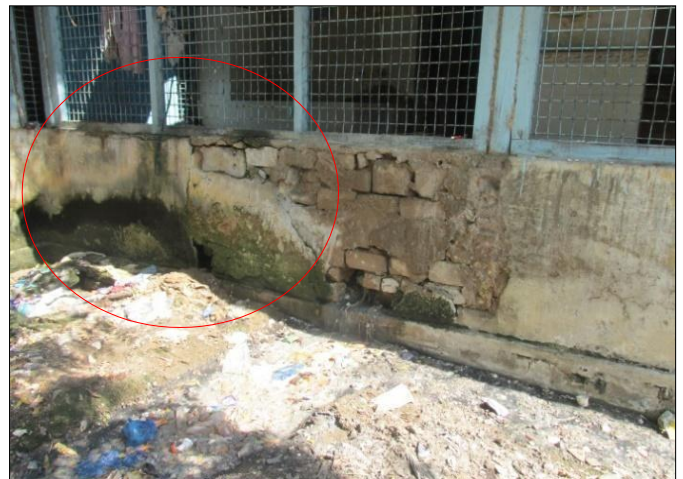
Fig -2: Loosening of Motor

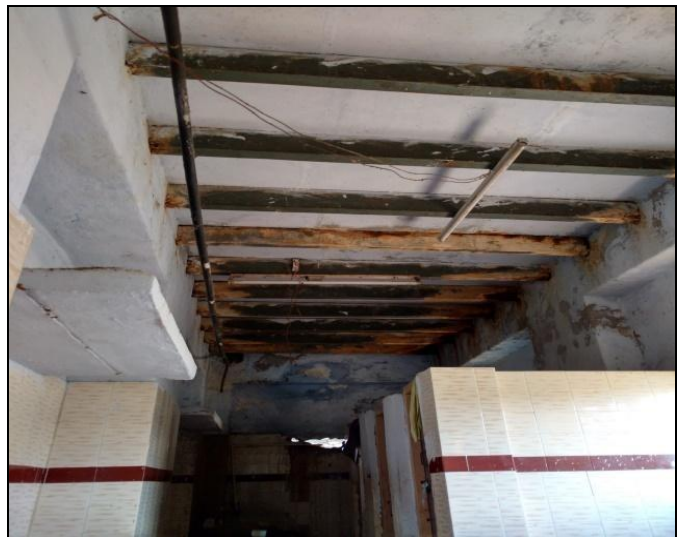
Fig -3: Distressed in wooden members

In corridor areas the existing AC sheets at the first floor level shall be replaced with metal sheets and the damaged wooden joists shall be removed and replaced with new wooden joists with existing dimensions.

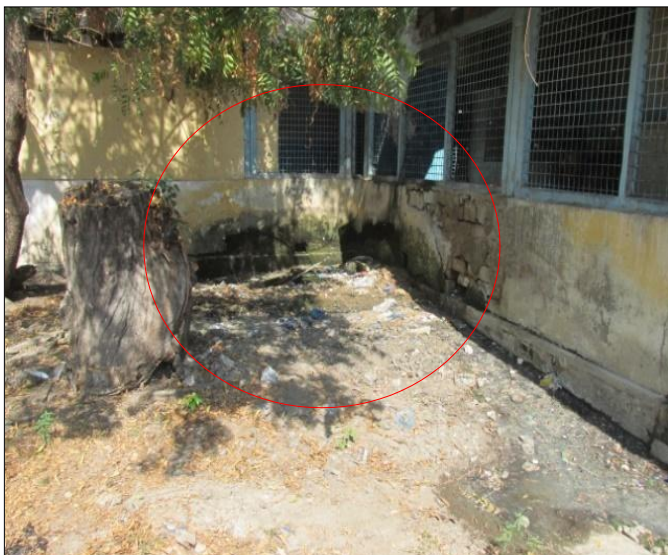
Fig -1: No Plinth Protection

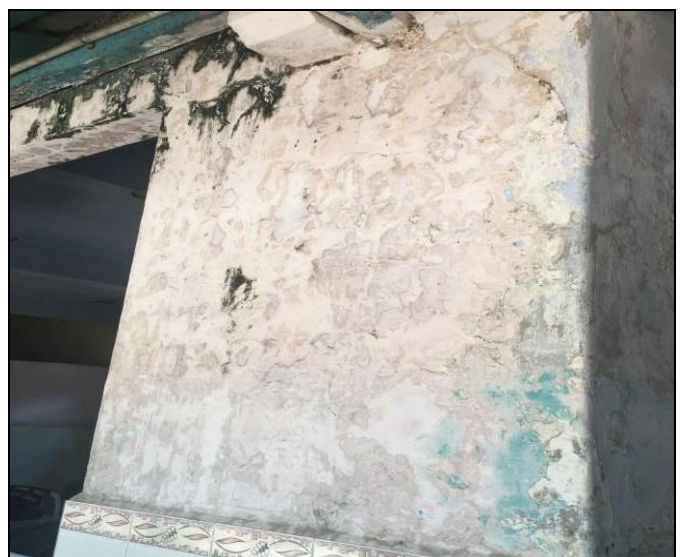
Fig -4: Dampness in columns

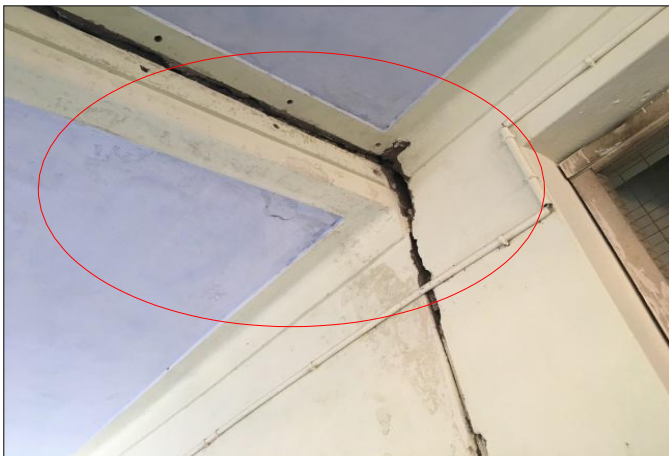
- Growth of Vegetation was observed at a few locations nearer to the plinth.
- Dampness was observed on sunshades at many locations.
- Plinth protection was observed to be damaged at some locations.
- False ceiling was observed to be damaged at many locations.
- Separation crack was observed between CRS and brick masonry.
- Separation cracks were observed between masonry joints at a few locations.
- Corrosion cracks were observed.
- Spalling and exposure of reinforcement was observed in slabs at a few locations.
- Wooden purlins were observed to be decayed at some locations.
- Cracks were observed in the existing WPC on the terrace.
- Severe leakages & dampness was observed in the roof & walls of the newly constructed toilet block.
- It was reported that, severe leakage was observed from the expansion joint during monsoon season.

Fig -5: Cracks near Expansion Joint

In view of leakages from the expansion joint, it is recommended to clean the joint and fill it with Polyurethane sealant and redo the portion as per IS 5256-1992 provisions.

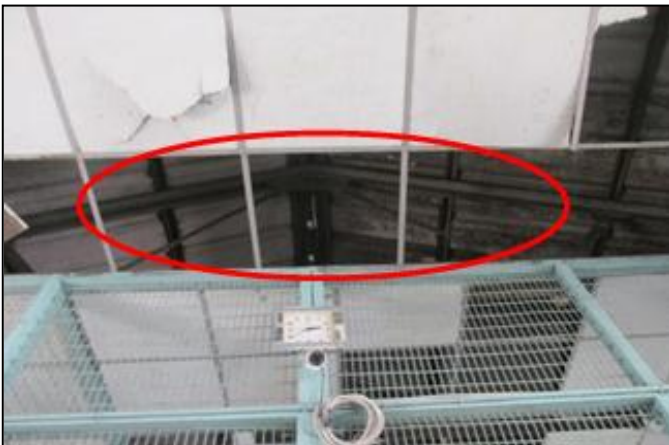
Fig -6: Damaged false roofing and Truss

In view of severe distress observed in the rear side corridor region of Portion -7 consisting of madras roofing system with wooden rafters, it is recommended to remove the madras roofing system. It shall be replaced with R.C precast slab panels with structural steel (ISMC) beams.

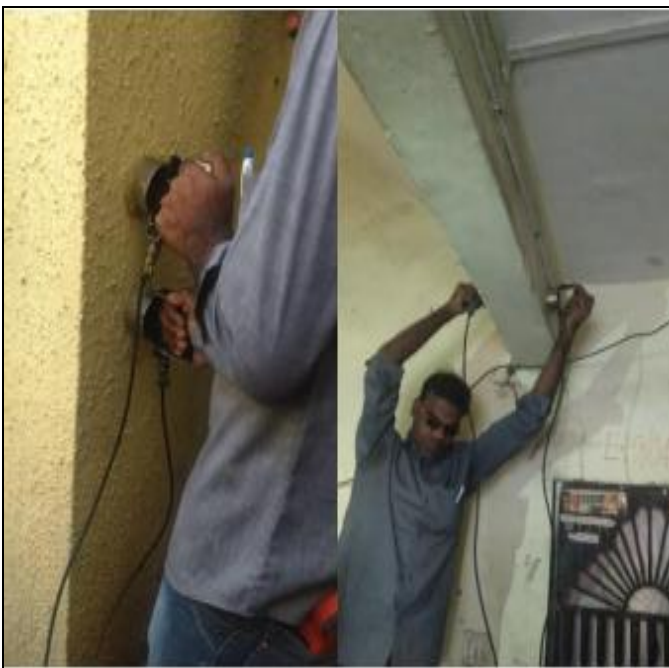
Fig -7: a) In-situ Non-destructive Tests

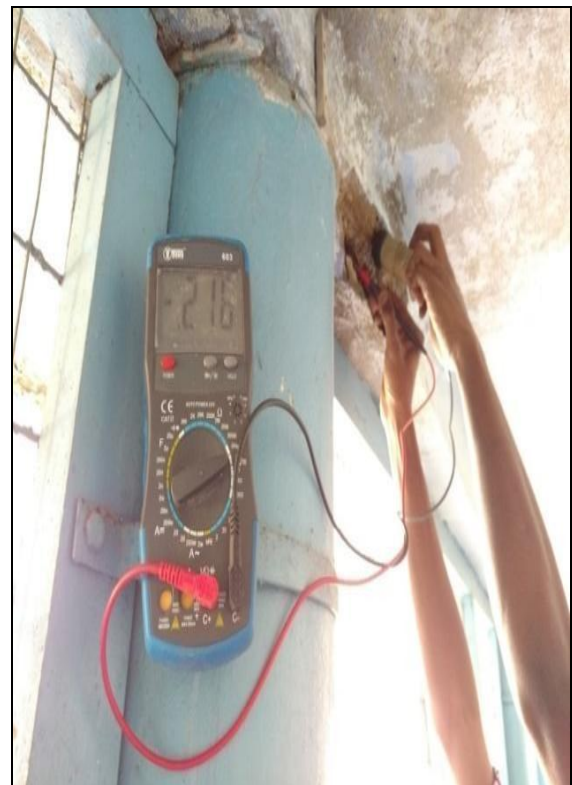
Fig -7: b) In-situ Non-destructive Tests

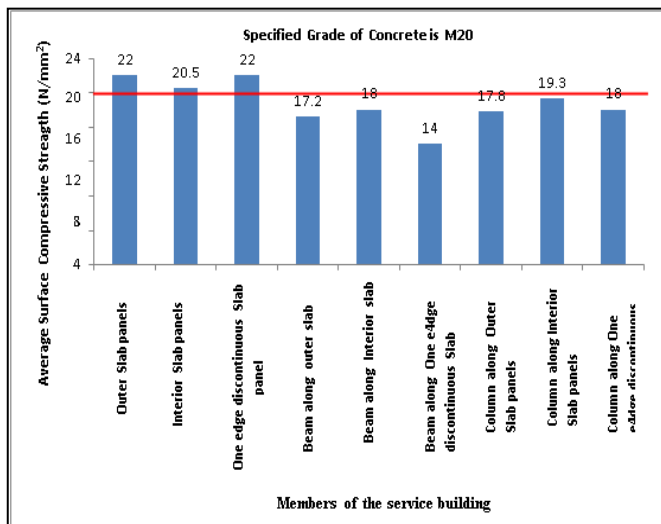
Rebound Hammer Test is a quick method to evaluate the quality of concrete based on surface hardness of the existing structure. The rebound number gives the average surface compressive strength of the concrete. Rebound Hammer Test was carried out on all accessible locations of R.C. slab panels, beams, and columns in order to assess the surface hardness / quality of in-situ concrete. Initially the surface was prepared by removing the Plaster and dusting the surface to get better results. The test was conducted by using 'Schmidt Rebound Hammer' The results are presented in Figure. And corresponding reference strength is presented in Table 1.

**Fig -8:** Shows Average Surface Compressive Strength of RCC Columns, Beams and Slab

• Based on the results obtained from Figure 8. for the Rebound Hammer Test conducted on selected structural members of the building, it is inferred that the strength of the cover concrete of R.C Slab panels in Ground floor is only satisfactory and also at few locations delamination of cover concrete was observed. The results were concluded in reference to Table 1.

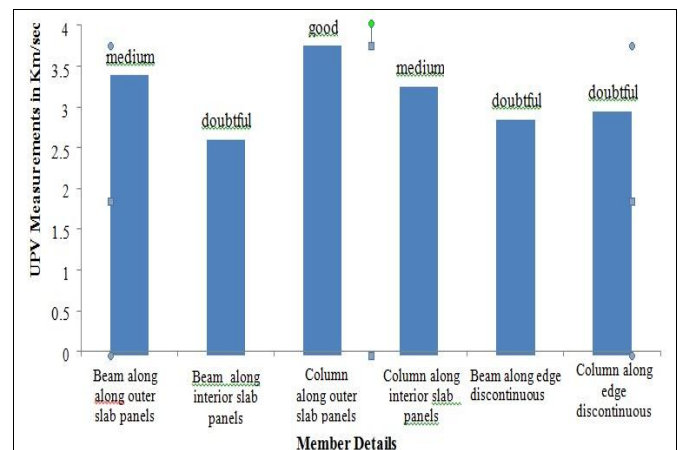
Ultrasonic Pulse Velocity Test was conducted on accessible locations of R.C. Beams and Columns such as Beam along outer slab panels, Beam along interior slab panels, Column along outer slab panels, Column along interior slab panels, Beam along edge discontinuous Slab panel, Column along edge discontinuous Slab panel. The transducers were coated with grease and placed on the opposite side of beams and columns for better electrical conductivity. Direct / Indirect method of scanning was adopted at site. The tests were conducted using 'PUNDIT LAB+' (Portable Ultrasonic Non-Destructive Digital Indicating Tester) equipment from M/s. Proceq, Switzerland.

**Fig -9:** Ultrasonic Pulse Velocity Measurements results on selected members

• The results of Ultrasonic Pulse Velocity Test obtained from Figure 9. inferred that the quality of in-situ concrete in the tested locations of the R.C. beams in Ground Floor was found to be “Medium to Good” grade, as per Table 2.

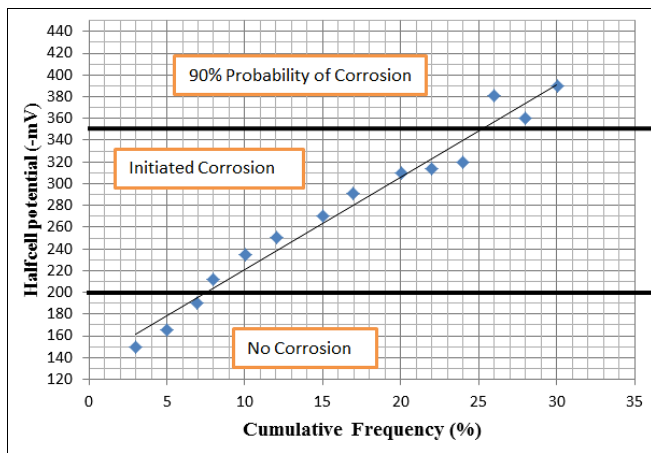
In order to assess the extent of corrosion in reinforcing bars of R.C members, 'Half-cell Potential Difference Measurement test' was carried out on randomly selected accessible locations of R.C members. The test was conducted using copper-copper sulphate half-cell solution. The test results are presented in Figure 10.

Fig -10: Half-cell Potential Test Results of selected Members

• The Half-cell Potential Difference Measurement Test, was carried out on the selected RC members and the results obtained from Figure 10. inferred that, the corrosion of reinforcing bars in the structure was observed to in the “Initial Stage” (where no corrosion was observed) but in the lintel beam it was observed to be in the “Moderate Stage” (where corrosion was observed) with a need of proper supervision. The results were concluded in reference to Table 3.
