INVESTIGATION REPORT ON PRELIMINARY TESTS ON FAILURE OF STRUCTURE AND MONITORING

Abstract - In this Research, various details for structural failures like Faulty Design, Inferior quality of materials, Poor Workmanship, Weathering conditions, Natural calamities etc., have been discussed. It is also discussed about the various methods of doing the repair works that is remedial measures. To know better about the nature of concrete elements, ten (10) concrete beams with nominal reinforcement have been cast. All the beams were subjected to loading test in Loading Frame at Nova Engineering College, Jangareddygudem, Eluru (District), Andhra Pradesh, India. Three beams were kept as control specimens. All the beams were first tested up to initial crack condition. The control specimens were tested up to ultimate failure. The values of load and deflections were obtained and tabulated. The repair materials used are GPRF of 225 GSM, 300 GSM, 400 GSM, Jute Fiber and Steel Jacket. After curing they were tested up to failure. The values of Load and Deflections were noted. Load Cells are used for noting down the Deflections. From the values obtained it was noted that, out of all the methods applie

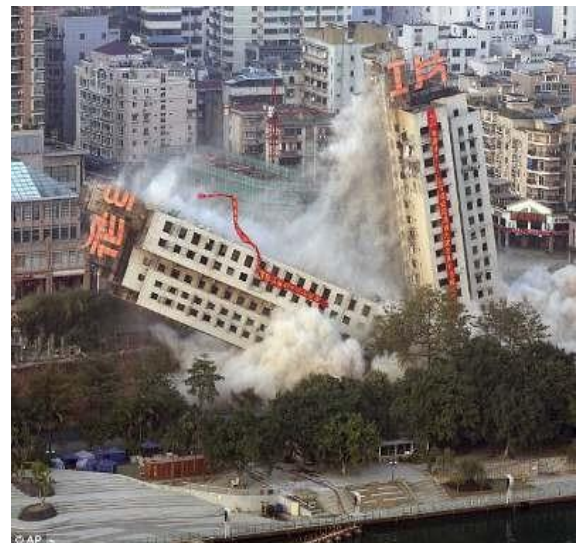
Fig -1: Splitting of a tall structure into two portions in a vertical manner at Oogue at Siberia

Wall at China, The White House etc., The failures of buildings are broadly divided into two types. Structural failures and the other is nonstructural failures. Structural failure affects the structures in a noticeable way and also the life of the occupants. Structural failure means the failure of a concrete construction to fulfill the purpose for which it was constructed. Nonstructural failures includes defects in brickwork, defects in plaster work, defects in plumbing work, and defects in electrical work etc., which do not affect the safety of structure to a great extent in grand manner. The past of failure of structures happening from very olden time from 300A.D. and lasts till date. Figure 1.1 shows the strong of a tall structure into two portions in a vertical manner at Oogue at Siberia.

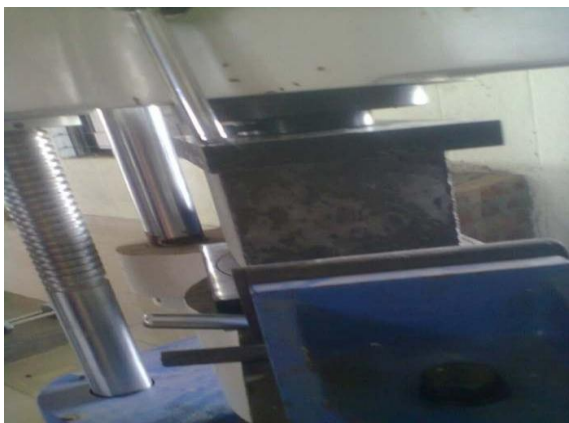
Fig -1: Compression Test on Cube

For checking the concrete strength with the design mix, cubes are casted and tested for compression strength and Tensile strength.

Compressive Strength of Concrete Cube	=	27.8N/mm ²
Tensile strength of Concrete	=	2.56N/n f _c ² (10% o k)
Flexural strength of concrete	=	31.6N/mm ²

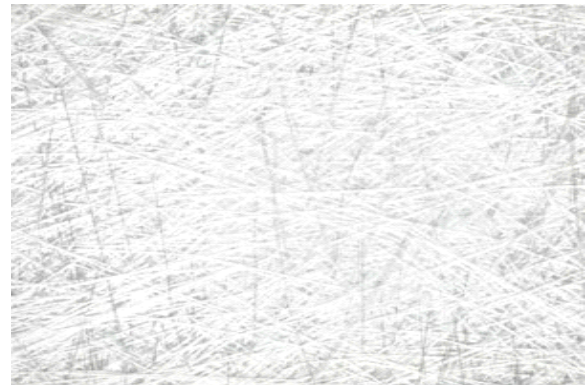
Chopped Strand Mat is also shortly known as CSM. It will have chopped glass fiber which is 3 to 4 inches in length and the fiber runs in multi-directions. Usually chopped strand fiber mat is compatible only with the resin like polyester and vinyl ester. Epoxy resin will not have compatibility with the chopped strand mat. Chopped strand

mats can be torn by using hand; these mats are used in specific region to increase the strength of the area.

Fig -2: Chopped Strand Mat

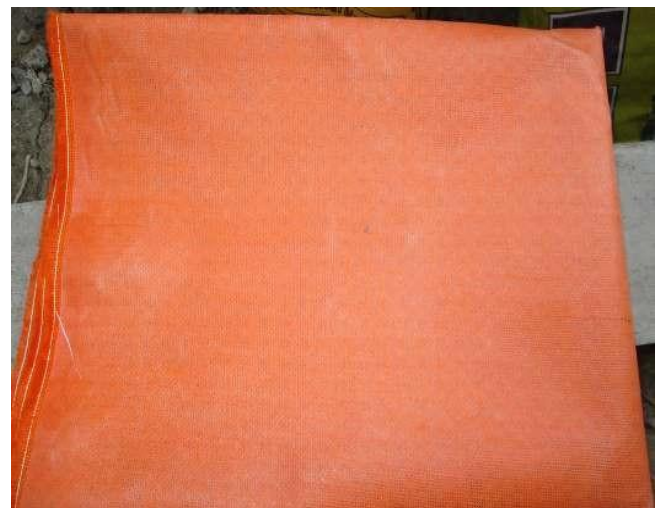
Jute Fiber is one of the easily available materials in India. The manufacturing process of the jute fiber is much easy and it is the done as a homemade business in many of the small villages in India. When jute fiber is compared with the glass fiber in the aspect of the cost it is much cheaper material. But in the aspect of the strength jute will not perform as much as glass fiber, still jute is used for rehabilitation work because of its availability and low cost of the material.

Fig -3: Jute Fiber

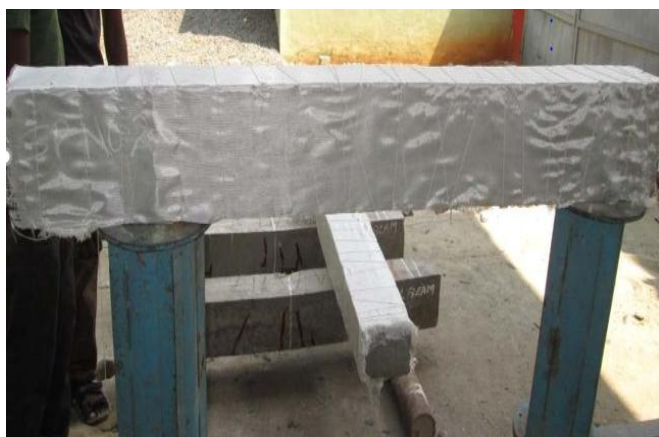
Fig -4: GFRP Wrapped Beam - 225GSM

- ❖ For the control specimens the mean cracking load is 65.33kN. The mean deflection is 14.1mm.
- ❖ For the beam rehabilitated by GFRP 225 GSM the average ultimate load taken by the beam is 72kN. So the load bearing capacity is increased by 10% . The deflection is 15.37mm which is increased by 9.7%.

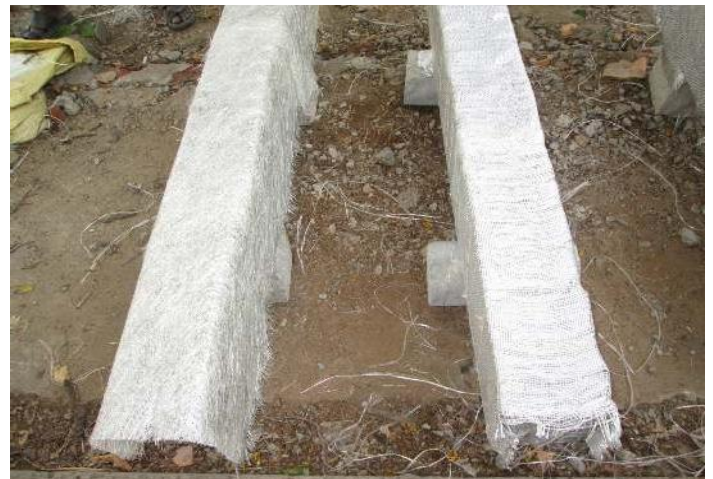
Fig-6: GFRP Wrapped Beam - 400GSM

- ❖ For the beam rehabilitated by GFRP 400 GSM the average ultimate load taken by the beam is 85.67kN. The load bearing capacity is increased by 31% . The deflection is 16.73mm which is increased by 18%.

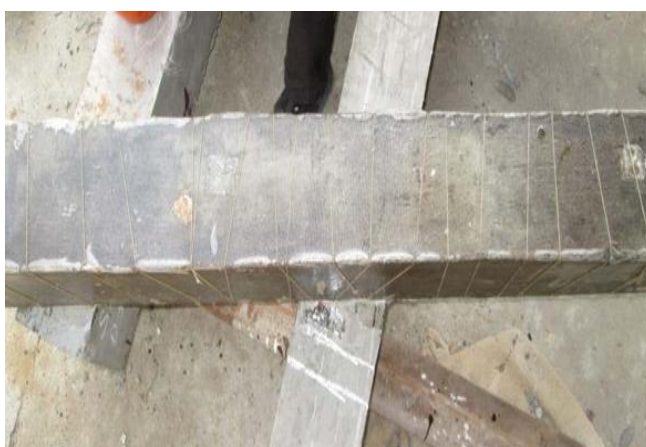
Fig -5: After applying Polyester Resin for bonding - 225 GSM

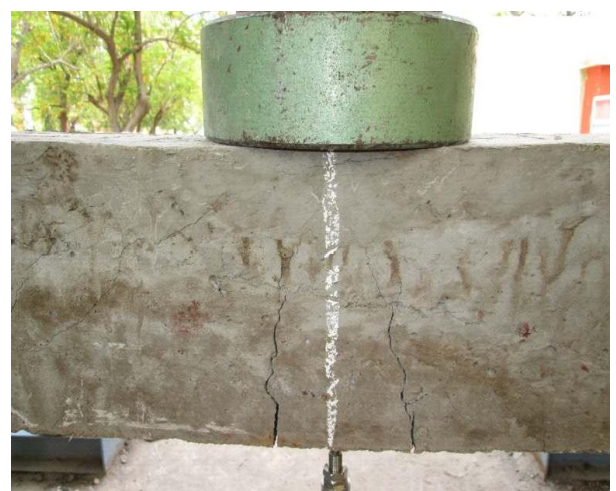
During the experimental work it was observed that when the beam reaches the cracking load the initial cracks are formed. After formation of initial cracks, continuous applying of the load, the initial crack has been developed into broader and deeper crack, which makes the beam incapable to carry loads, thus ultimate load is attained by the beam. As a flexural member, due to deflection crack is formed at the middle 1/3 portion of the beam. This beam is designed as an under-reinforced beam so that the failure of the concrete takes place first by the formation of crack. This kind of beam is safe, because we can get warning of stress in beam by the crack appearance. If the beam is reinforced as over reinforced beam steel will fail first due to failure of steel, concrete will fail immediately, therefore we can't get any kind of warning from the beam member.

Fig-7: Crack Due to Ultimate Load
