Road Safety Auditing of Koratty Intersection

Abstract – Road safety audit is done on existing roads and proposed roads. Main objective of this audit is to determine the deficiencies of each road and suggest the methods to overcome those deficiencies. Accident study has to be carried out at the selected intersection and the probable reason for accidents and remedial measure to avoid accidents in future has to be suggested. Various road furnitures have to be identified and the observed data has to be compared with the standard data given by Indian Roads Congress (IRC). The aim of this study was to carry out road safety audit at Koratty intersection located on NH544. Accident data, spot speed data and other road geometry data were collected and suitable conclusions drawn. Traffic volume count was taken for three days and traffic flow diagram was plotted.

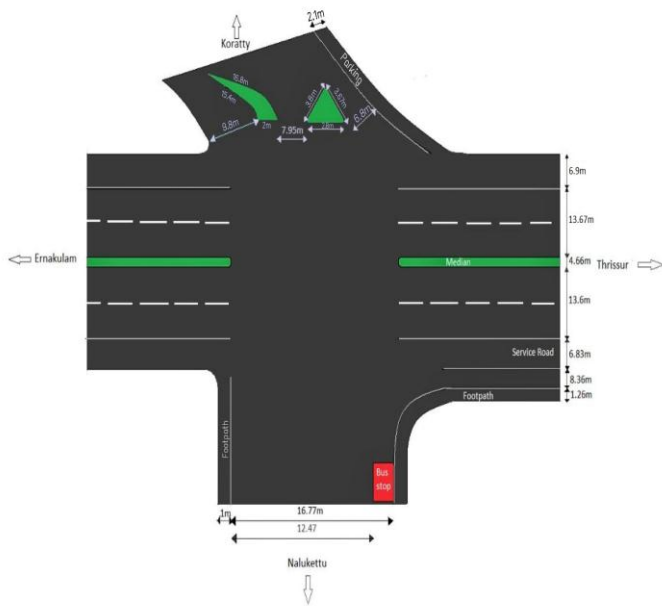
Fig-1: Layout

Width of different roads and medians were taken with the help of a measuring tape and following results obtained. The distance of the bus stop from the junction was also measured using a tape. The bus stop to Nalukettu was at a distance of 20m from the junction and the bus stop to Ernakulum was at a distance of 27m from the junction.

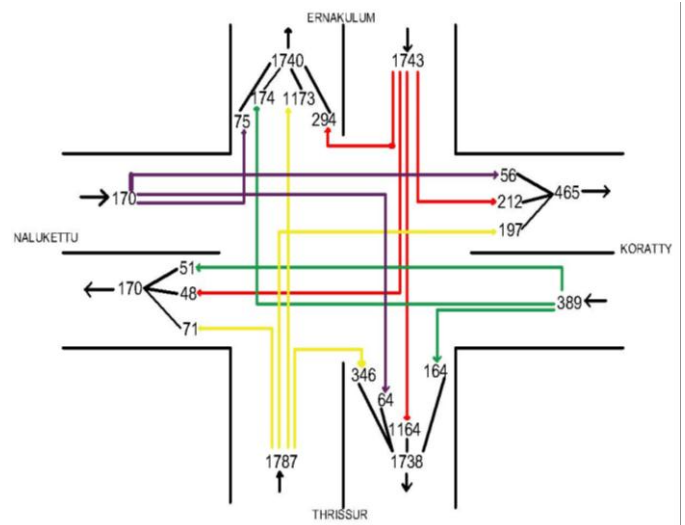
Fig-2: Traffic Volume on Sunday

Traffic volume count was taken for three different days: Sunday, Monday and Wednesday. Number of vehicles entering and leaving the junction was found out. The count was taken at three different time that is morning from 7.30 am to 10.30 am, at noon from 12.00 pm to 2.00 pm and at evening from 3.30 pm to 6.30 pm. The obtained number of vehicles were classified as mentioned in IRC: SP: 41-1994 Guidelines for the design of at-grade intersections in rural and urban areas. The vehicle count obtained was represented in passenger car unit (PCU) for design purpose. This is done by multiplying the obtained number of vehicle with equivalency factors obtained from IRC: SP: 41-1994. Vehicular traffic was maximum on Monday followed by Wednesday and the least on Sunday. It follows the usual pattern. Traffic flow is more during the morning and evening peak hours and less during the off-peak hours.

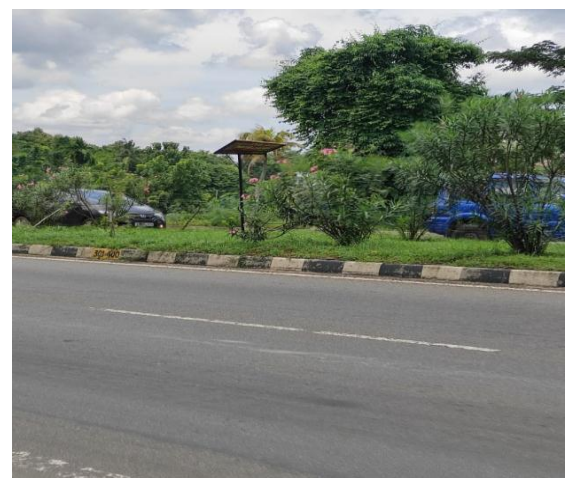
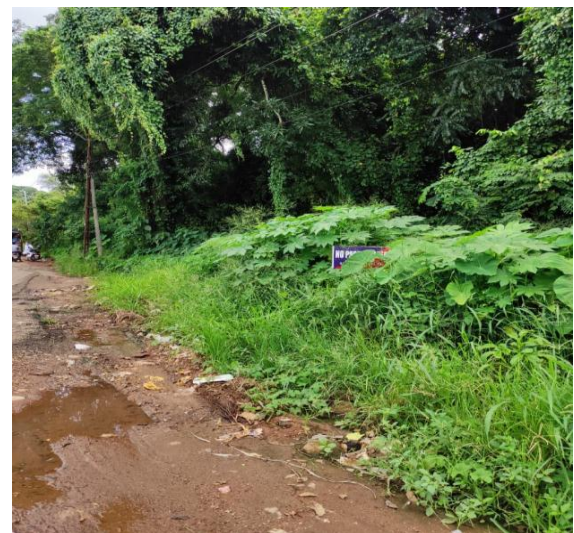
Fig-5: Road Observations

Pavement edges are not well maintained. Median has sufficient width but the plants grown on the median are projecting to the traffic lane adjacent to the median which forces more vehicles to move to left lane. Pavement failures like cracks and edge break are seen in many spots. Hoardings and flex boards are placed even on the traffic signal posts which affect the visibility of the driver. Bus stops are located near to the intersection which affect the traffic flow especially when green signal is given to the traffic. Road markings are not clear on many of the road stretches. Pedestrian crossing is absent at main points also. Foot path is not provided on both sides of the road. Sign posts are also missing at some important locations. Direction boards and speed limit boards are not maintained properly.

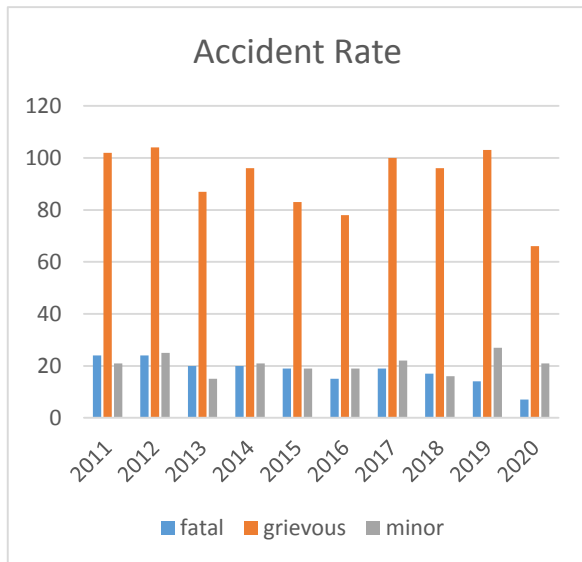
Fig-6 : Accident classification

Accident data for past 10 years that is from 2011 to 2020 were collected from Koratty police station and was classified into fatal, grievous and minor accidents. Fatal means that death of a person due to the accident. Grievous means the

person involved in the accident has got some serious injury including fracture of bones and damage to teeth. Minor stands for accident involving persons with minor scratch and injury. It was also found that more accidents occurred at day time when compared to night.
