Material Characterization of Buried GFRP Pipeline Failed during Hydrostatic Testing

^aDepartment of Scientific Services, Metallography Laboratories, Tata Steel Limited, Jamshedpur 831007, India

Abstract - Glass Fiber Reinforced Plastic (GFRP) pipe is made up of diverse materials, the qualities of the different materials combine to provide superior properties. GRP pipes consist of glass fibers, vinyl ester resins, or unsaturated polyester and different reinforcing agents. There was premature failure of GFRP composite pipes during hydrostatic (hydro) testing while laying out in the construction site. The hydro test is a process where components are tested for strength and leaks before putting them in service. Two pipe samples, one referred to as good pipe and another referred to as leaked or used pipe, were investigated to find out the root cause of failure. The investigation consisted of field-visit, studying the layout procedure, visual observation, microstructural characterization, Raman spectroscopy analysis, Thermogravimetric analysis (TGA) and Fourier transform infrared spectroscopy (FTIR) analysis analyses. Visual observations of the leaked or used pipe sample reveals some a

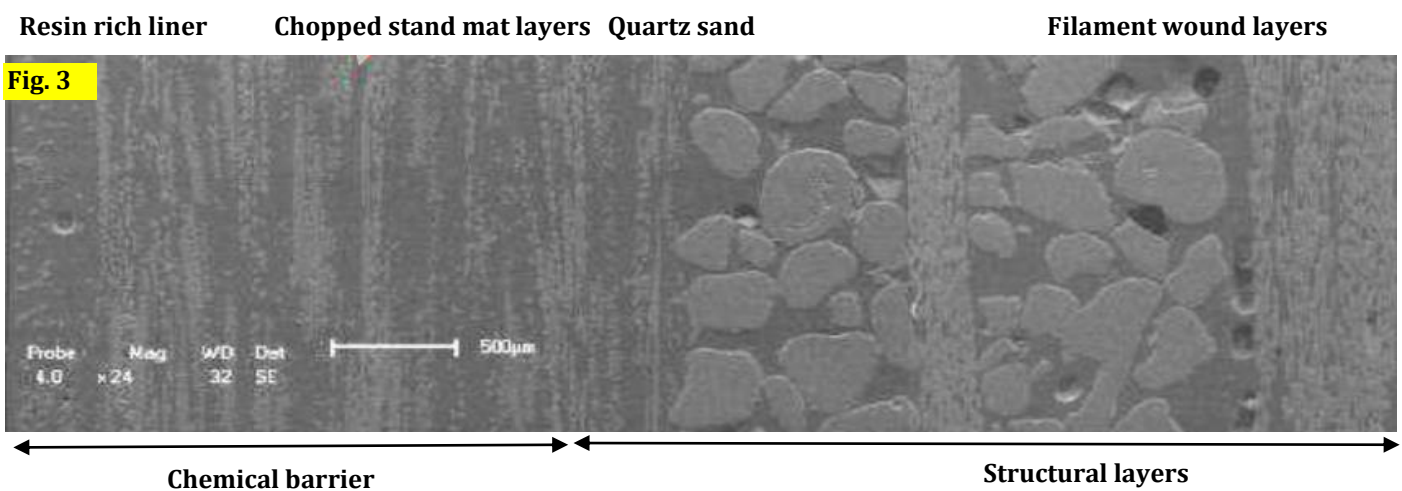
Fig.3: The innermost (at left) to the outermost surface microstructure of the GRP pipe wall

The typical microstructure of GRP pipe is shown in Fig.3.
