Analysis of Landslide near Ambo City, Ethiopia, East Africa

Anand Hulagabali¹, Dumesa Gudissa², Woyesa Ararsa³

^{1,2,3}Civil Engineering Department, Institute of Technology, Ambo University
Ambo, West Showa, Ethiopia, East Africa

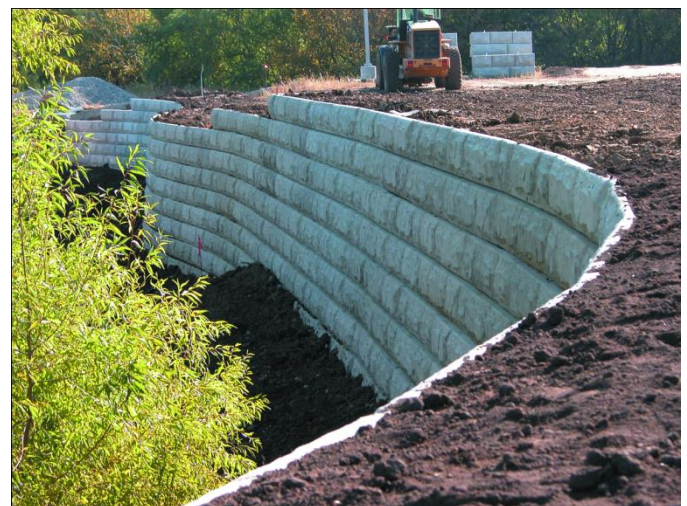
Fig -5: MSE Wall used for Slope Protection

Reinforced Earth wall: Reinforced earth is a composite material formed by cohesion less soil and flexible metal reinforcing strips. The earth and the reinforcement are combined through friction. The result is monolithic mass that act cohesively supporting its own weight and applied loads. Mechanically Reinforced earth wall u utilize tensile reinforcement in many different forms: from galvanized metal strips or ribbons, to HDPE geotextile mats, like those shown above right. This reinforcement increases the shear strength and bearing capacity of the backfill.

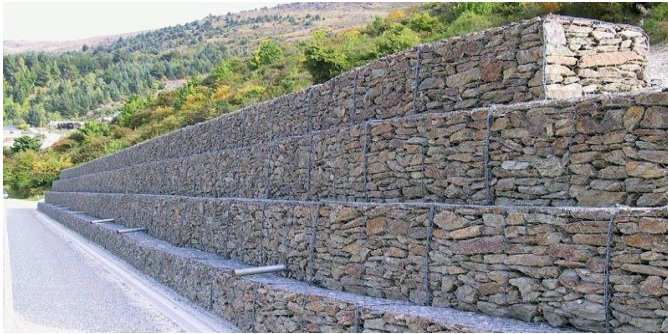
Fig -6: Gabion Wall used for Slope Protection

Gabion Wall: A gabion wall is a retaining wall made of stacked stone-filled gabions tied together with wire. Gabion walls are usually battered (angled back towards the slope), or stepped back with the slope, rather than stacked vertically.

The life expectancy of gabions depends on the lifespan of the wire, not on the contents of the basket. The structure will fail when the wire fails. Galvanized steel wire is most common, but PVC-coated and stainless steel wire are also used. PVC-coated galvanized gabions have been estimated to survive for 60 years. Some gabion manufacturers guarantee a structural consistency of 50 years.

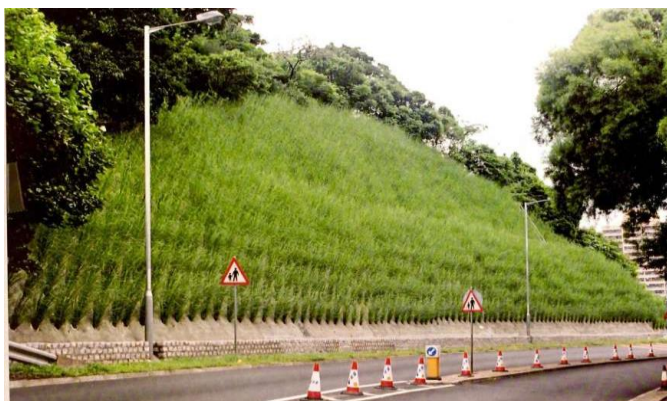
Fig -7: Vetiver Grass for Slope Protection

Vetiver grass can reduce or control soil erosion on the slopes if planted in rows across the slope. Row spacing should be 1 m and clump spacing 10-15 cm. Soil erosion protection occurs both in surface and sub-surface soils. When the vetiver clumps grow close laterally, they act as a living wall which stands against and slows down runoff, and the eroded soil is deposited behind the vegetative barrier. The vetiver grass tillers grow up through it and go on building natural terraces, and they adjust themselves to rise above these natural terraces, which still act as living walls as long as the vetiver is alive. Under the vetiver hedgerows where the soil condition is good, the root system penetrates as deep as about 3 m and expands to about 0.5 m. The root system acts as an underground curtain that tightens the soil particles like reinforced earth to protect from erosion.
