FORENSIC ANALYSIS OF COLLAPSE OF SURFSIDE CONDOMINIUM, MIAMI

Alessandro Anil Mathew¹, Er.Gopika Moorthy²

¹Department of Civil Engineering, Saintgits College of Engineering, Kottayam

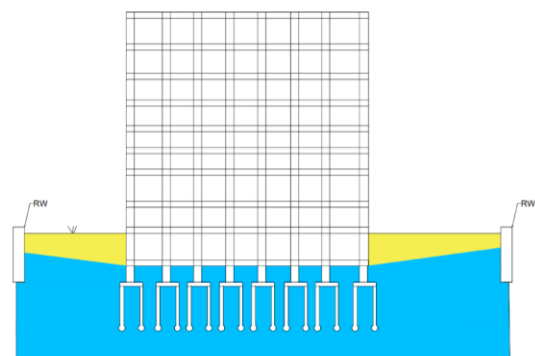
The whole building is on top of small columns extending from the foundation. These columns act as a box. During monsoon in the water table rise to the floor of the garage as shown in Fig. 11.

Fig -11: Water table during the monsoon period

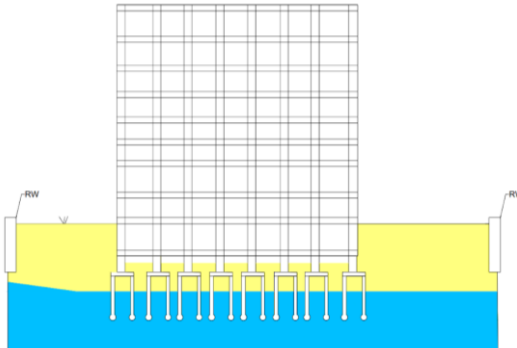
Then during summer, the water table goes down along with the soil near the columns, Hence creating a void near the foundation as shown in Fig. 12.

Fig -12: The water table goes down the following summer.

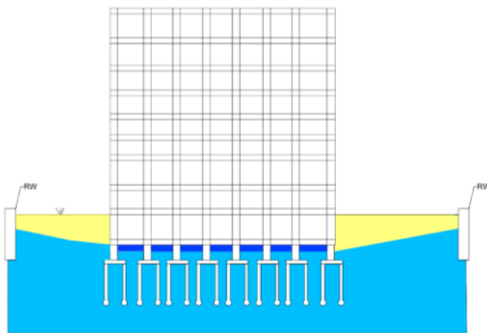
Then the following monsoon period the water table rise filling the void in the foundation as shown in Fig. 13.

Fig -13: The water table rises in subsequent monsoon.
