SAFETY ON RAILWAY LEVEL CROSSINGS IN KURUNEGALA DISTRICT, SRI LANKA

Kumudu Vidana Gamage^{1,2}

¹Department of Civil Engineering, University of Peradeniya, Sri Lanka

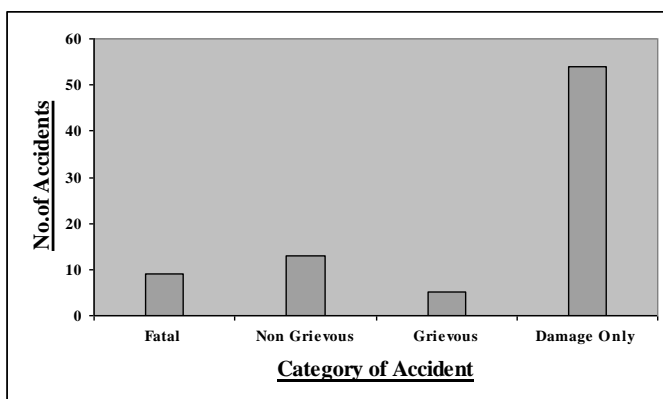
Fig - 3: Variation of No. of Accidents with the Category of Accident

According to Fig. 3, number of damage only accidents are at a high level with respect to other accidents and according to Fig. 4, number of railway induced accidents is comparatively high. Most of the damage only accidents are of collision with the rail gate. Drivers' negligence and poor visibility of the rail gate at night were affected for those accidents. Nine fatal accidents were occurred during last six year period. Most of them were happened by collision with the train. According to the collected data, out of those nine accidents only two accidents were happened at unprotected level crossings. Therefore, the driver negligence was seriously affected for those accidents.
