DETECTION OF DEFECTS IN SOLAR PANELS USING THERMAL IMAGING BY PCA AND ICA METHOD

ABSTRACT: For good efficiency, fast, reliable and smooth operation of any process we need a failure free operation. It gives a high production and also ensures high return on investments. A failure free operation is of fundamental importance for modern commercial solar power plants to achieve higher power generation efficiency and longer panel life. So a simple and reliable panel evaluation method is required to ensure that. By using thermal infrared imaging, glitches or defects in the solar panels can be easily detected without having to incorporate expensive electrical detection circuitry. In this paper, we propose a solar panel defect detection system based on thermal imaging, which automates the inspection process and mitigates the need for manual panel inspection in a large solar farm. So in this way solar panels can be checked while in operation without disturbing the continuity of operation. So it saves lot of time and cost of detection.

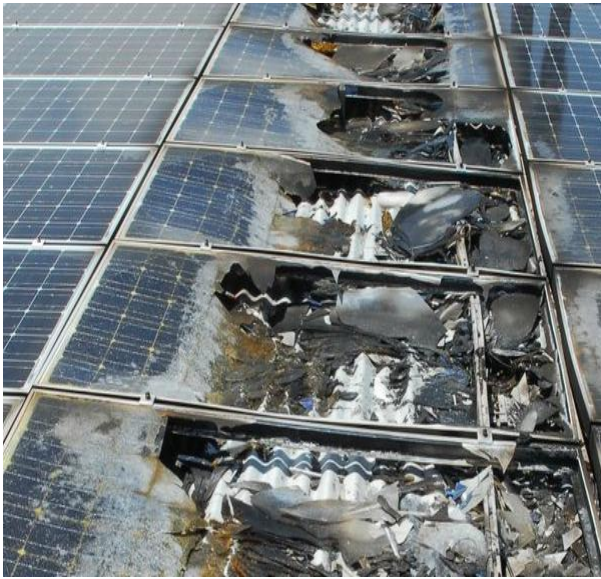
Fig 1.1 (b) fault occurred in 1 MW PV power plant in Mount Holly, North Carolina, in 2011

Several severe fire hazards have been reported in PV systems due to non detection of fault. For example- Fig. 1.1(a) shows the fire hazard which took place in a 383 kW PV module in Bakersfield, California in 2009. Another fire hazard was occurred in a 1 MW PV power plant in Mount Holly, North Carolina, in 2011 shown in fig 1.1(b). In both these cases, the fault remained unnoticed and hidden within the system until the hazard caused catastrophic fire and shut down the system completely.

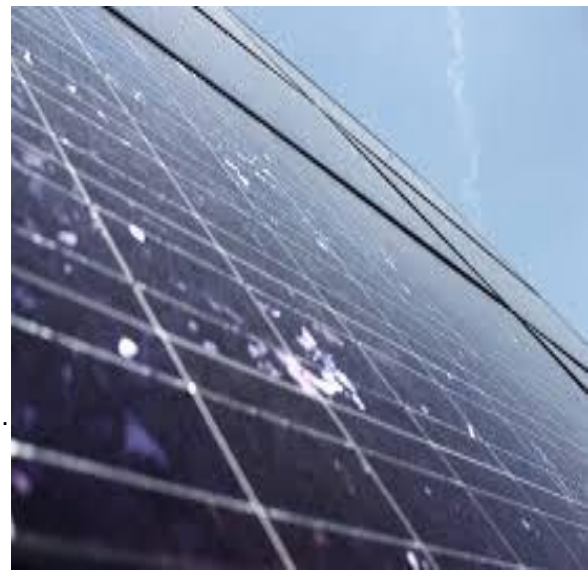
Figure (a) shows a defected input image of a solar panel

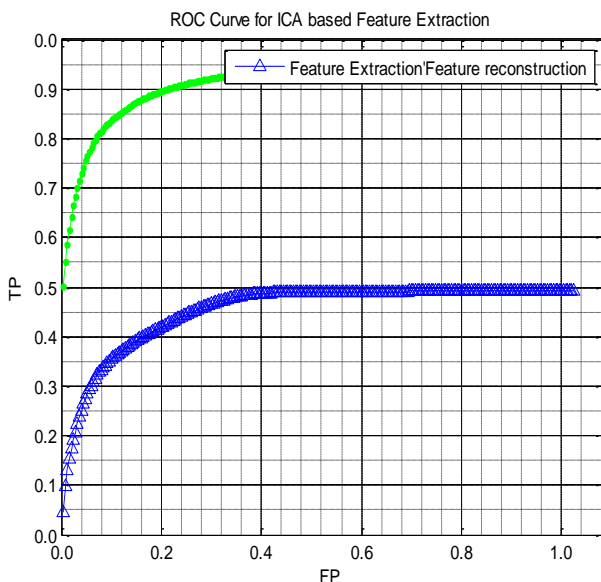
Fig: A ROC curve for ICA based feature extraction over FP and TP
