COMMON MYTHS REGARDING THE FALL OF ICE FROM THE SKY

By Bimal Kumar Srivastava

Abstract- Reports about bizarre incident of fall of a lump of Ice (Blue, Greenish, white or of any other colour) from sky even when the weather might have been dry keep on appearing through the media all around the world mentioning. Mostly such ice is not related to weather, but is a mixture of human bio-waste and liquid disinfectant that freezes at high altitude and is known as "Blue ice" or "Aircraft Ice".

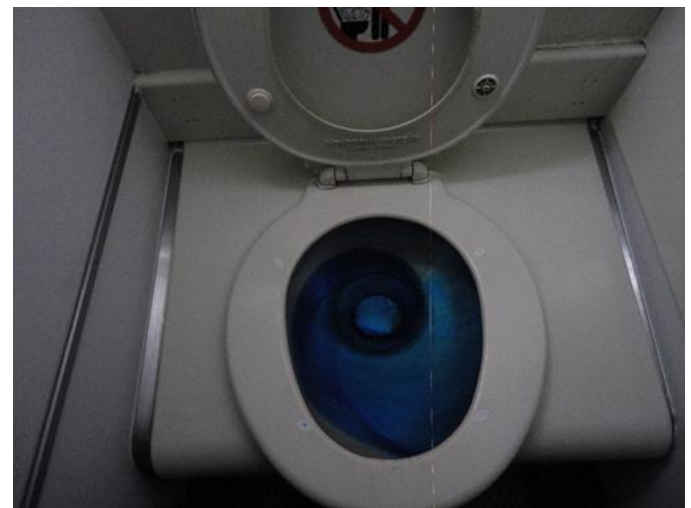
'Based on physical and chemical examination of the sample of blue ice, it appears to be frozen bio-waste mixed with commonly used blue coloured liquid disinfectant material.'

This confirmed the origin of the ice as from the aircraft.

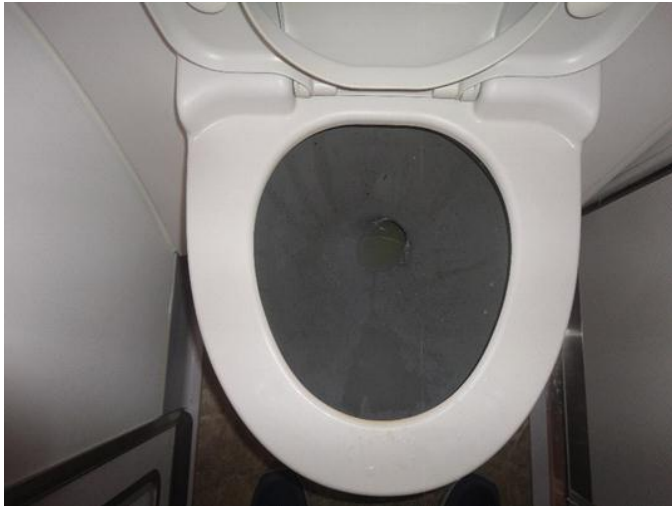
Blue/ Green and Greenish-Blue Coloured Chunks:

The earlier generation aeroplanes *say till the early 1980's* had toilet bowls mounted on top of self-contained toilet waste tanks. These toilet tanks were serviced with a chemical fluid that was mixed with a blue or green dye, and deodorant, and were serviced from toilet service panels. The same fluid was used right through the flight each time the flush handle in the toilet was operated. The blue ice problem could be linked to leakage of the drain valve at the bottom of these toilet waste tanks as well as leakage of the drain valve at the toilet service panel, which always could be blue, greenish-blue or Green. On such aeroplanes, one could see blue stains on the sides of the fuselage close to the toilet servicing stations. In other words, before mid-eighties, any ice chunk from an aircraft invariably used to be Blue. And that was the origin of the word "blue ice" which has been in use even till today. In case the quantity of the urine in the flush tank was more, the colour of ice used to become green or greenish on mixing with blue disinfectant. was or greenish.

It is also worth mentioning, that even in modern-day aircraft, sometimes still they do use blue coloured sanitizer liquid, though occasionally. Thus, in such cases, the leakage maybe blue.

For example, on 15 June 2013, the author flew on an ATR-72 aircraft, where the Blue sanitizing liquid was used in the toilet bowls. Hypothetically, leakage from the defective toilet lines of this aircraft will be Blue, as shown below:
