# Waterproofing Work of Existing Building in Mumbai

Vivek Singh<sup>1</sup>, Shalaka Nawle<sup>2</sup>

<sup>1,2</sup>Creative Consultants, Mumbai, Maharashtra

Our Project Name SIDBI (Small Industries Development Bank of India) Officers Quarters is located at Videocon Tower, Plot No. 25, Veera Desai Road, Andheri (W), Mumbai, Maharashtra. The building is a R.C.C. frame structure having Basement & Stilt + 10 storeys. Fieldwork started from 28th December, 2016 and the entire work was completed by 7th January, 2017. Preliminary drawing preparation, visual inspection and tapping was carried out simultaneously; results of the same are presented in this document.

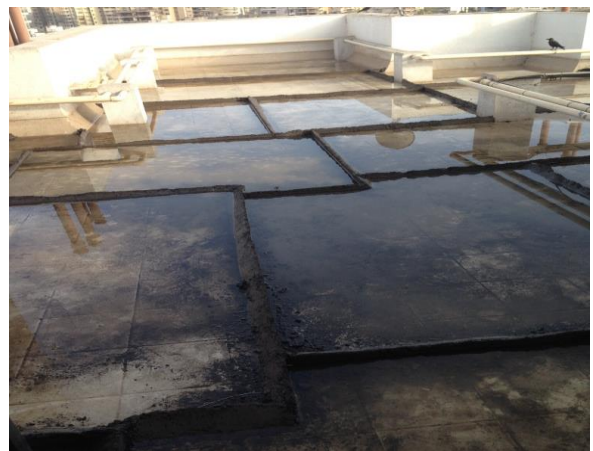
Existing Terrace top of the building was of I.P.S finish. Leakages from terrace top to below flats has been observed at the time of survey. To validate the source we have conducted the water ponding test. After 48 hours, we inspect the flats below terrace and observe dampness patches on ceiling.

Fig -1: Water ponding Test

Before starting the actual work of Waterproofing of slabs it is highly recommended to conduct a water ponding test or flood test. For water ponding test the surface with water to a depth of 50 mm for 48 hours or longer. This tests the water tightness of the floor. The test is found satisfactory if there is no leakage and there is no damp patches observed on the surface of the floor.

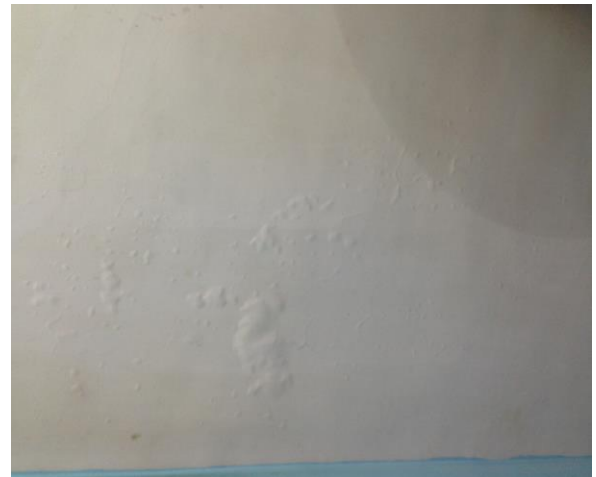
Fig -2: Leakages observed

However based on actual observation from inner side of the flat, dampness is observed due to leakage from terrace; it was a need of time to retrofit the terrace with injection grouting or waterproofing by brickbat coba method or chemical waterproofing or any other suitable method.

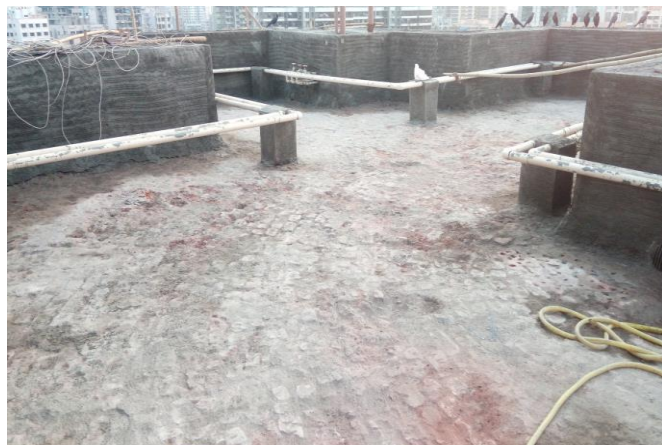
**Fig -3:** After Breaking of IPS

Remove the existing IPS Top completely up to the brick bat layer with the help of breaker machine, to be used for puncturing & subsequently chisel & hammer using chisel at an angle to ensure that the existing brick bat does not get damaged. Dispose off the removed debris and clean the bare slab thoroughly.

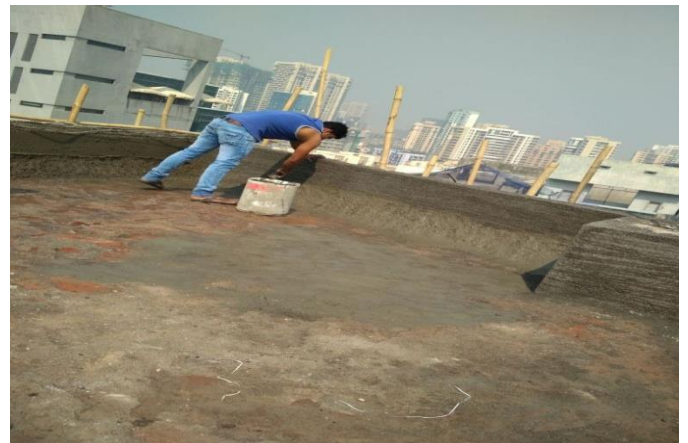
**Fig -4:** Applying coating

Open the visible cracks on the top surface in V groove & fill the cracks with a paste of Approved Polymer, cement & water. Fill the gaps in the brickbats by applying two coats of Polymer Emulsion: Cement slurry of 1: 1 to the entire bare slab. All gaps to be filled properly and the entire bricks should be completely covered.

Apply the cement slurry over the levelled surface for smooth Ghutai. Polish the surface with metal float i.e. patra.

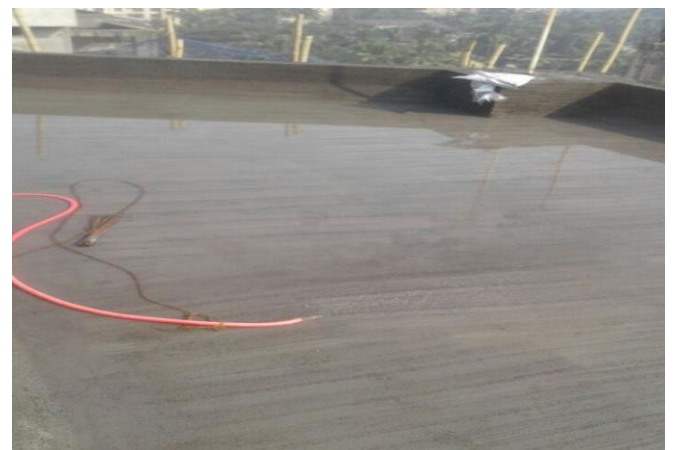
**Fig -5:** Water ponding after complete of IPS

Carry out pond test by ponding water on the coated surface for a minimum 3 days.

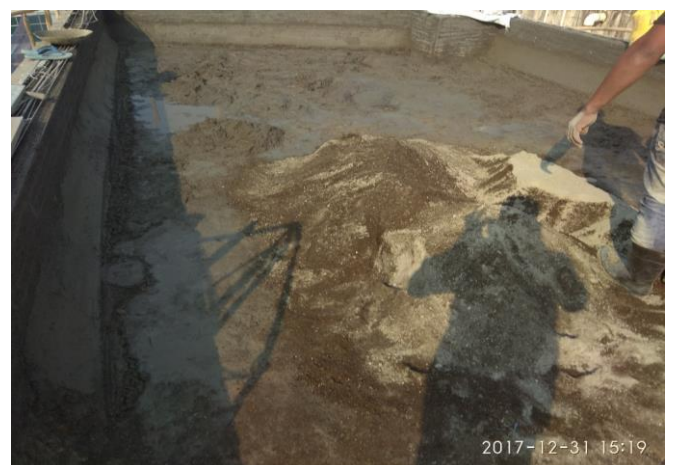
**Fig -6:** Spreading Cement-Mortar

Spread the cement-mortar in 1:4 proportion with the thickness of 20 to 25mm. This bed is checked for levels and slops. Water is sprinkled on this bed and dry cement is spread on the work area.

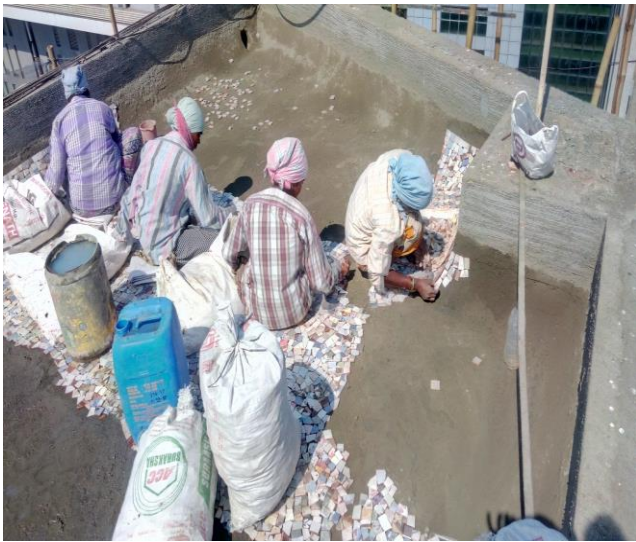
**Fig -6:** Fitting China Mosaic chips

Pieces of china mosaic are then pressed and fitted in position. The joints between these 2 pieces should not be more than 3 to 4 mm. Coving (Vatta) height to be maintained at 9" or 230mm. After laying of China mosaic pieces they are hammered with wooden mallet to achieve a uniform surface.

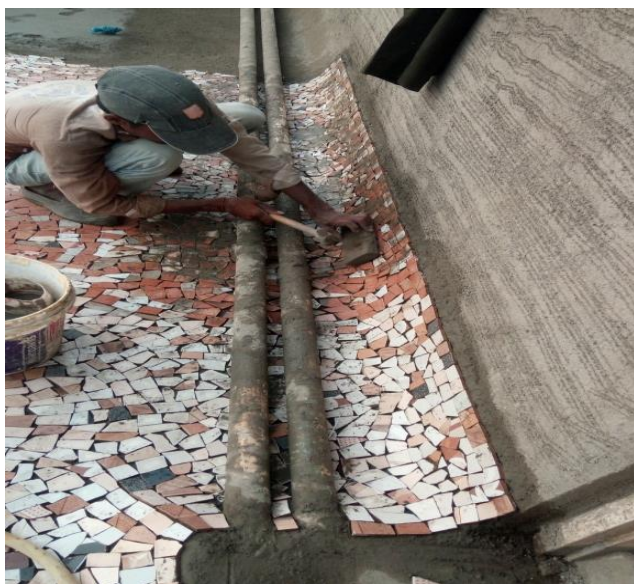
**Fig -7:** Pressing CM chips with Mallet

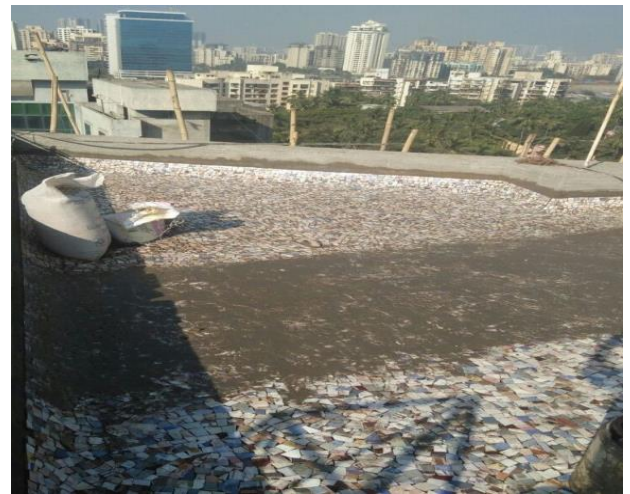
**Fig -8:** Surface left for drying

The surface is cured for at least 3 days. The surface is then cleaned with saw dust to remove access cement sticking to the glazed china mosaic. Completed work is then cured for 15 days.

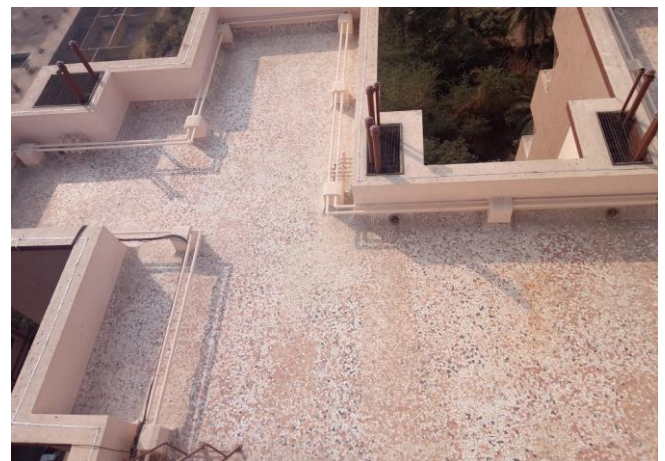
**Fig -8:** Finished Surface
